# NATIONAL TRANSPORTATION SAFETY BOARD

## MATERIALS LABORATORY FACTUAL REPORT

Report No. 16-081

Place : Chatham, Massachusetts  
Date : June 17, 2016  
Vehicle : Robinson R44, N141TM  
NTSB No. : ERA16LA216  
Investigator : Robert Gretz, AS-ERA

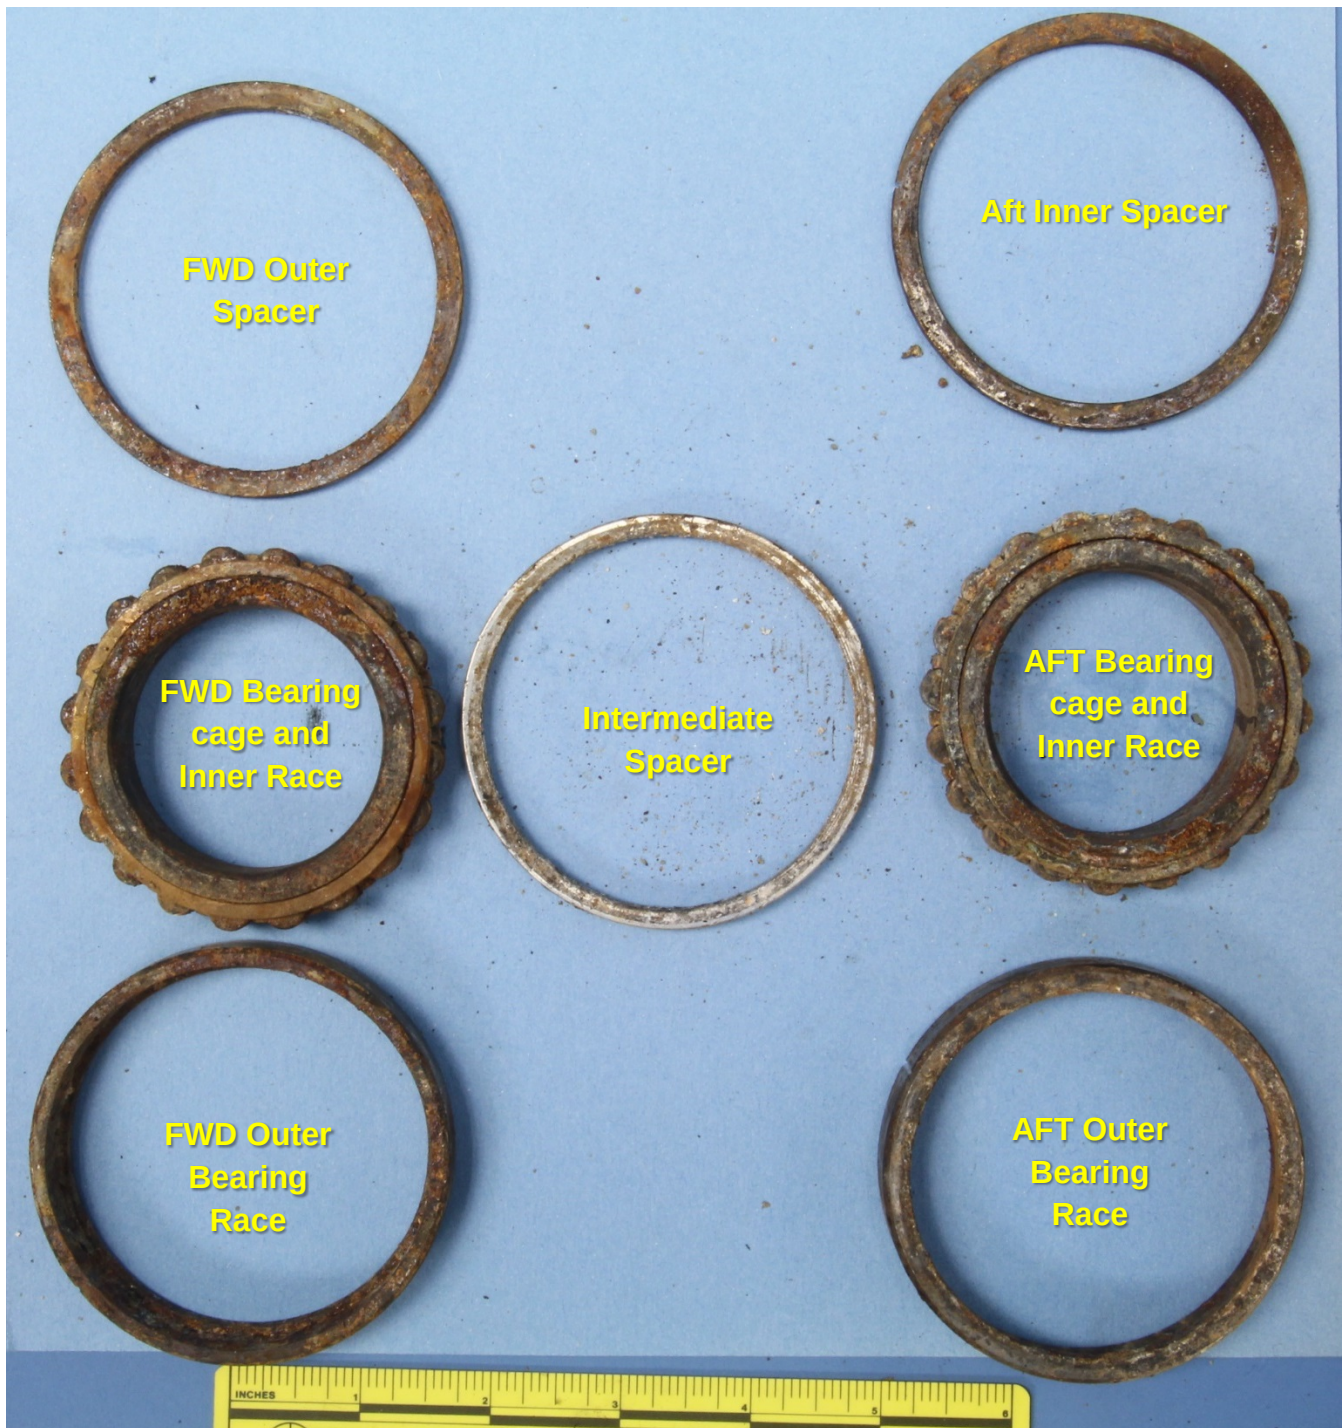
Figure 5 – The bearing components, after complete disassembly, ordered from forward side to aft side from left to right.

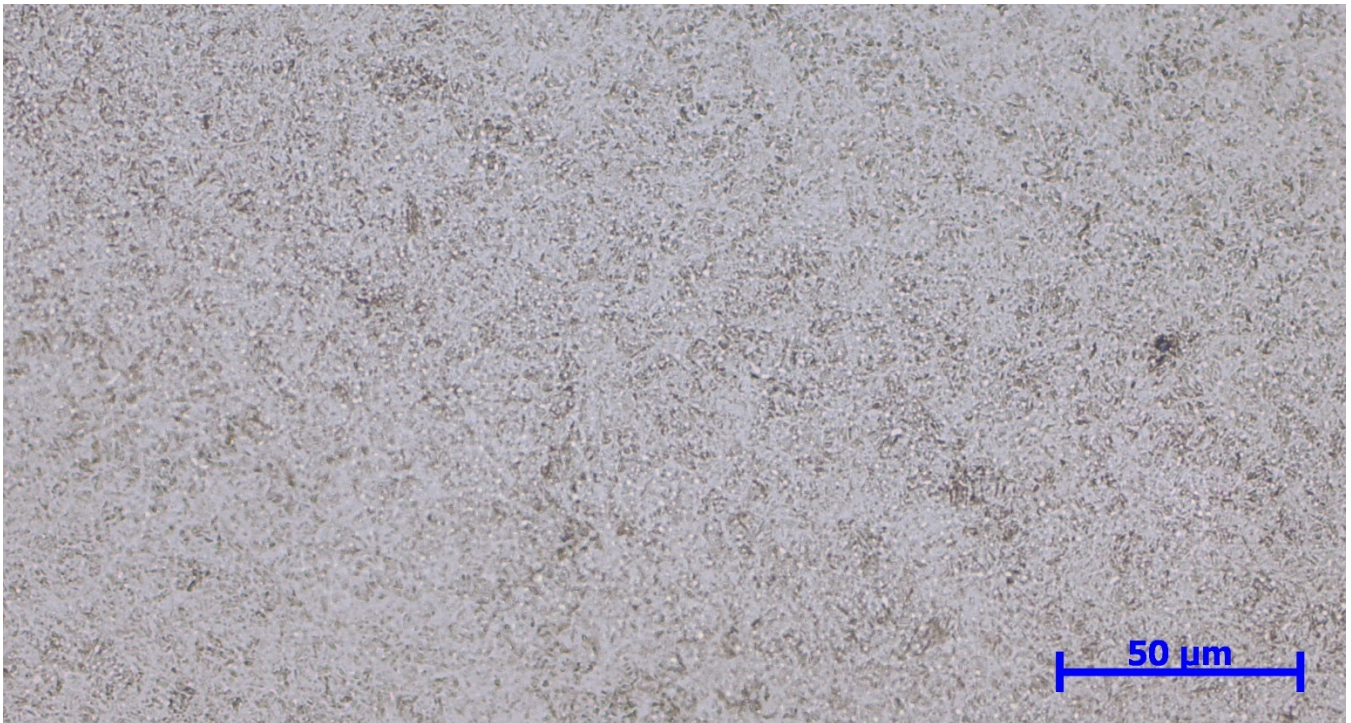
Also of note was a change in the general microstructure in the inner race from the outer and inner surfaces (compare Figure 17 and Figure 18). Figure 19 shows a closer view of the general microstructure of the inner race. This microstructure was typical for a tempered AISI 52100 bearing steel, exhibiting a matrix of martensite, containing primary carbides and some retained austenite. This microstructure was comparable to one of the same material having been austenitized at close to the solid phase transformation temperature and then oil quenching and then tempering.<sup>2</sup>

Figure 19 – BF optical metallograph of the forward bearing inner race, showing a typical area of microstructure away from the inner surface (~500X, etched 2% Nital).

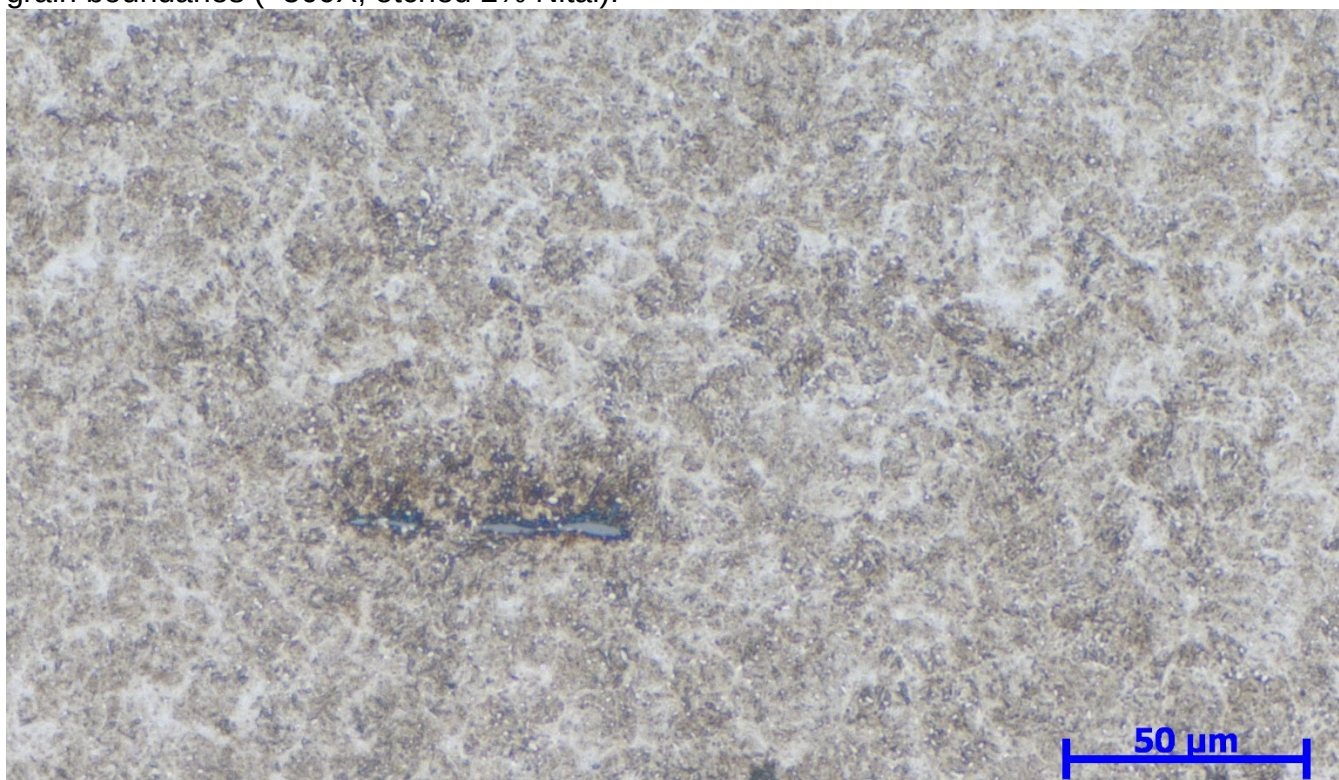
The microstructure of the outer race and rollers were consistent with the microstructure of the outer portion of the inner race: a matrix of tempered martensite, containing primary carbides with some retained austenite (see Figure 21 and Figure 22, respectively). The bearing cage, being a brass, exhibited a two-phase microstructure typical of most  $\alpha$ -brass alloys (see Figure 23). No surface discrepancies or material defects were observed in the microstructures of the cage, outer race, or roller specimens.

Figure 21 – BF optical metallograph of the forward bearing outer race, showing a typical area of microstructure (~500X, etched 2% Nital).

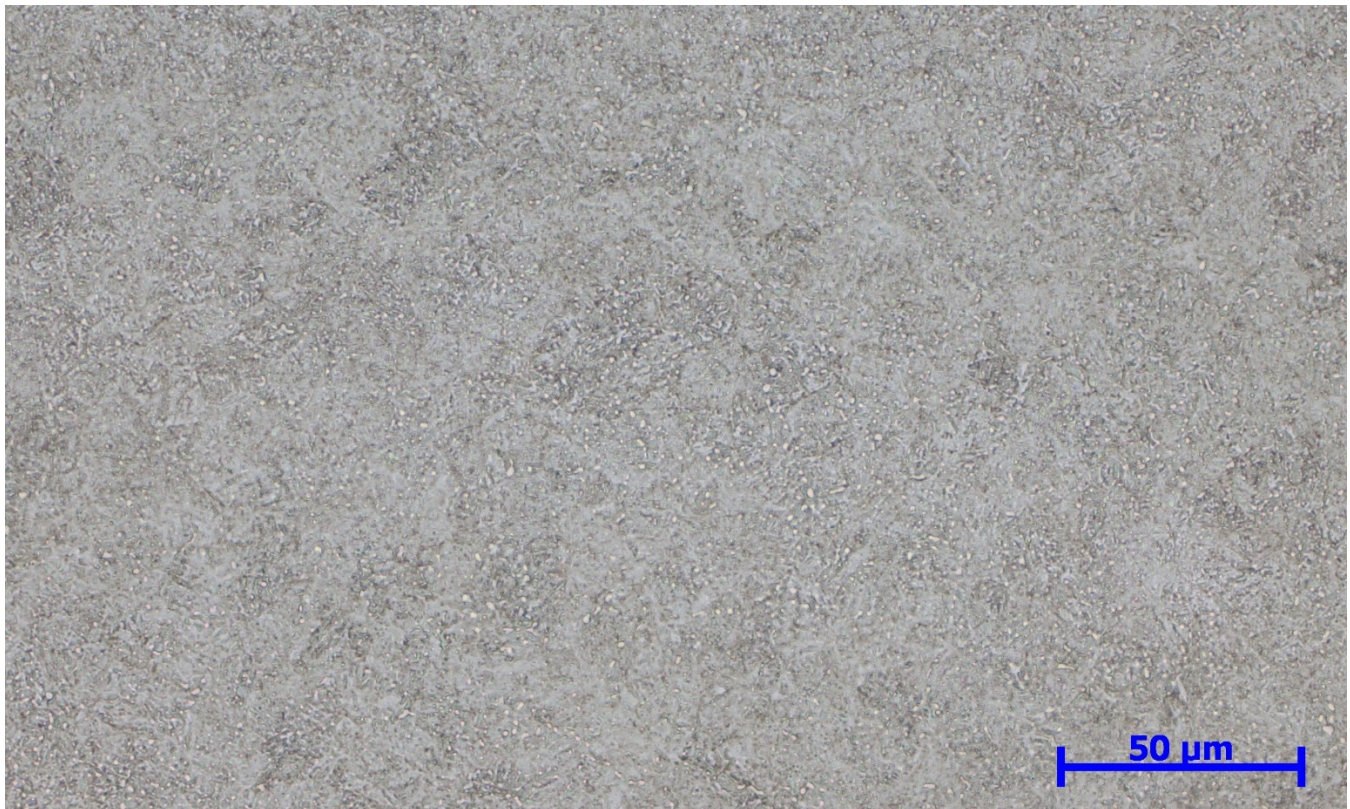
Figure 22 – BF optical metallograph of a forward bearing roller, showing a typical area of the microstructure (~500X, etched 2% Nital).

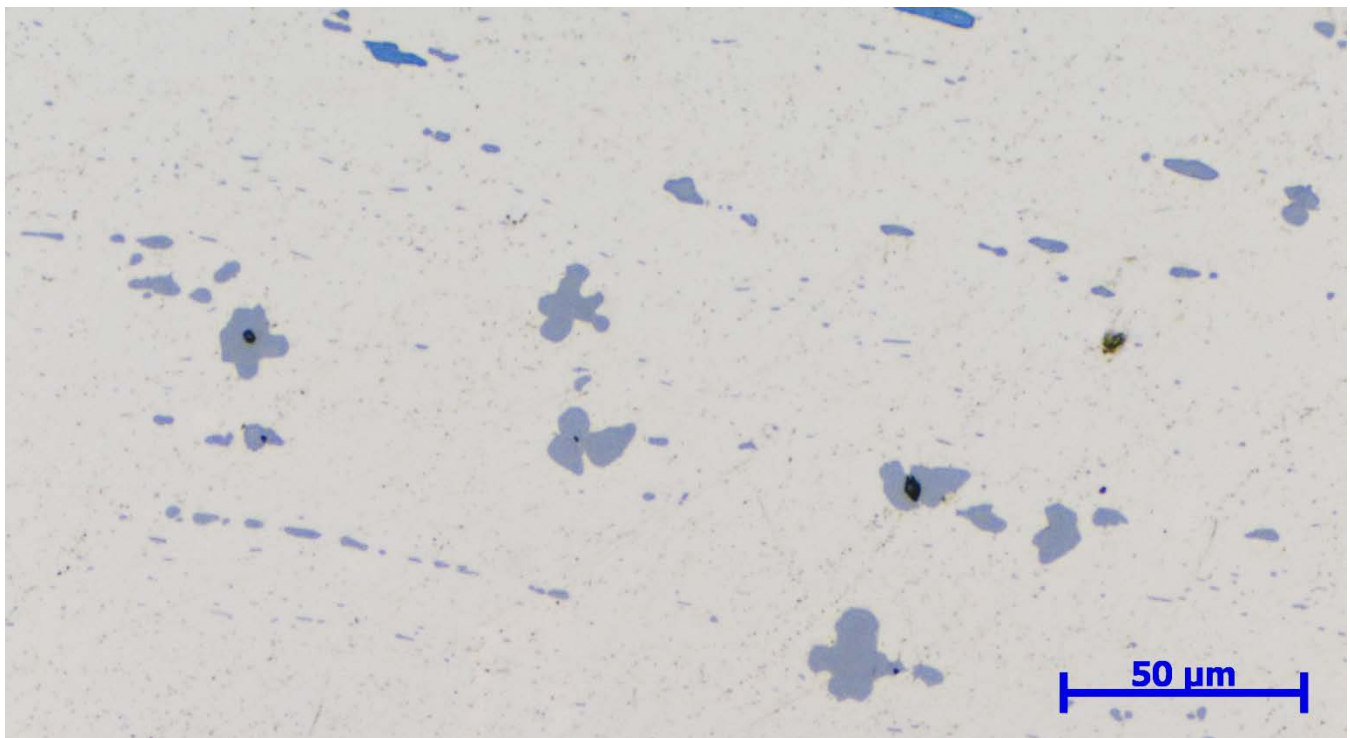
Figure 23 – BF optical metallograph of the forward bearing cage, showing a typical area of microstructure with the two phase microstructure of an  $\alpha$ -brass (~500X, etched 2% Nital).
