## **INVESTIGATION REPORT**

| <b><u>ACCIDENT INFORMATION</u></b> | | | |
|---|---|---|---|
| <b>Date of accident:</b> | 07/09/2016 | <b>NTSB file number:</b> | ERA16LA247 |
| <b>Aircraft Make:</b> | Adventurea | <b>Aircraft registration:</b> | N932MC |
| <b>Engine Type:</b> | Rotax 912 ULS | <b>Engine TTSN</b> | Unknown |

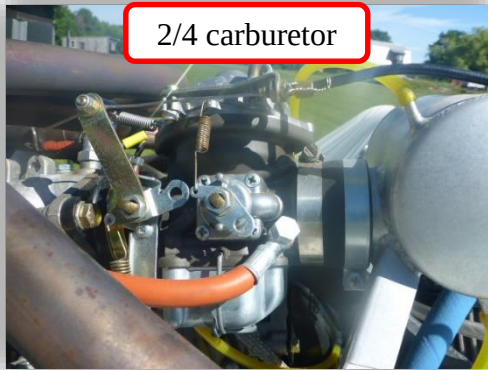
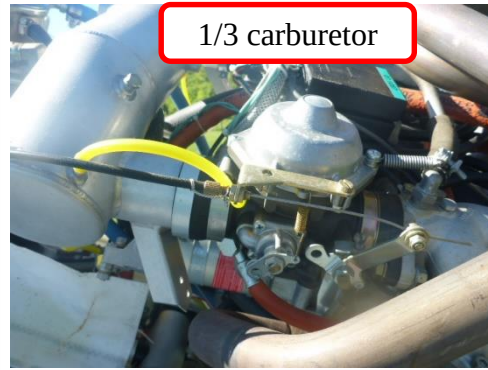
**1/3 Carburetor:** The 1/3 Carburetor float bowl was removed and examined for fuel contamination. Corrosion was found within the 1/3 float bowl underneath the float. No fuel was contained inside.

Corrosion found within both the 1/3 and 2/4 Carburetor float bowls was the only anomalies found with the 1/3 and 2/4 carburetors.

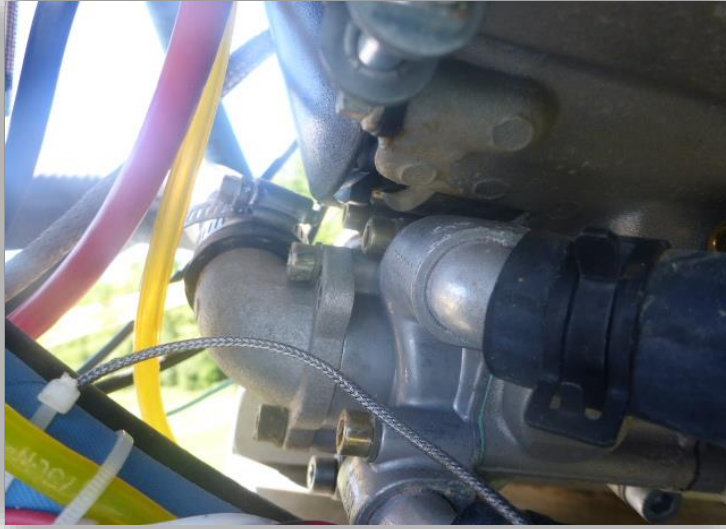
**Water Pump:** The Coolant Water Pump was examined for condition and modifications. No anomalies were seen with the Coolant Water Pump.

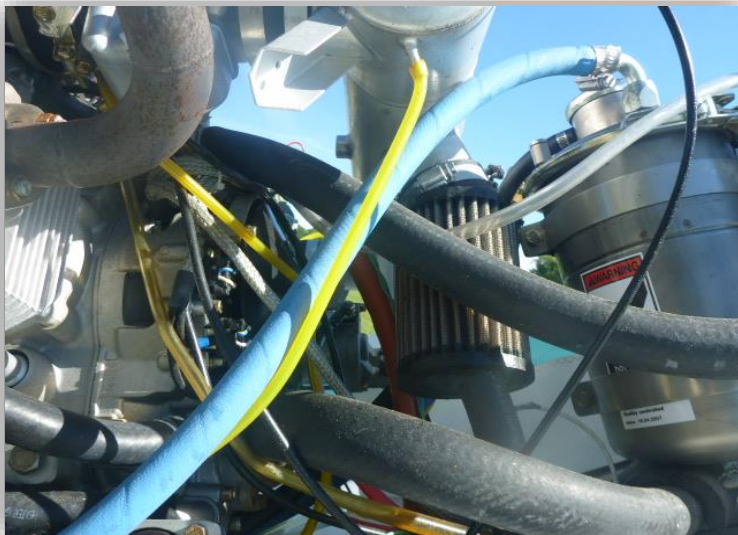
**Coolant Lines:** The coolant lines were examined for condition. All coolant lines were in good condition. No anomalies were seen with the coolant lines.

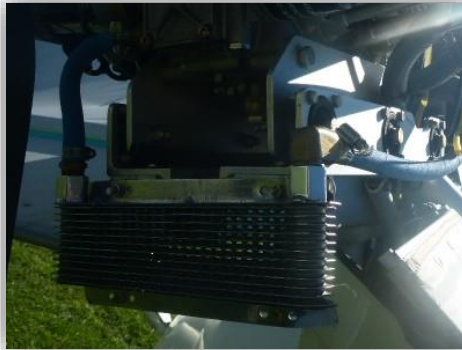
**Oil Cooler:** The oil cooler was examined for condition, conformity and installation. The oil cooler was in good physical condition and mounted correctly. No further anomalies were found with the oil cooler.

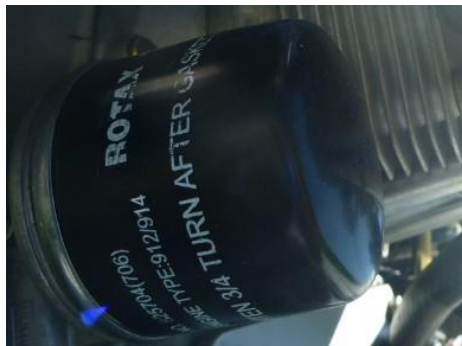
**Oil Filter:** The oil filter was examined for condition and proper type. No other anomalies were found with the oil filter.

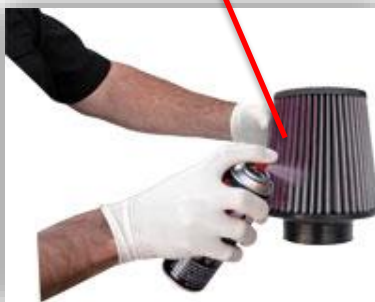
Air filter protection oil (Red spray)

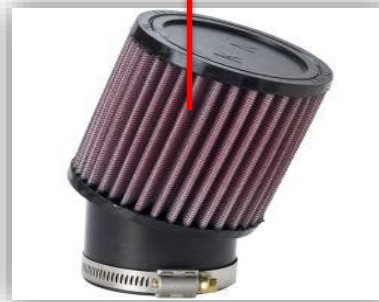
“Example” Properly oiled air filter with red pleats

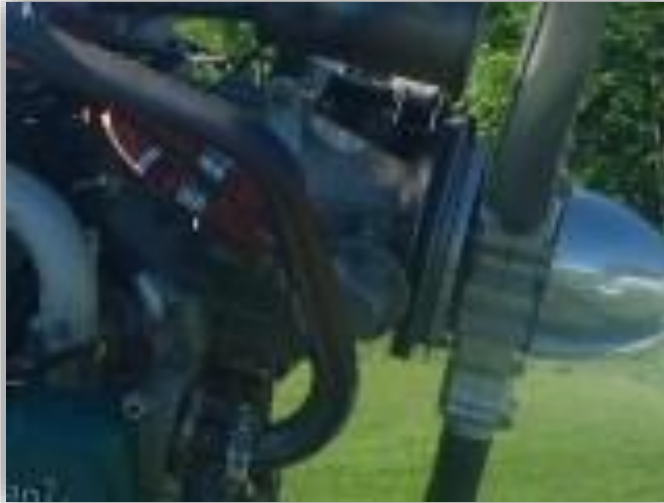
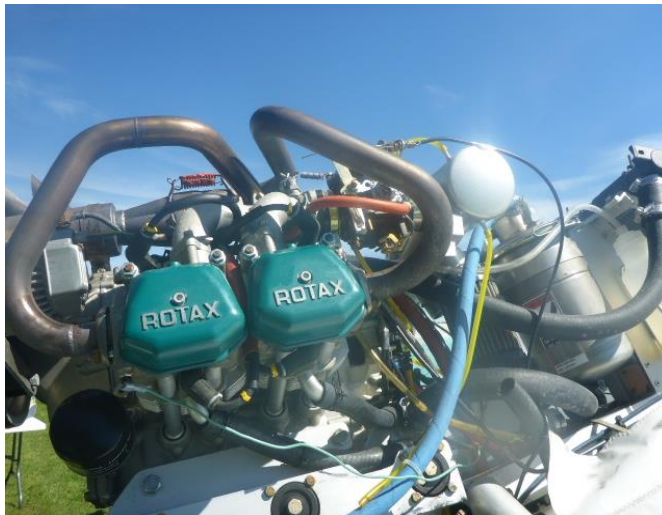
**Gearbox:** The Rotax engine comes equipped with a reduction gearbox. The reduction gearbox was externally examined and the propeller shaft rotated by hand to hear and feel anything unusual. No anomalies were found with the gearbox as everything fled and sounded normal during hand rotation.
