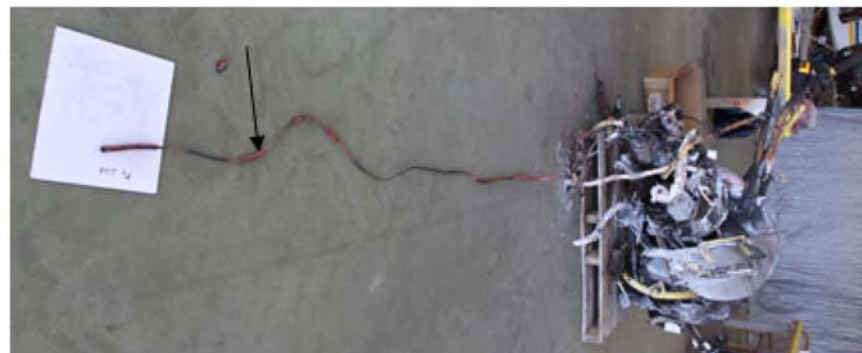
Photo No. 22  
Py line

**Power Turbine Control (Py):** The Py line was found connected to the fuel control unit (Photo No. 21). The Py line (arrow, Photo No. 22), which was fractured near the connection at the propeller governor, was found to show damages from heat exposure. The fractured end at the propeller governor was found secure (arrow, Photo No. 23).

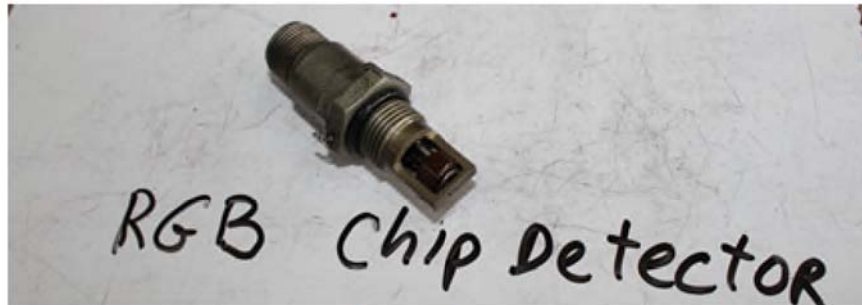
Photo No. 27

**Reduction Gearbox Chip Detector:** The reduction gearbox magnetic chip detector was found in place and secure although the connector showed mechanical damage and the cable was sheared (arrow, Photo No. 26). The magnetic chip detector was clean (Photo No. 27). The scavenge strainer was clean (Photo No. 28).

Reduction gearbox magnetic chip detector

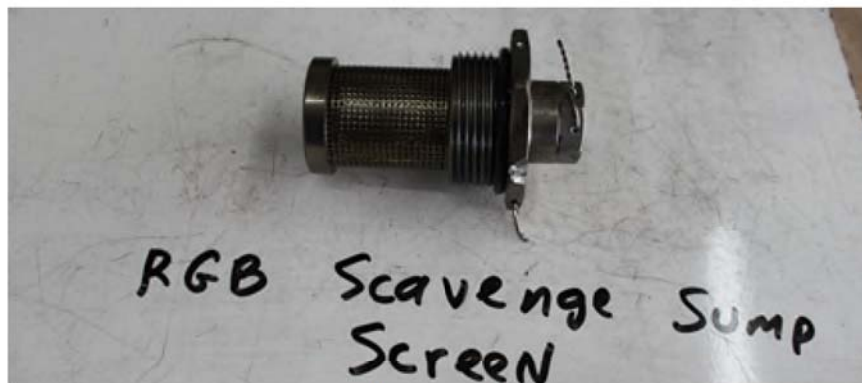
Photo No. 28

Reduction gearbox scavenge strainer

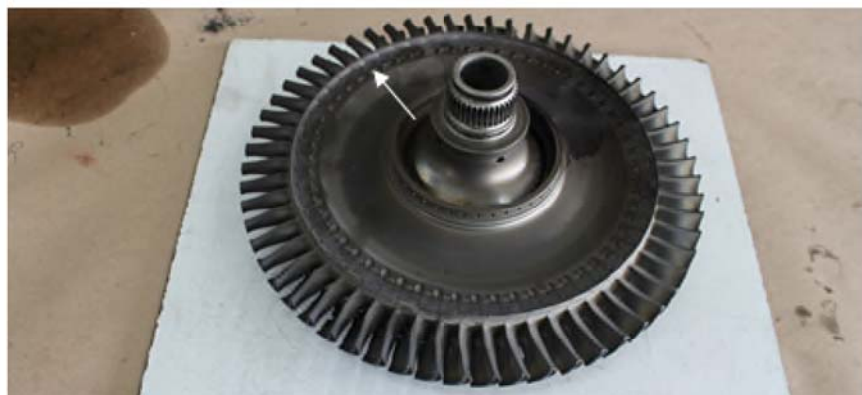
Photo No. 51

**Compressor Turbine:** The compressor turbine trailing edge view showed circumferential rubbing, scoring and wear on the trailing edge disc face, firtree region, blade platforms and airfoils (Photo No. 47). Circumferential rubbing marks were also observed at the disc inner diameter surface adjacent the retention bolt bore (arrow, Photo No. 48). The trailing edge wear on the airfoils also resulted in material removal, deformation, and cracking and /or fracture of sections of some airfoils (Photo Nos. 49 and 50). The blade tips showed rubbing wear and heat discoloration from contact with the compressor turbine shroud segments (arrow, Photo No. 50). The leading edge view of the compressor turbine disc showed rubbing contact with the inner wall of the compressor turbine stator at the leading edge blade platforms and the adjacent disc firtree region (arrow, Photo No. 51).

Leading edge view of compressor turbine disc
