**Date of Accident:** March 19, 2017

**NTSB File No.:** ERA17FA131

**Aircraft:** Air Tractor AT-602

**PROPELLER TEARDOWN REPORT**

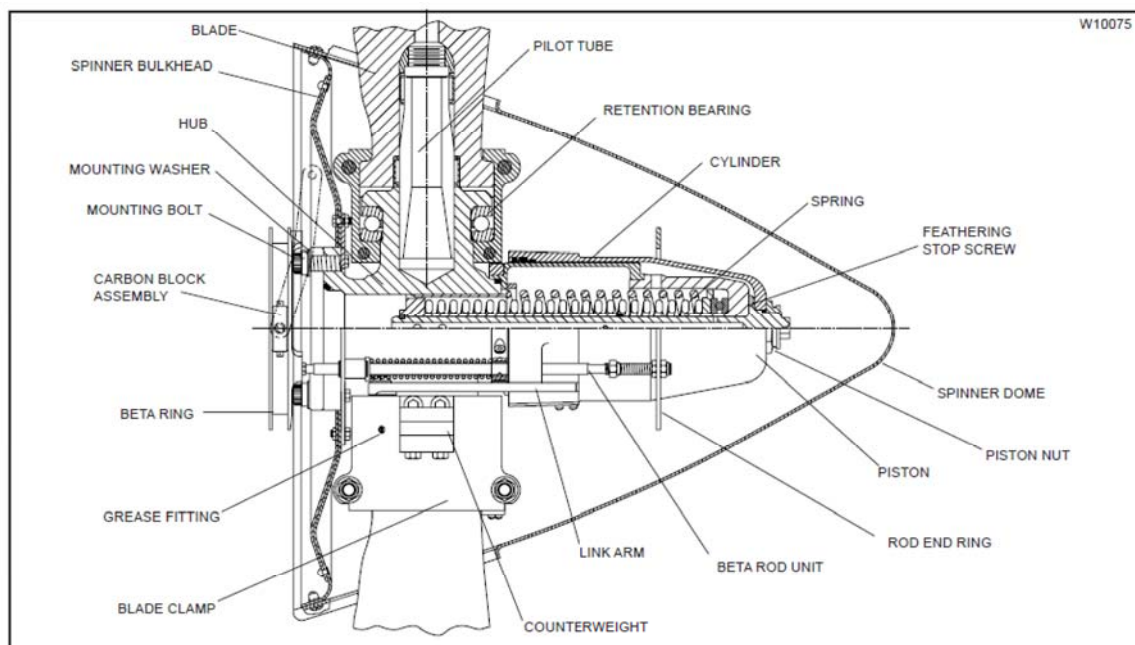
**General Comments:** The propeller examined is a 111.2-inch diameter, 5-blade single-acting, hydraulically operated, constant speed model with feathering and reversing capabilities. Oil pressure from the propeller governor is used to move the blades to the low pitch (blade angle) direction. Blade mounted counterweights and a feathering spring provide moments and force towards the high pitch direction in the absence of governor oil pressure. The propeller incorporates a Beta mechanism that actuates when blade angles are lower than the flight idle position. The blades are of aluminum construction. The hub and blade clamps are steel. Propeller rotation is clockwise as viewed from the rear.
