**NATIONAL TRANSPORTATION SAFETY BOARD**

**Airworthiness Group Chairman's Factual Report**

**A. ACCIDENT ERA17FA135**

Location: Marietta, Georgia  
Date: March 24, 2017  
Time: 1922 Local Time  
Aircraft: Textron Aviation Citation 500 N8DX

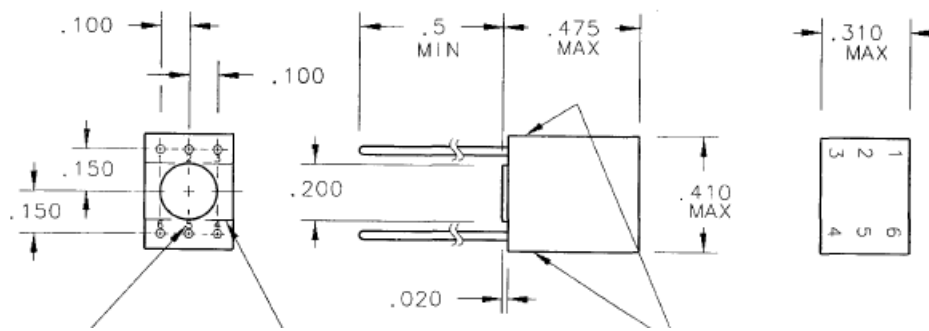
Figure 11 - Drawing of the transformer.

The transformer is part of the roll CCA feedback loop circuit. Honeywell indicated that a failure of the A1T1 isolation transformer could cause the autopilot to roll the aircraft if the autopilot was still engaged and the commanded heading was different than the current heading. As the A1T1 is a component in the circuitry that determines roll rate feedback for the autopilot computations, if the A1T1 transformer fails (assumed to go to no output, voltage = 0), then the calculated roll rate would be zero and thus the autopilot would continue to command an increase in roll angle in order to try to get the heading rate to increase in order to turn to the desired heading.
