## ENGINE EXAMINATION REPORT

| ENGINE MODEL | IO550B (6F) |
| AIRCRAFT MAKE & MODEL | Beechcraft A36 Bonanza |
| FILE NUMBER | 16-507 |

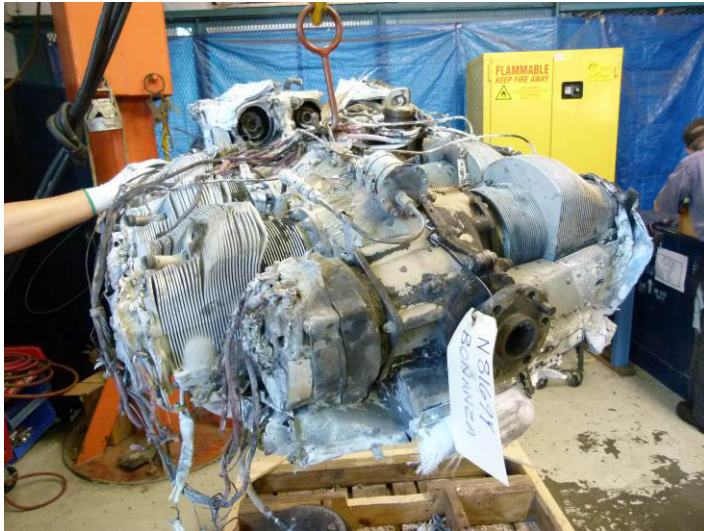
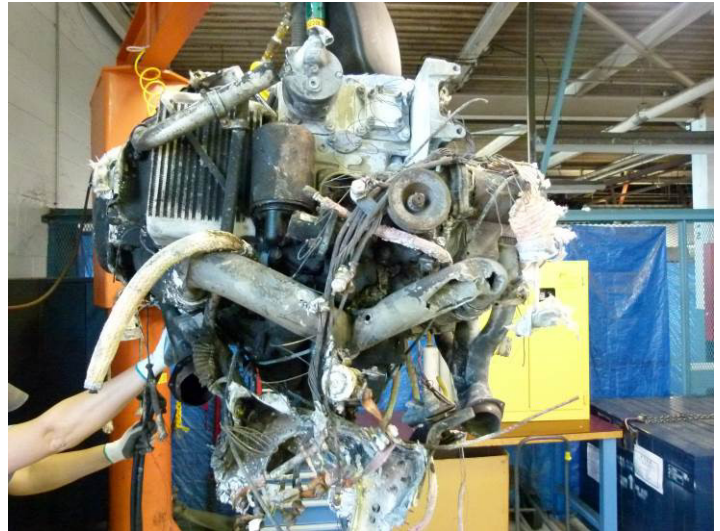
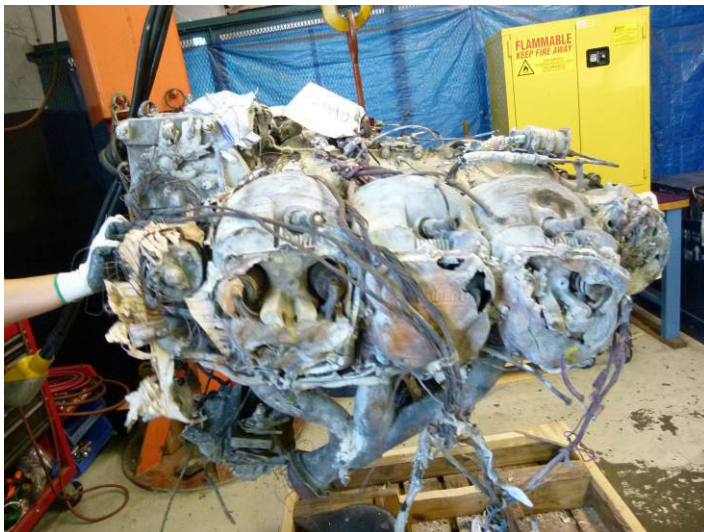
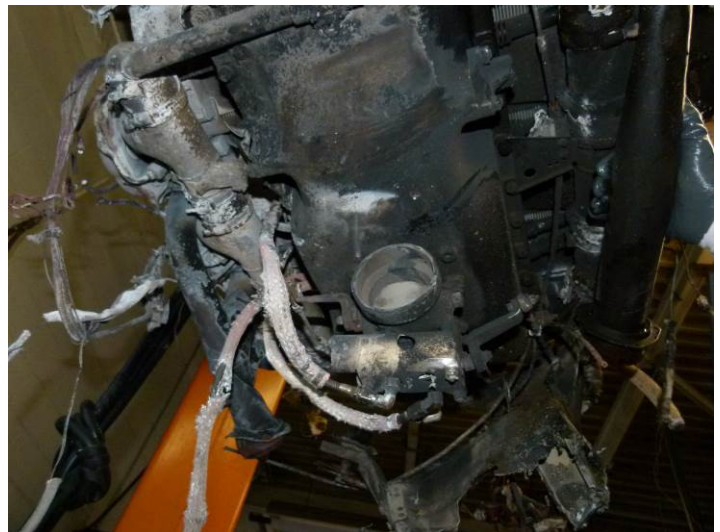
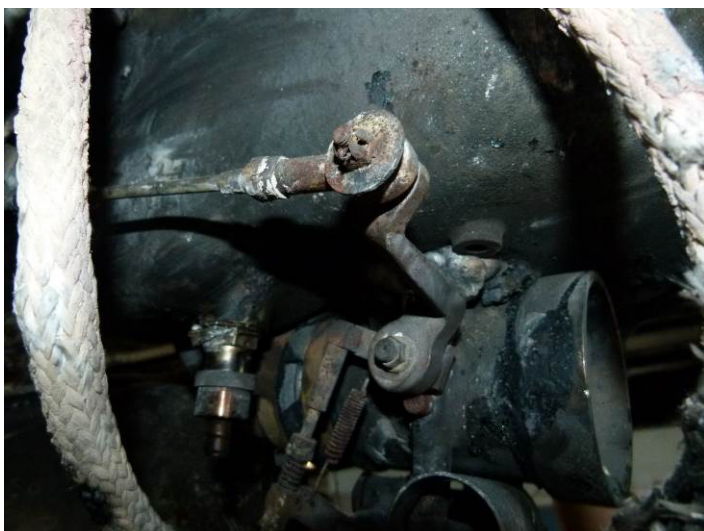
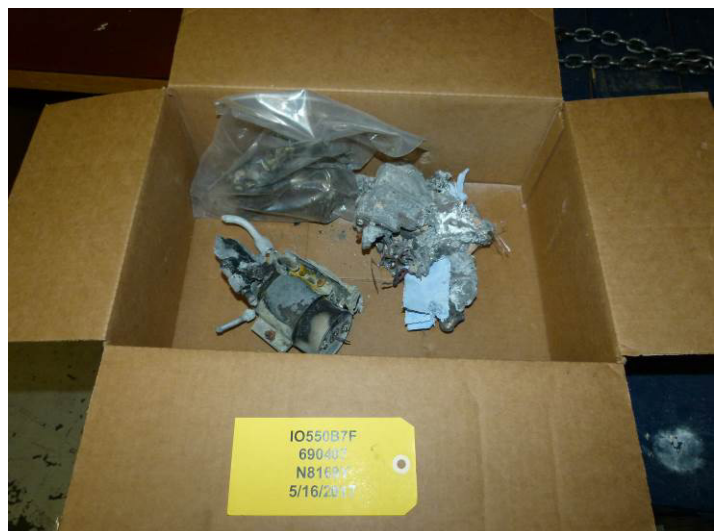
The engine exhibited thermal and impact damage overall. Cylinders one, three and five exhibited extreme thermal damage. Rocker box covers for cylinders one, three and five were thermally damaged and valve train components were visible. The engine data plate remained intact and indicated that this engine was a model IO-550B (6), serial number 690407.

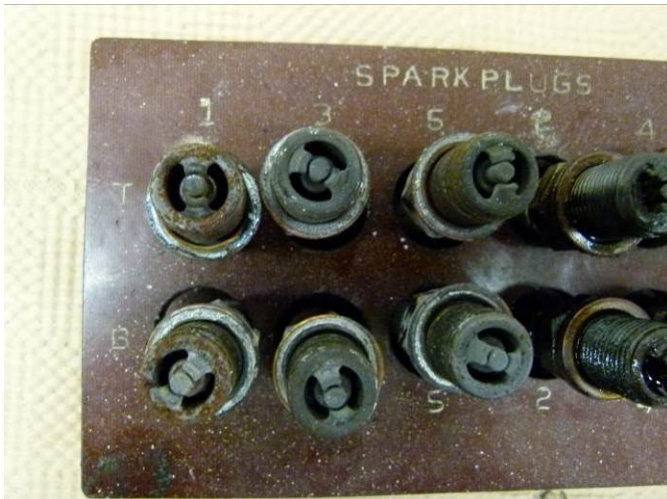
| Condition: | Sparkplugs from cylinders one, three and five appeared normal in wear and coloration when compared to a Champion Check-A-Plug chart. Sparkplugs from cylinders two, four and six were oil contaminated. This oil contamination is possibly the result of the engine orientation at the accident site. | |

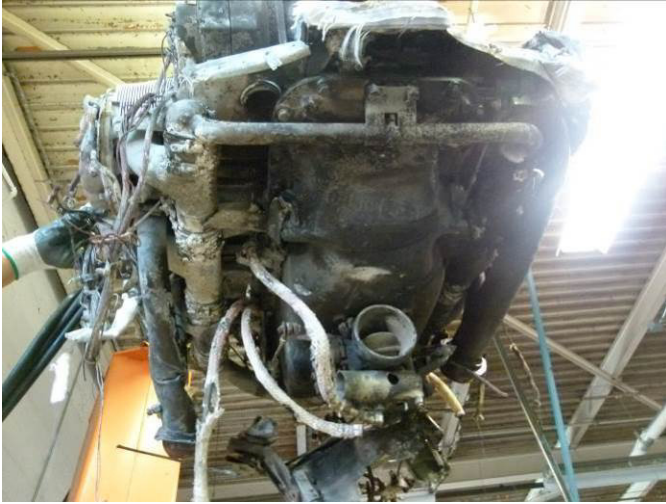
The oil sump was thermally damaged but remained intact.

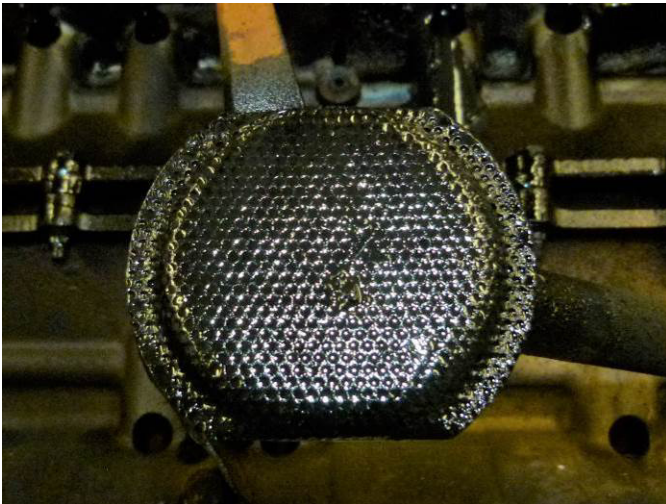
#### OIL PICK-UP TUBE & SCREEN

The oil pick-up screen was intact and no contamination was present.

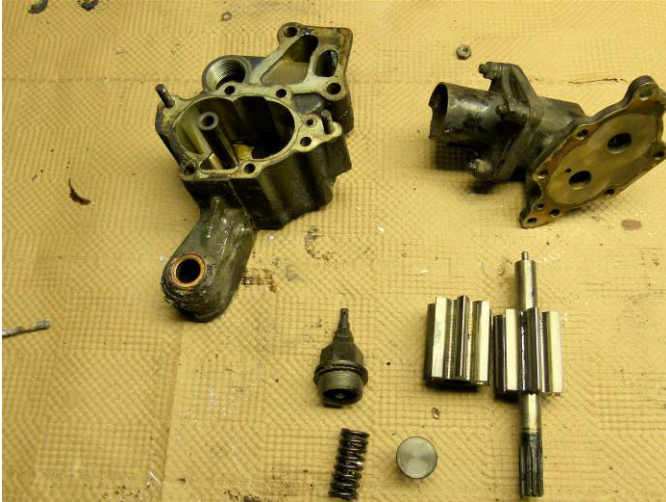
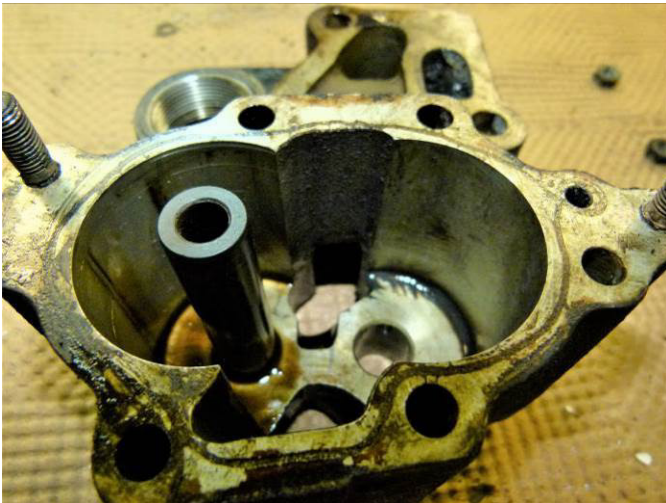
The pump was disassembled and inspected. There was no scoring or scratching in the pump chamber to indicate hard particle passage. The gears were normal in condition and the oil pressure relief valve and spring were intact.

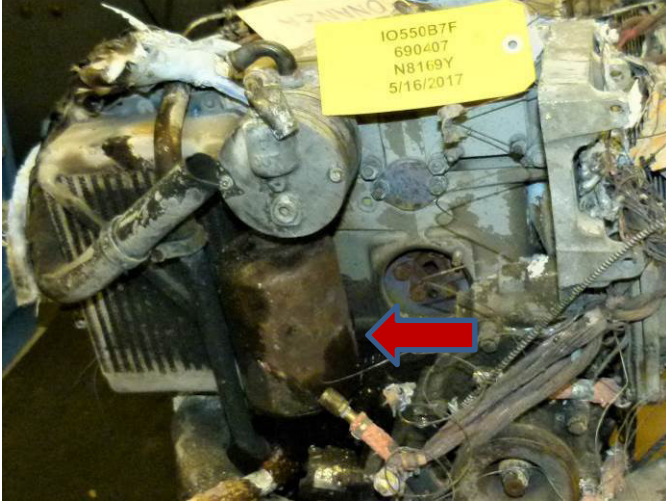
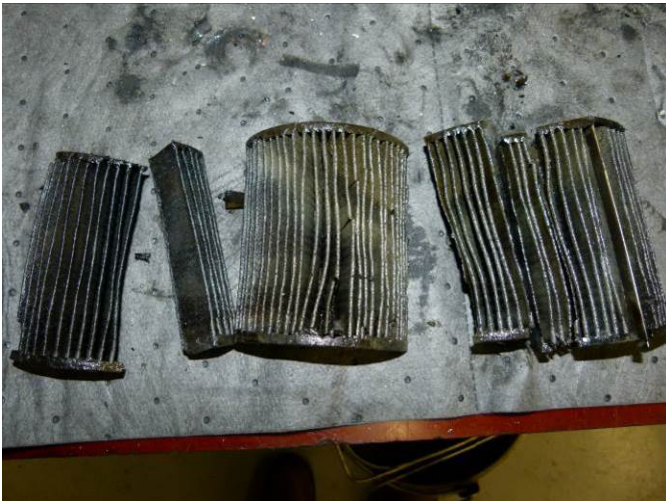
The exterior of the oil filter was thermally damaged and manufacturer and model number were unreadable. The filter was opened and the filter media inspected. No metal contamination was exhibited.

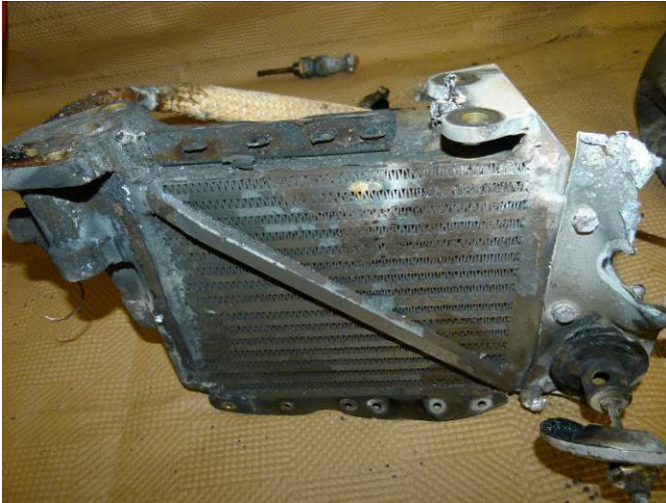
**Condition:** The oil cooler was intact. No data plate was found. The exterior surfaces of the oil cooler exhibited thermal damage.

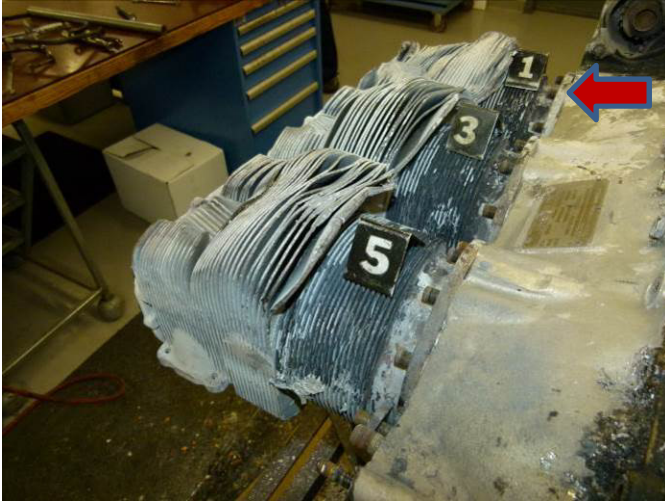
| Condition: | Cooling fins were damaged by impact forces and thermal distress. | | |

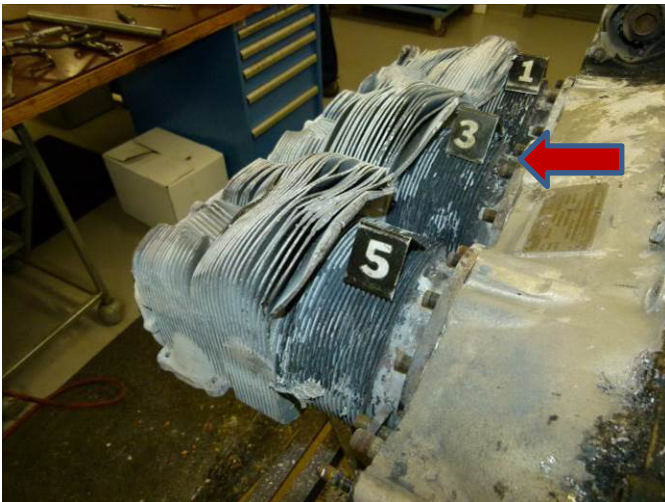
| <b>CYLINDER #3</b> | P/N: 658175A1 | S/N: AC14IA | Head Date: 10-14 |

| Condition: | Cooling fins were damaged by impact forces and thermal distress. | | |

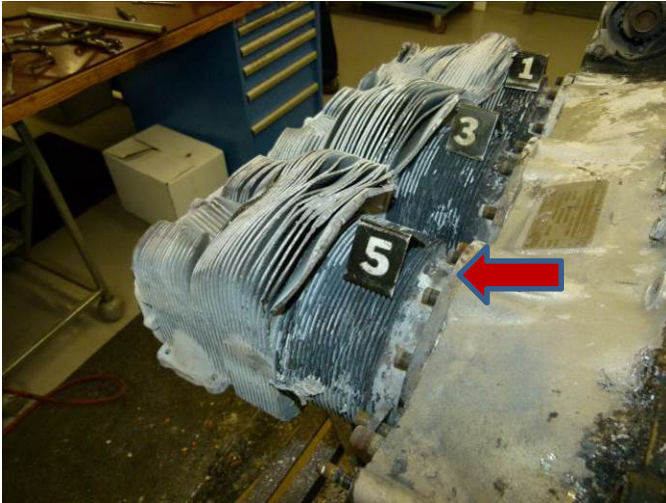
| Condition: | Cooling fins were damaged by impact forces and thermal distress. | | |

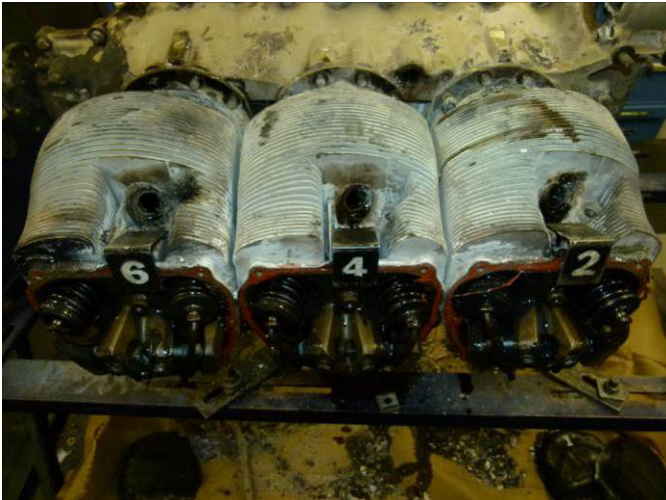
| <b>CYLINDER #2</b> | P/N: 658175A1 | S/N: AC14IA | Head Date: 10-14 |

| Condition: | Cylinder was intact with minor external thermal distress. | | |

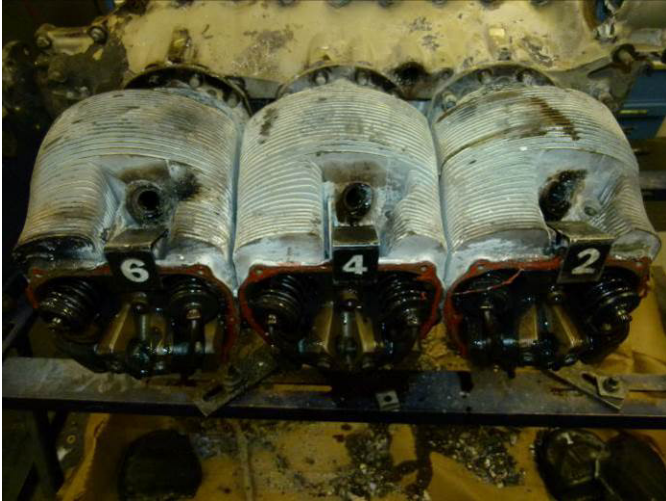
| Condition: | Cylinder was intact with minor external thermal distress. |

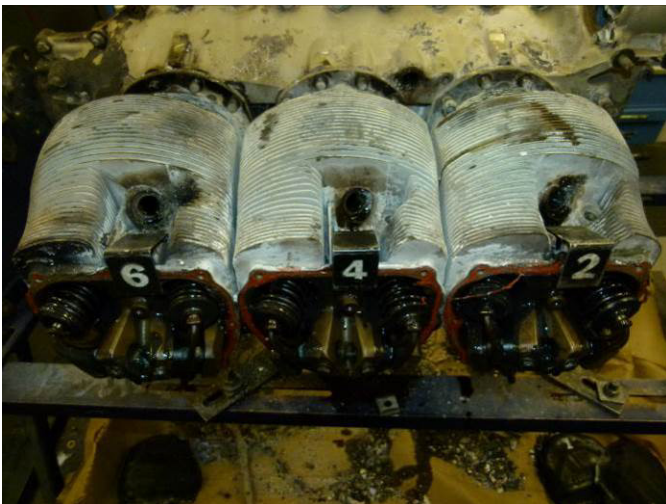
| <b>CYLINDER #6</b> | P/N: 658175A1 | S/N: AC14IA | Head Date: 10-14 |

| Condition: | Cylinder was intact with minor external thermal distress. |

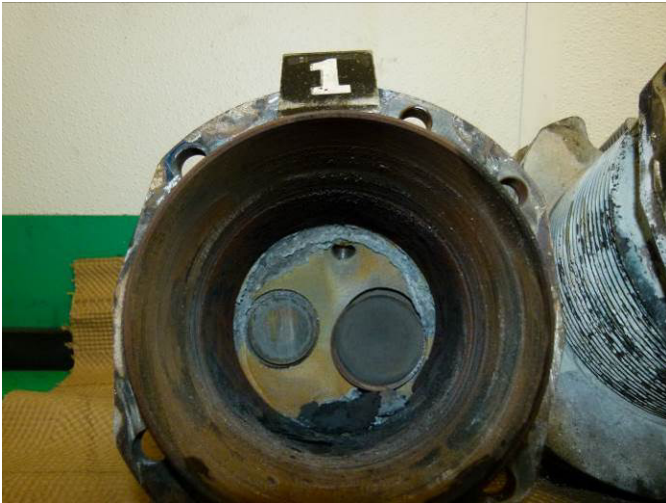
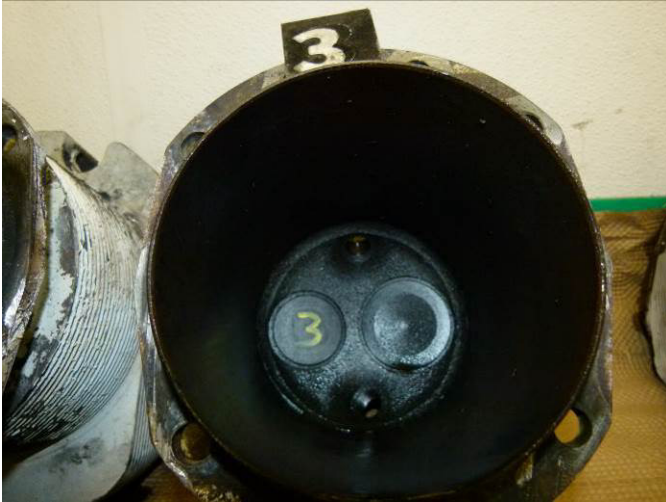
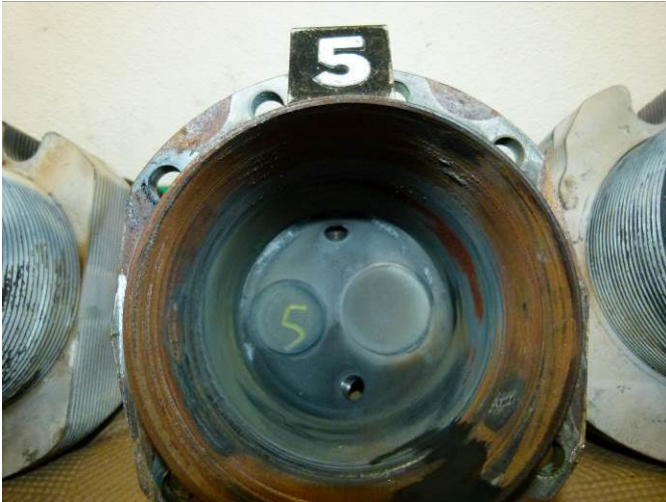
## VALVES

Condition: All valves were intact and in place.

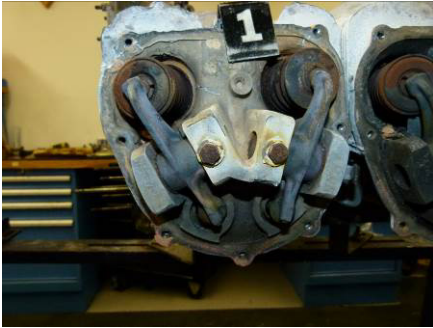
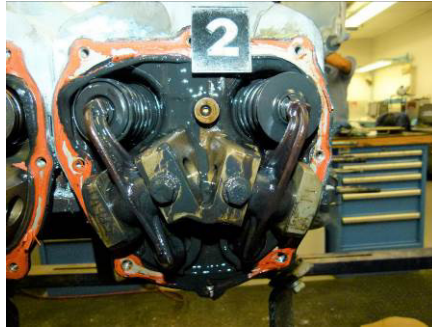
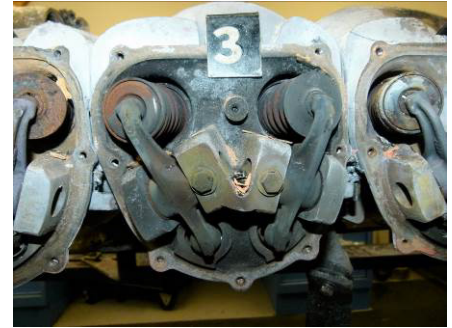
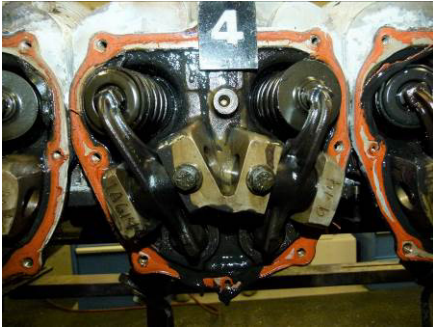
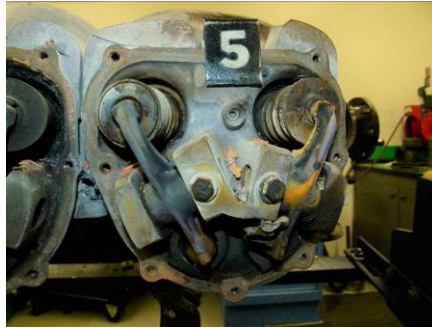
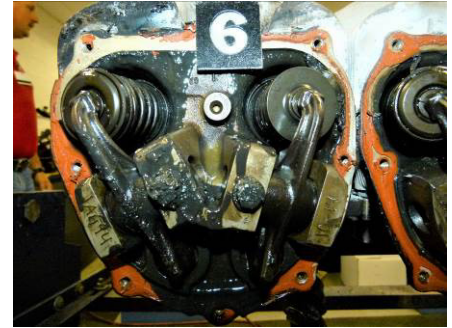
### ROCKER ARMS AND SHAFTS

Condition: All rocker arms and shafts were intact. Cylinders one, three and five were exposed to an after impact fire destroying rocker covers and exposing components to thermal distress.

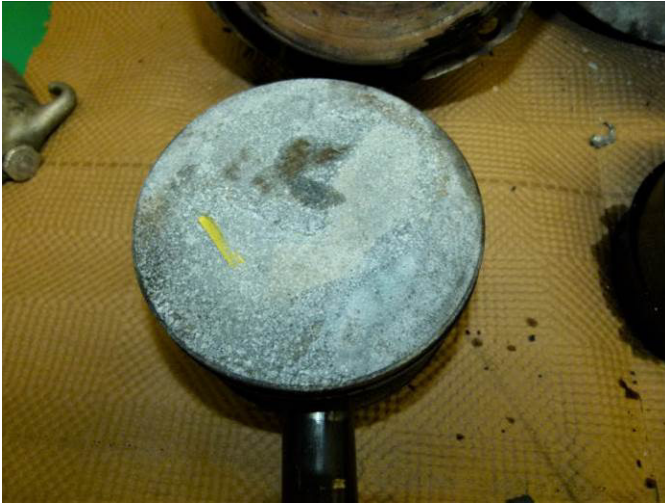
Normal wear. Surface oxidation due to normal lubrication being destroyed by external fire after impact. This piston was stuck inside of the cylinder and manual manipulation was required to remove it.

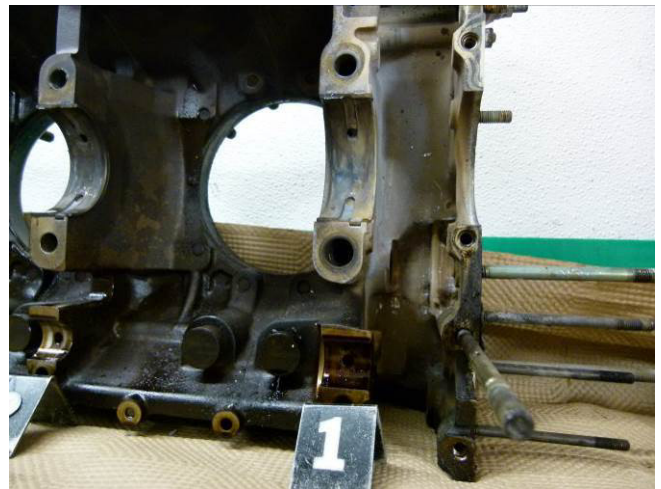
| #2 MAIN BEARINGS | | P/N: 634503 | Date Code: 06-14 |

| Condition: | #2 main bearing exhibited thermal damage to the bearing surface. | | |

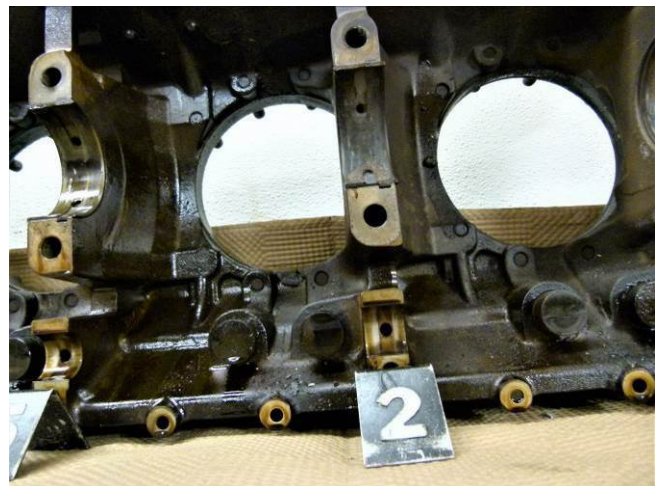
Condition: Normal wear patterns.

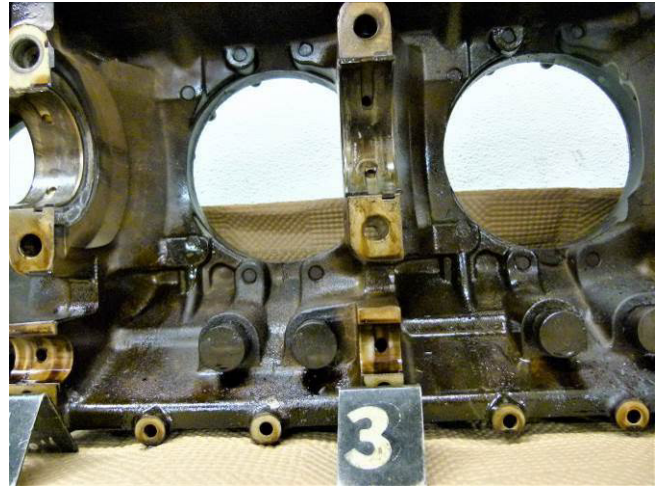
## #4 MAIN BEARINGS

Condition: # 4 main bearings exhibited thermal damage to the bearing surface.

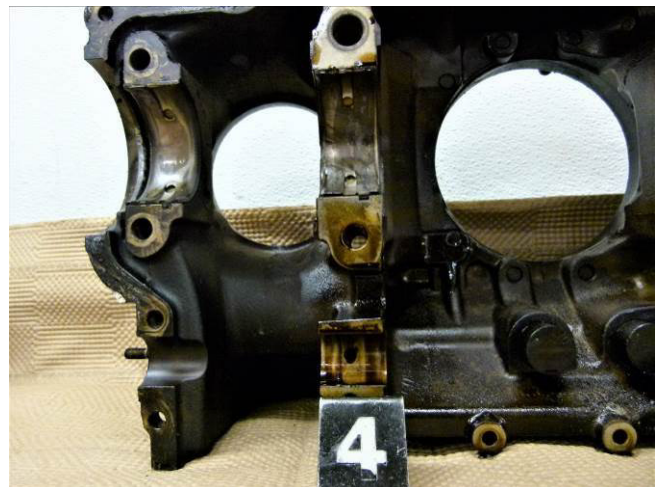
| #5 MAIN BEARINGS | P/N:653547 | Date Code: 08-14 |

| Condition: | # 5 main bearings exhibited thermal damage to the bearing surface. | |
