## ENGINE RUN REPORT

| ENGINE MODEL | IO-550-N68B |
| FILE NUMBER | 16-295 |

| GENERAL INFORMATION | | | |
|---|---|---|---|
| DATE | 04/04/201 | NTSB ACCIDENT # | ERA17LA063 |

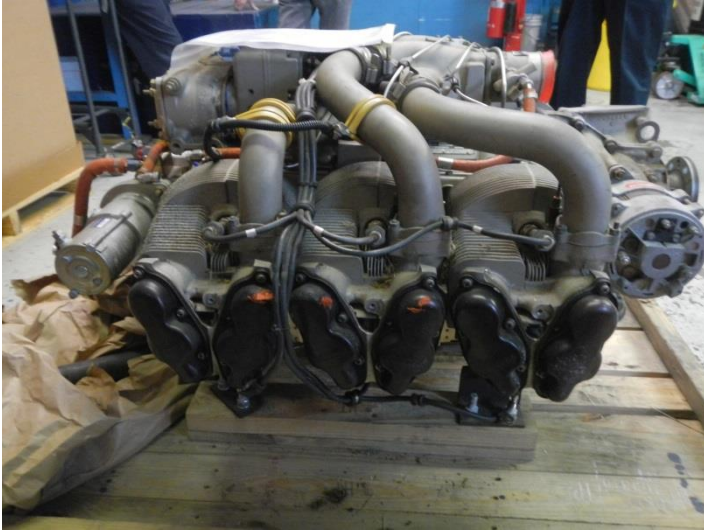
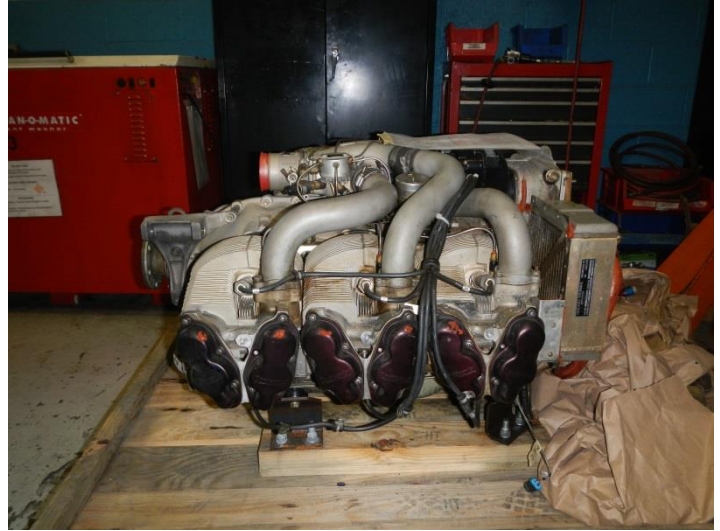
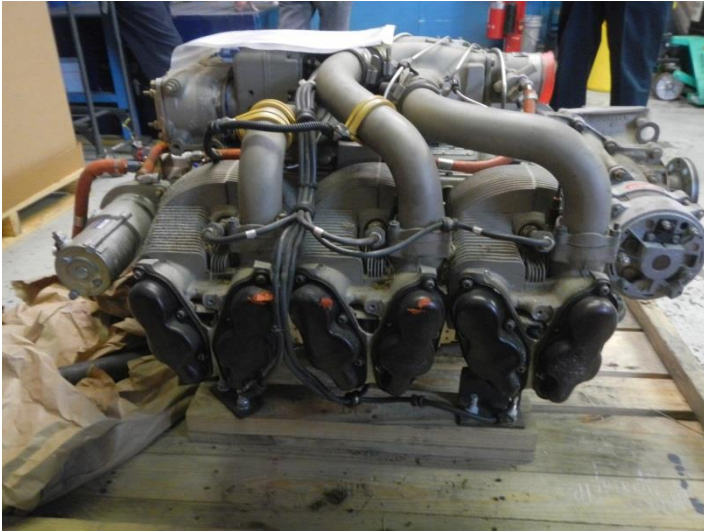
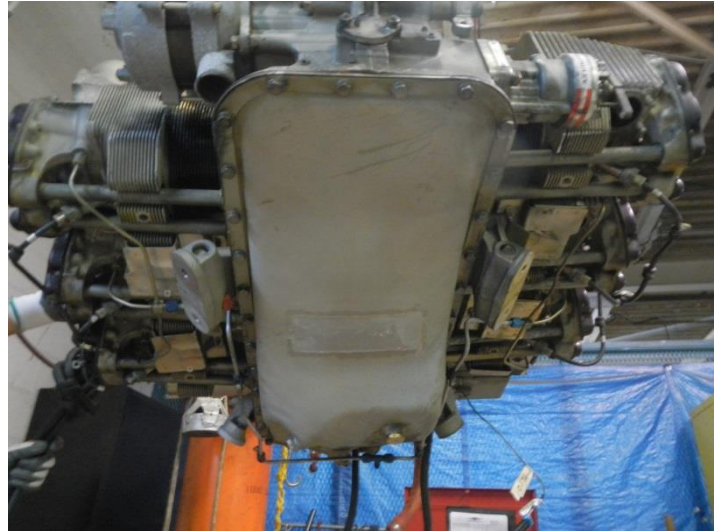
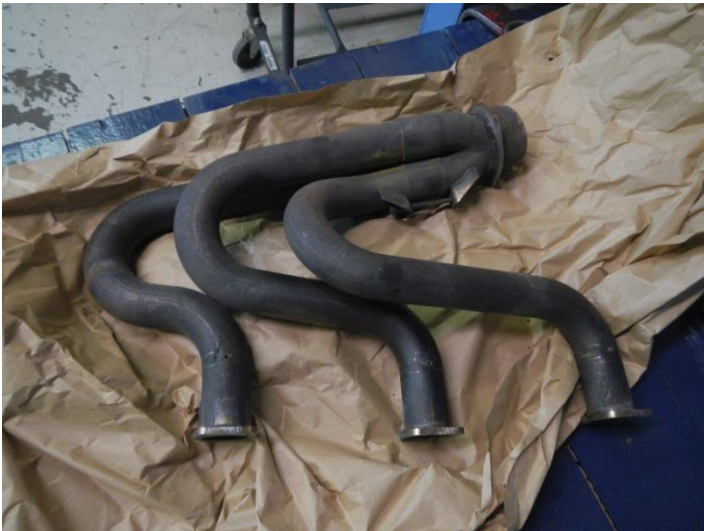
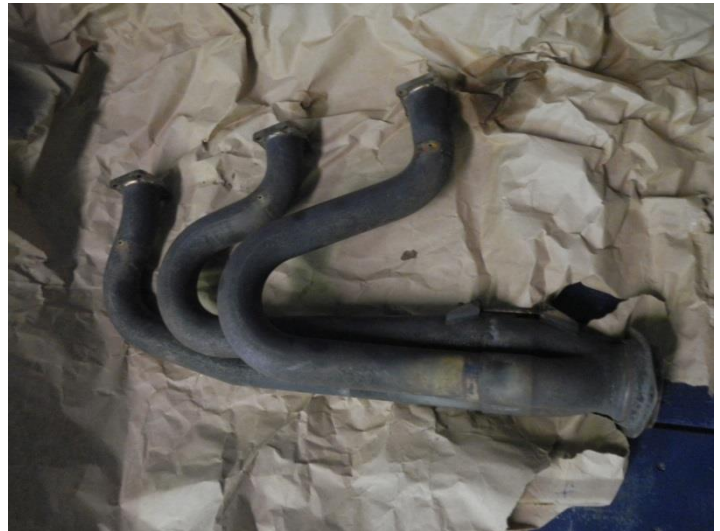
The engine was in the shipping crate with the exhaust manifold removed and placed within the crate separately. There were no external anomalies noted with the engine or the engine-related systems. Movement of the throttle and mixture control levers resulted in a coinciding movement of their control shafts with no slipping or binding noted. Only residual oil remained on the oil dipstick. The engine was placed on a test stand for pre-test run examination.

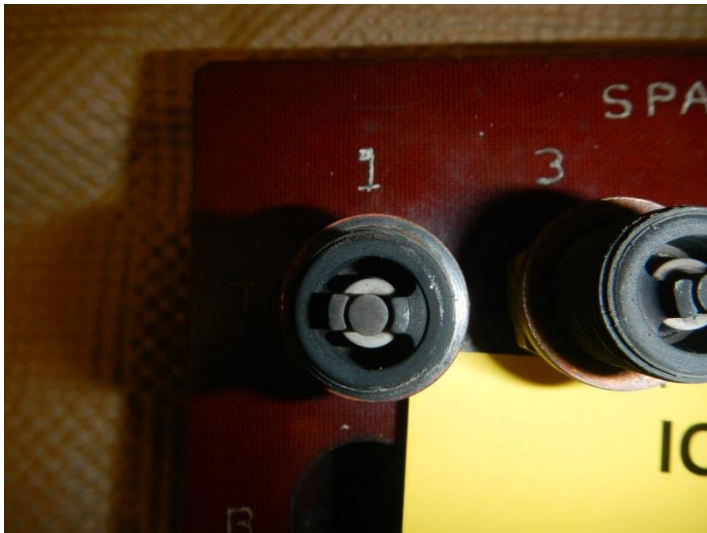
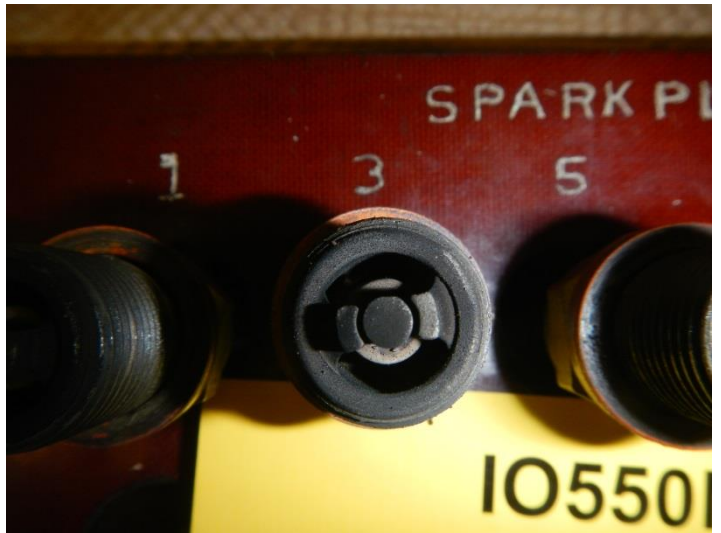
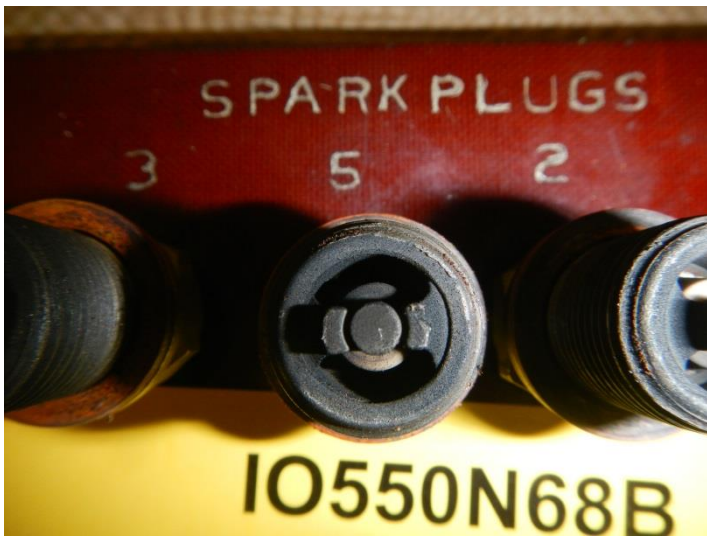
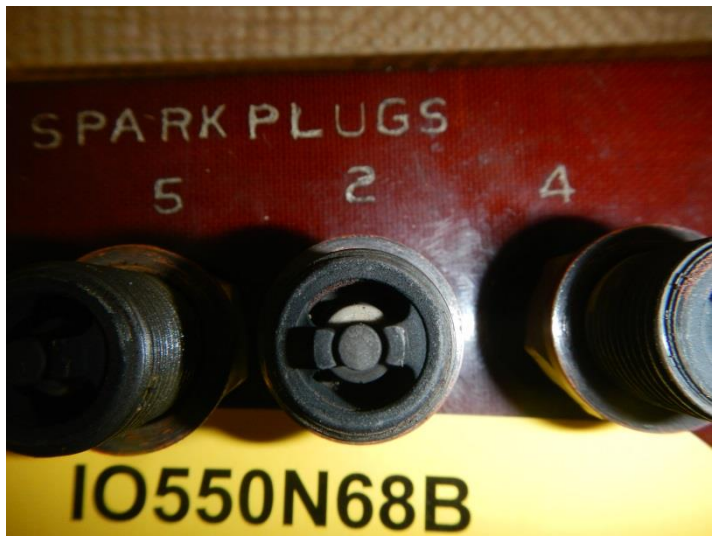
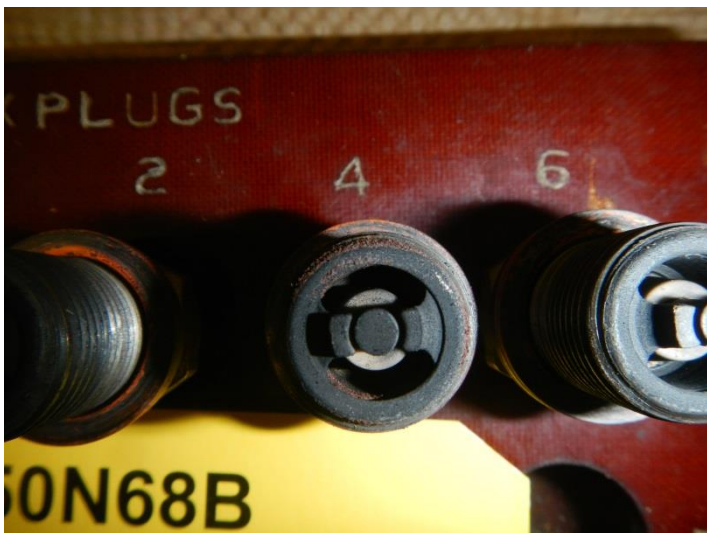
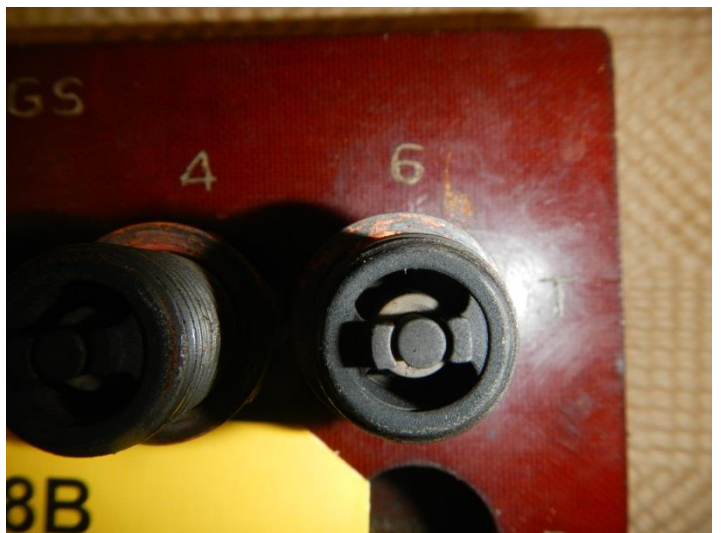
The top sparkplugs were removed and examined. The top sparkplugs displayed a near-new were condition with normal combustion deposits. There was no sign of carbon or lead fouling.
