## VEMD READ-OUT & ANALYSIS REPORT

**Report EAI n°:** EAI 51\_2017  
**Date of examination:** 03/05/2017, Marignane, FRANCE  
**Attendees :** BEA representatives, Airbus Helicopters representatives

**Type of helicopter:** AS350 B3  
**S/N and registration:** SN3228 / N413LP  
**Customer:** HELICORP INC  
**Date of the accident:** 21/02/2017, San Juan, Puerto Rico, USA

**Designation:** VEMD mounted and powered on Airbus Helicopters test bench

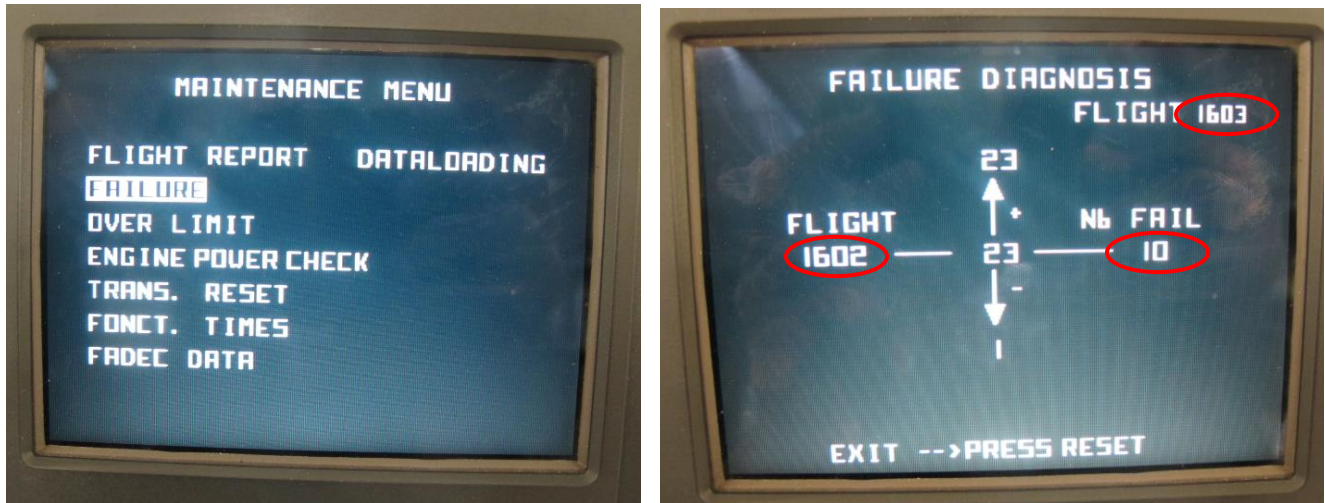
#### “Maintenance” mode – “Failure” submode

The “Failure” submode has been opened.  
10 failures have been recorded during the accident flight #1602.
