## Hydro-Mechanical Unit (HMU) and Assembly Valve examination Final report

Document ID: **BEA2017-0116\_tec05**  
 Date of occurrence: 21st February 2017  
 Place of occurrence: San Juan Airport (Puerto Rico)  
 Aircraft type: AEROSPATIALE - AS350 – B3  
 Registration number: **N413LP**  
 Equipment examined:

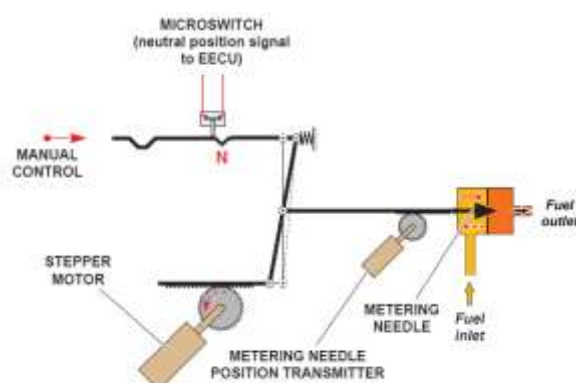
**Fig 1 : Regulation functional diagram**

- When the twist grip is turned towards idle position (“reducing power direction”), the stepper motor is able to compensate until the twist grip reaches the “idle position” (at this position, an electro-switch gives the indication to the stepper motor to reduce to “idle mode”).

- When the twist grip is turned towards Emergency + position (“increasing power direction”), the stepper motor compensates to its mechanical stop. If the twist grip angle is increased over this stepper motor limit, the fuel flow will increase and, consequently, the engine rotation speed (NR) will also increase.
