# SERVICE BULLETIN

Service Bulletin No. 475C  
(Supersedes Service Bulletin No. 475B)  
Engineering Aspects are  
FAA Approved

SUBJECT: Crankshaft Gear Modification and Assembly Procedures

MODELS AFFECTED: All Lycoming direct drive piston aircraft engines (including VO-360 and IVO-360; excepting O-320-H, O-360-E, LO-360-E, TO-360-E, LTO-360-E, and TIO-541 series engines).

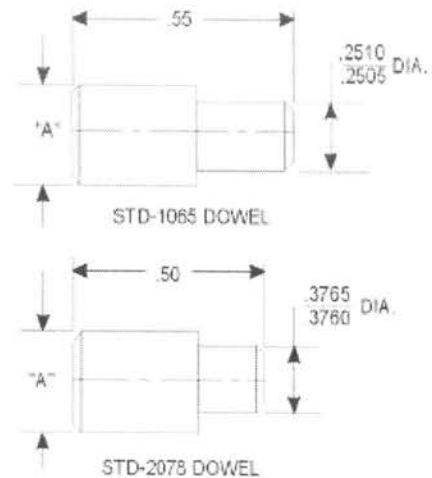
Figure 4. Details of Crankshaft Dowel

2. Check the condition of the dowel in the end of the crankshaft. It should be perfectly smooth with no indication of nicks or deformation. If it is out of round, it should be removed and replaced with a new one. Replacement instructions are in paragraph 4. If dowel condition is acceptable, insure that it is installed as shown in Figure 2 or 3.

- e. Chamfer edge of pilot diameter  $45^\circ \times .03$  as shown in Figure 1.
4. If the dowel has been removed, check the condition of the dowel hole in the crankshaft. If out of round or oversize, ream as required for installation of an oversize dowel. Available oversize dowels and the corresponding size for reamed holes are shown in Table 1.
5. Install a new dowel in the crankshaft as shown in Figures 2 and 3. Insure that the correct dowel is installed.
