# Continental Motors

## ENGINE EXAMINATION REPORT

| ENGINE MODEL | O-170-3 |
| FILE NUMBER | 16-696 |

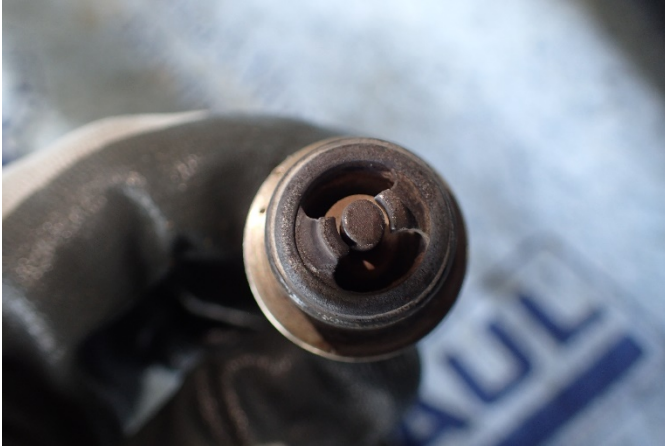
#3 Top Spark Plug

The spark plugs remained secured in their cylinders and displayed varying amount of impact damage with the bottom spark plugs displaying the most impact damage. The top spark plugs were removed and visually inspected. The spark plug electrodes displayed normal operating and wear signatures. The bottom spark plugs were inspected using a lighted borescope. The bottom spark plugs displayed normal operating and wear signatures; the bottom #4 spark plug insulator was broken which was consistent with impact damage. It was noted that the top #2 spark plug was a different manufacture and had a different heat range.

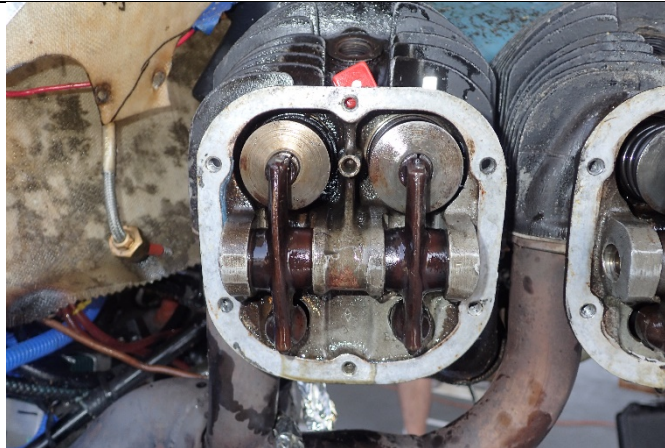
| <b>CYLINDER #1</b> | P/N: Not observed | S/N: Not observed |
|---|---|---|
| Condition: | The cylinder remained attached to its installation point and was undamaged. The internal portion of the cylinder was inspected using a lighted borescope. The piston face, cylinder bore, and valve heads displayed normal operating and combustion signatures. The overhead components (valves, springs, rocker arms, and push rods) displayed normal operating and lubrication signatures. During crankshaft rotation the cylinder displayed good thumb compression and suction. | |

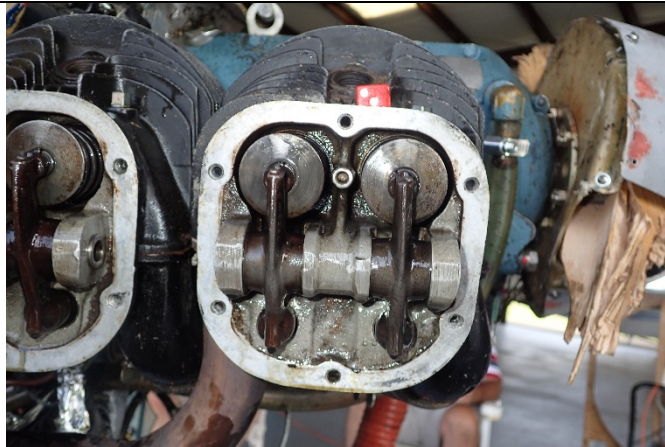
| <b>CYLINDER #3</b> | P/N: Not observed | S/N: Not observed |
|---|---|---|
| Condition: | The cylinder remained attached to its installation point and was undamaged. The internal portion of the cylinder was inspected using a lighted borescope. The piston face, cylinder bore, and valve heads displayed normal operating and combustion signatures. The overhead components (valves, springs, rocker arms, and push rods) displayed normal operating and lubrication signatures. During crankshaft rotation the cylinder displayed good thumb compression and suction. | |

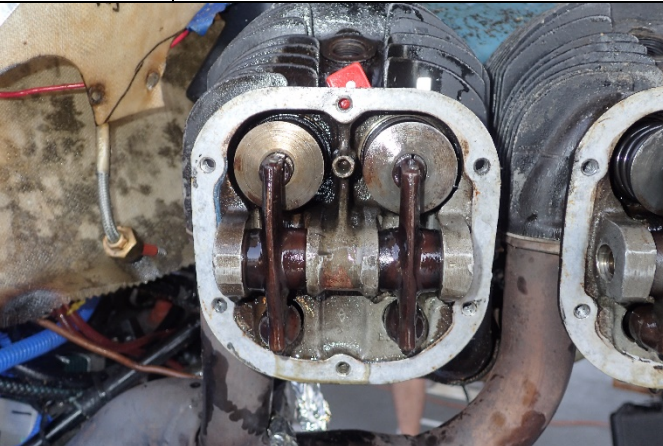
#1 Rocker Arms

The #2 exhaust rocker arm was noted to be impinged in its installation point which was consistent with impact damage to the cylinder. The rocker arms displayed normal operating and lubrication signatures.

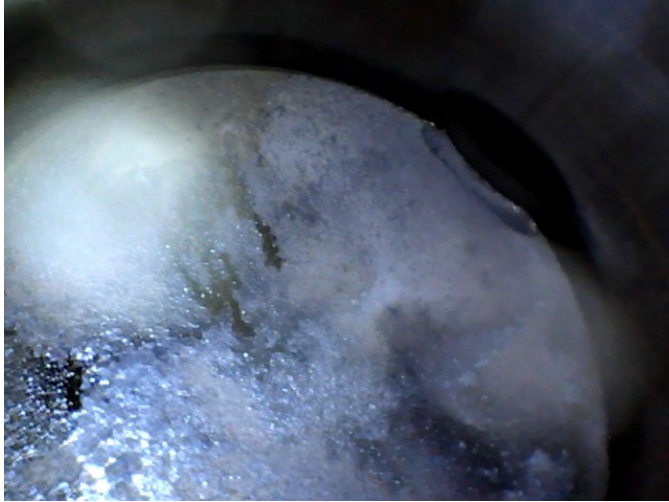
#1 Piston

The pistons were inspected using a lighted borescope; the #2 piston was examined further after the cylinder was removed. All of the pistons displayed normal operating and combustion signatures. The piston rings on the #2 piston displayed normal operating signatures and were capable of normal movement.
