## **N146DU Accident Investigation Findings & Analyses**

(SafranHE ref. RA 2017/238)

22 Sept. 2020

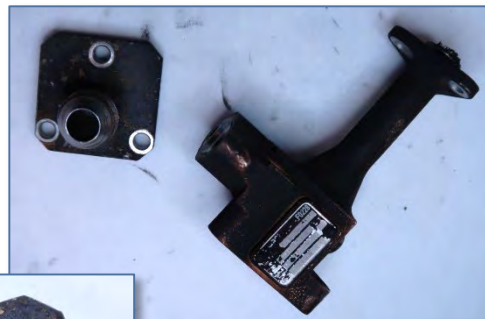
Ejector assembly

- Fuel ejector covered with soot externally and otherwise in good condition
- Internal holes clear with no foreign object
- Jet in place within ejector
- Astatic valve in good condition

→ No findings to report for fuel ejector

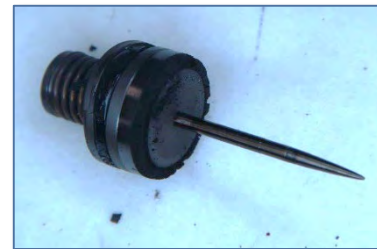
Fuel filter (HP)  
clean

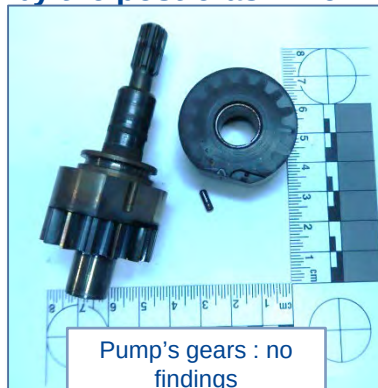
Pump's gears : no findings

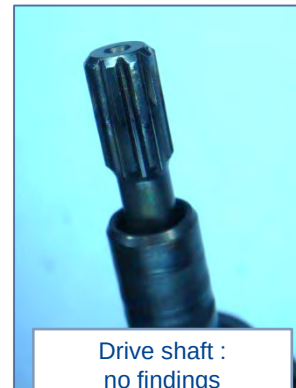
Drive shaft : no findings

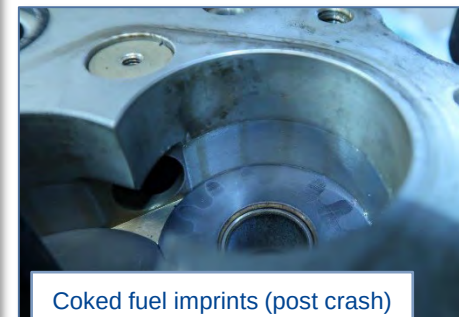
Coked fuel imprints (post crash)

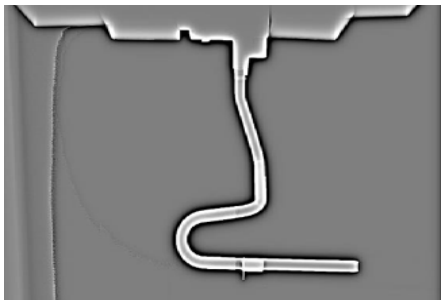
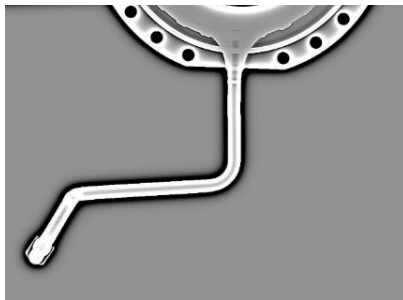
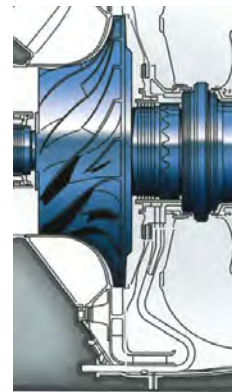
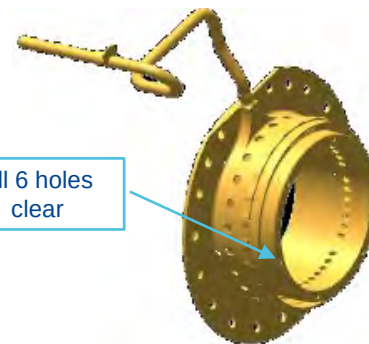
- According to maintenance records, the permeability check of the fuel injection manifold was performed at TSN 2710 hrs (1 flight hour before the accident).
- X-ray check : no deposits nor particles inside the pipe nor inside the 6 holes

→ **No findings to report for the fuel injection manifold**

All 6 holes  
clear

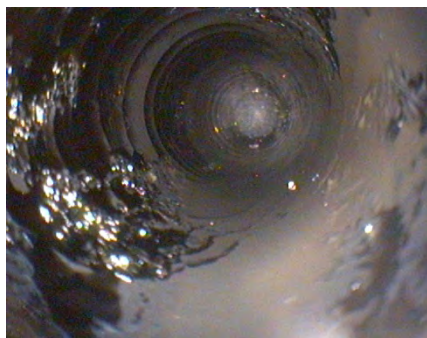
Oil supply tube

- Scavenge tubes and vent tube : Layer of coked oil adherent to inner surfaces. Holes clear.
- Oil supply : Presence of thin layer of coke
- The three tubes are not obstructed.

→ **No significant reduction to oil flow**

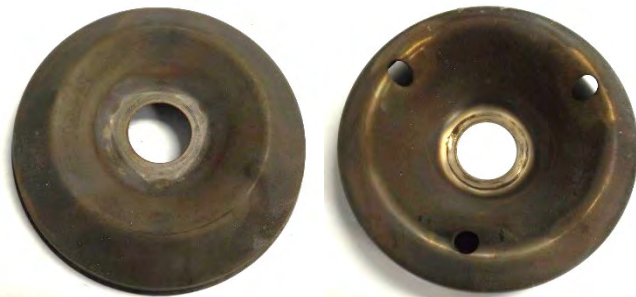
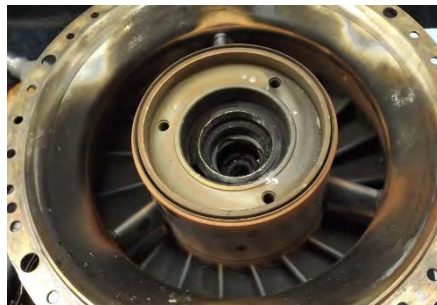
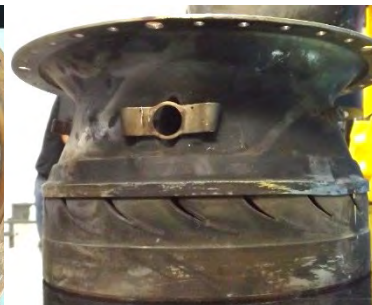
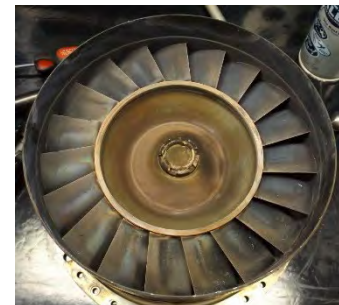
- **internal cavities around rear bearing chamber**
  - No traces of oil on front face of rear bearing chamber
  - No traces of oil on internal cup plates
  - No traces of oil on Power Turbine's NGV in main air path or in the hollow vanes

→ **No signs of oil out of rear bearing chamber**

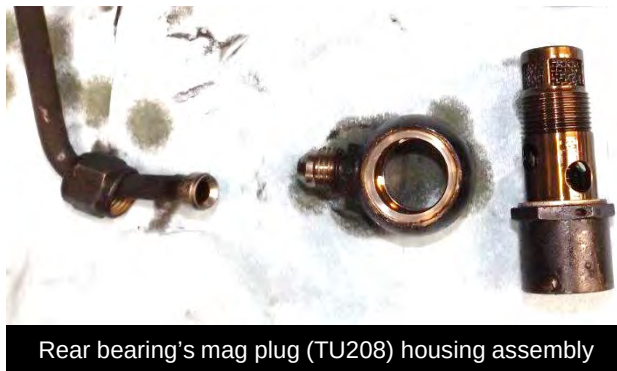
Rear bearing's mag plug (TU208) housing assembly

- The examination of the magnetic plugs and oil filter did not reveal any metallic particles
- The housing and strainer for the rear bearing's magnetic plug (TU208) contained only oil as normal

→ **No metallic particles on the magnetic plugs nor in oil filter**

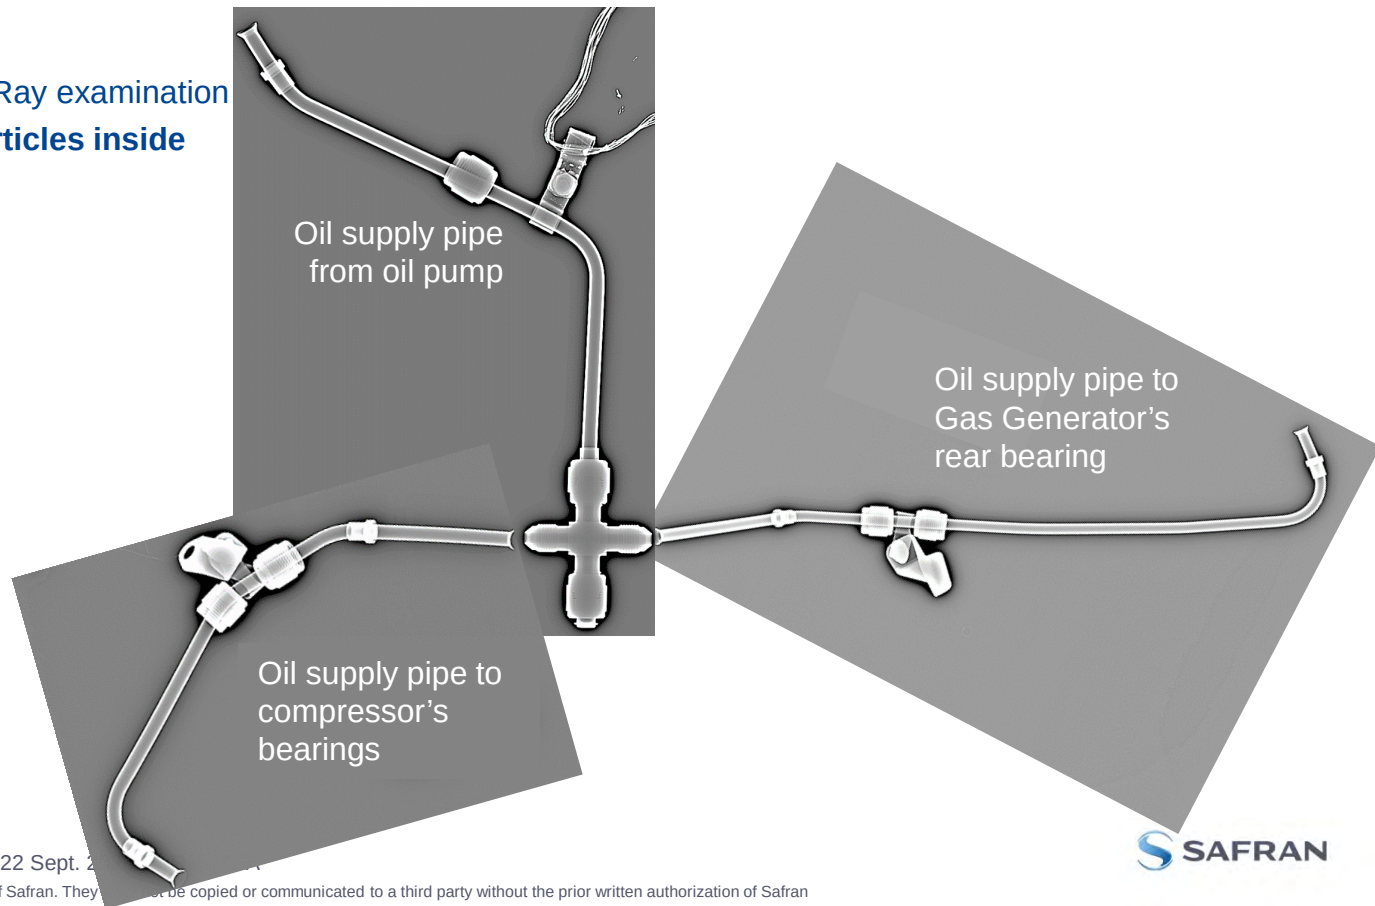
- **Oil supply pipes :** X-Ray examination  
→ **No deposits nor particles inside**

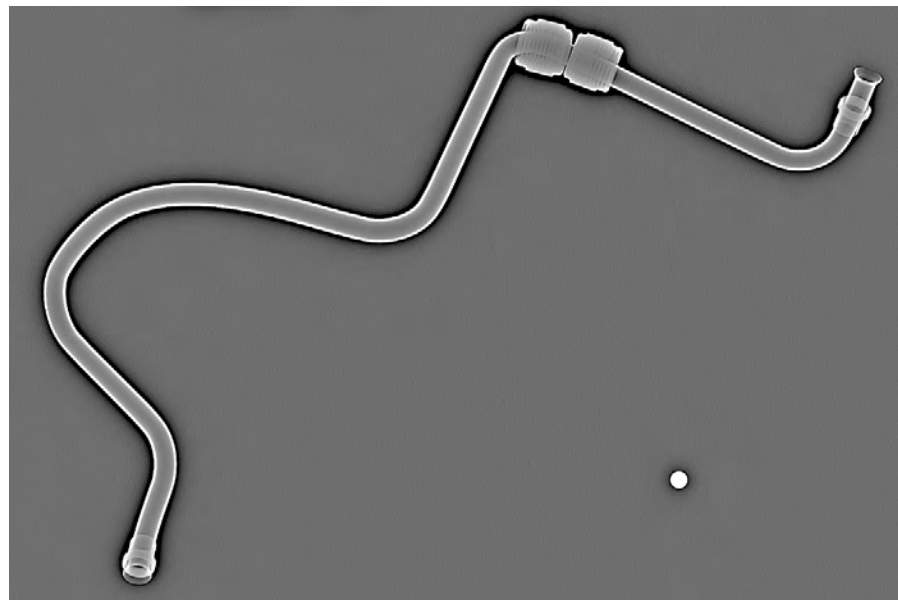
- **Oil scavenge pipe :** X-Ray examination  
→ **No deposits nor particles inside**

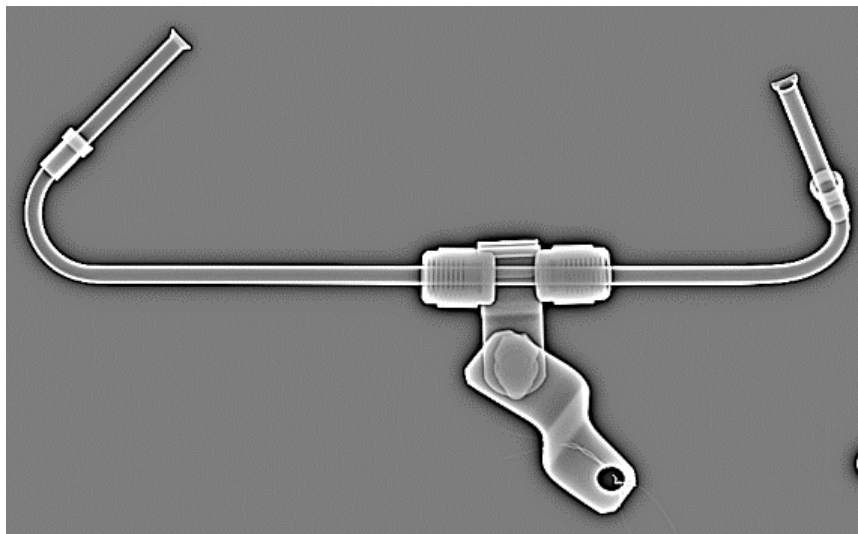
- **Oil pipe to low oil pressure switch : X-Ray examination**  
→ No deposits nor particles inside

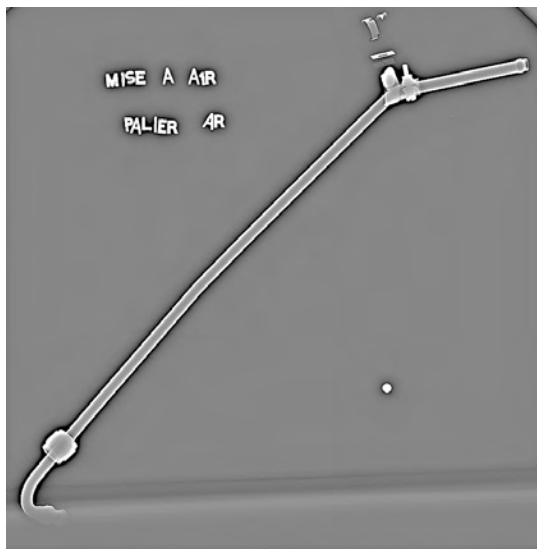
Aircraft side  
(outlet)

- **Vent pipe : X-Ray examination**  
→ **No deposits nor particles inside**

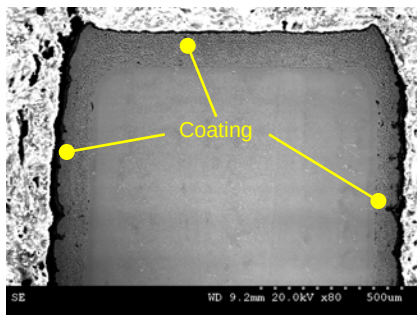
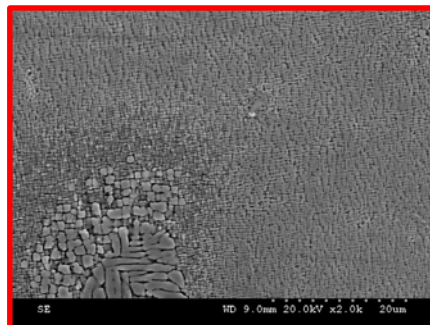
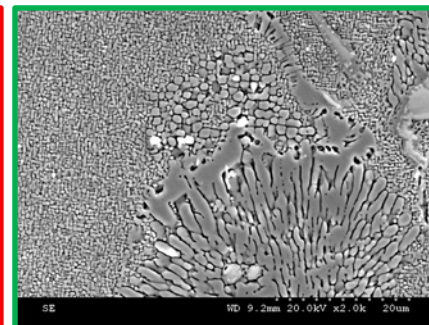
HPT1 HPT2

- Coating present all round and in good condition
- Slight evolution of the metallographic structure from blade foot to tip in line with experience

→ **HPT1 blades' condition in line with experience**

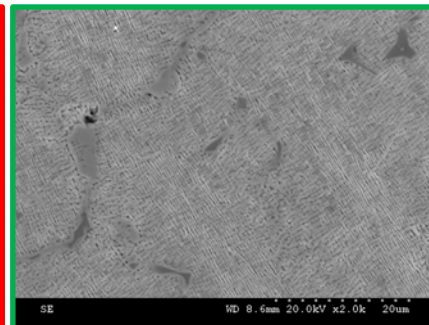
- Coating present all round and in good condition
- Slight evolution of the metallographic structure from blade foot to tip in line with experience

→ **HPT1 blades' condition in line with experience**

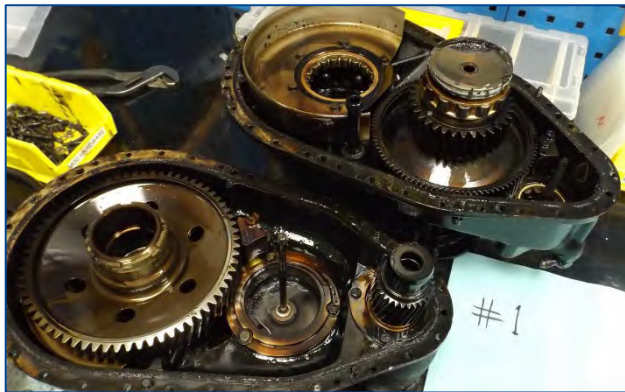
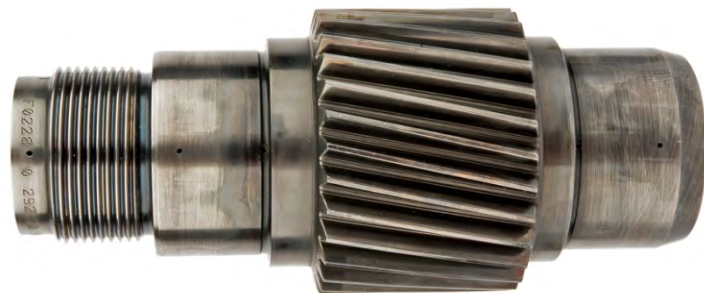
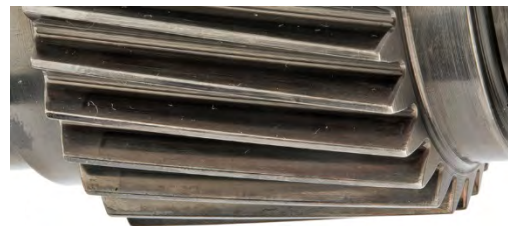
- The reduction gearbox was opened. Gears and bearings were unremarkable.

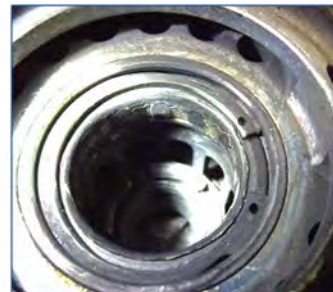
- No FOD damage to compressor
- Fuel control lever on FCU was in full-open position
- Rear bearing damage due to seizure. No evidence of coking.
- Metallic (magnetic) debris found on rear bearing's magnetic plug
- 3-way union (deck fitting, AHD supply) of vent line found clear, unobstructed
- Blue stains on axial compressor's shaft at bearings' and bevel gear locations
- Contact marks on Gas Generator's components consistent with bearing's seizure
- Imprints by NPT's blades on NGV consistent with no PT rotation at time of crash

- Findings were consistent with the engine 2 being at stand-still at the time of impact
- Origin of rear bearing seizure not determined

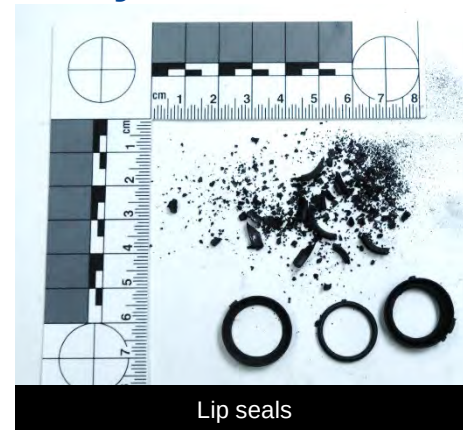
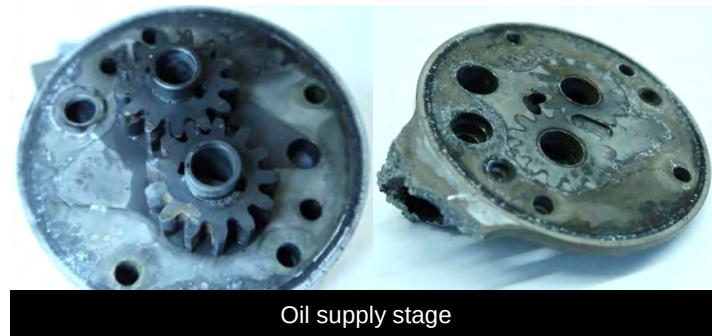
- The pump was slightly greasy at places but mainly dry inside
- All elastomers were cooked. They crumbled on contact. The lip seals between the pressure and scavenge stages shattered in many fragments (only support rings remained intact).
- The gears left an imprint of their shapes in the adjacent plates. This imprint resulted from a dried layer of oil after the engine shut-down which acted as glue thus explaining the impossibility to rotate the gears manually → the seizure is due to the post-crash fire heat
- The overpressure valve was in place. Its spring kept its “in position” height probably due to the post-crash fire’s heat.
- All gears exhibited a few traces of oxidation which can be associated to the storage time since the event.
- Oil supply stage : gears in good condition, no scratches.

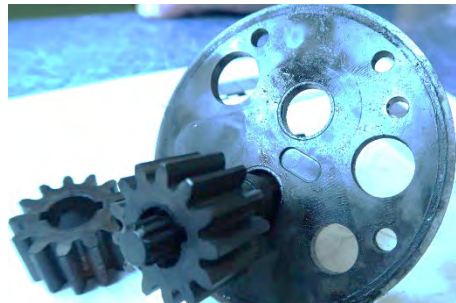
MO1 scavenge stage

- Accessories and reduction gearboxes scavenge stages : light superficial scoring at periphery and on adjacent plates in line with experience

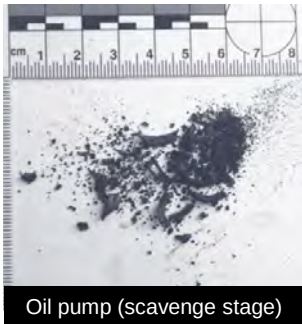
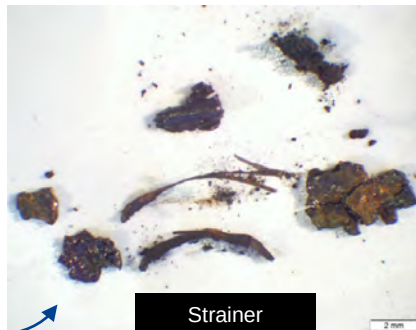
### Particles Analysis (SEM + EDS) : scavenge line

C-Zn-Pb-P-Na-S-Sn-Fe-Al /  
C-F-Ca-Mg / C-F-Ca-Mg-Al /  
C-Zn-Fe-Ti / C-O-Zn-P-S-Al /  
C-O-Zn-S-P-Na-Fe /  
C-O-Zn-S-P-Fe-Ag /  
C-Zn-S-P

Ag, C, O, P, S / Ni-Fe / Fe-Sn-P /  
Ni-Cr-Fe-S-Si-Mo / Fe-Ni-Sn-Cr-S-Si /  
Fe-Cr-Mo-V-Mn-Si-Ni-Al

Fe-F-Cr-Mn-Al-Ni-Mo-Ti-Si /  
Fe-Cr-Zn-F-Cu-Ni-Al-S-Mn /  
Fe-Cr-F-Zn-Ag-Si-Ti-Al-Mn-S

- The metallic debris could not be identified. They could be the result of the final deterioration in the rear bearing chamber with different components involved.
- **All metallic components indigenous to the rear bearing assembly and oil**
- **Numerous debris show that oil flowed through the rear bearing chamber and the scavenge system (duct, pipe, mag plug assembly, strainer and pump)**
- The pieces found in the Module 5 could originate from an O-ring and many particles found in the oil pump originate from the elastomer lip seals separating the pressure stage from the scavenge stages.

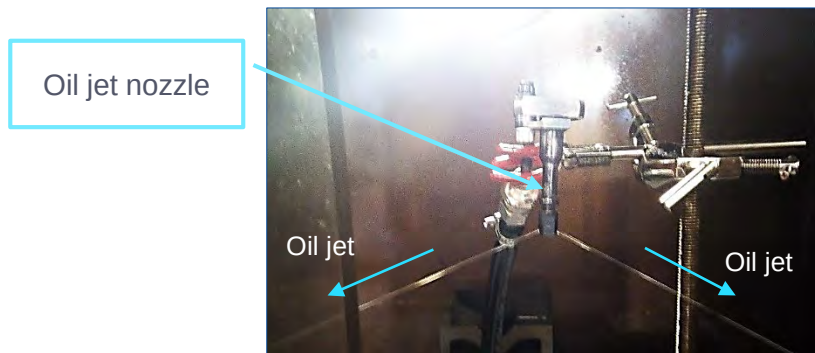
- **Oil lubrication jets for compressor's bearings**
    - The oil jet nozzle was tested on a specific test bench and the result was satisfactory
- **No obstruction of the oil jets**

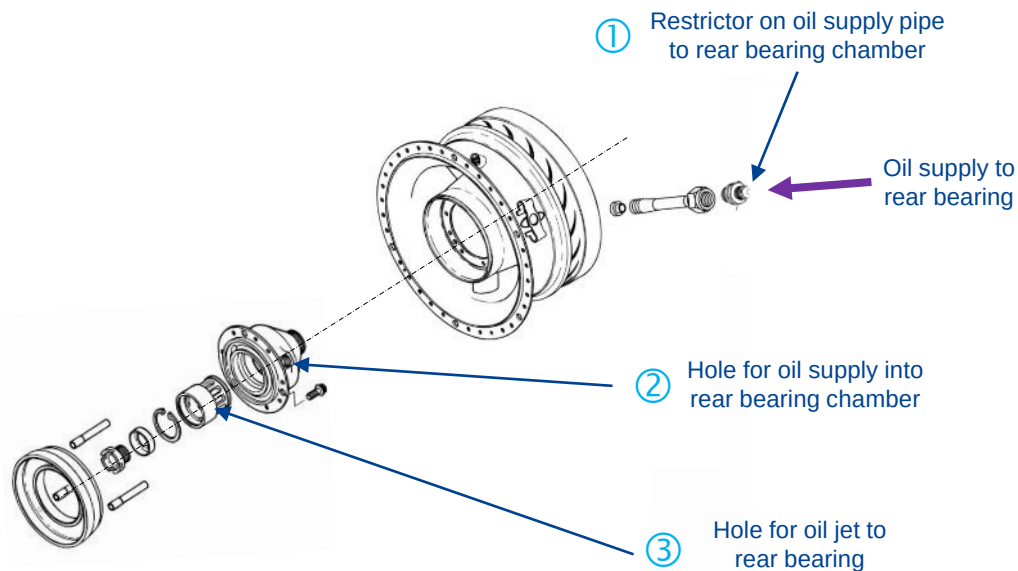
- Oil restrictors and jet on supply line to Gas Generator's rear bearing

→ Oil restrictors : no significant reduction to oil flow passage

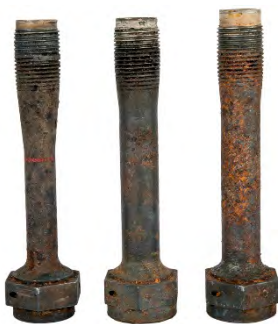
Oil supply   Scavenge   Vent

- **Tubes to / from Gas Generator's rear bearing chamber**
  - Oil supply and scavenge tubes : Layer of coked oil adherent to inner surfaces. Holes clear.
  - Vent tube: Presence of thin layer of coke
  - The three tubes are not obstructed.

→ **Tubes : no significant reduction to oil/air flow passage**

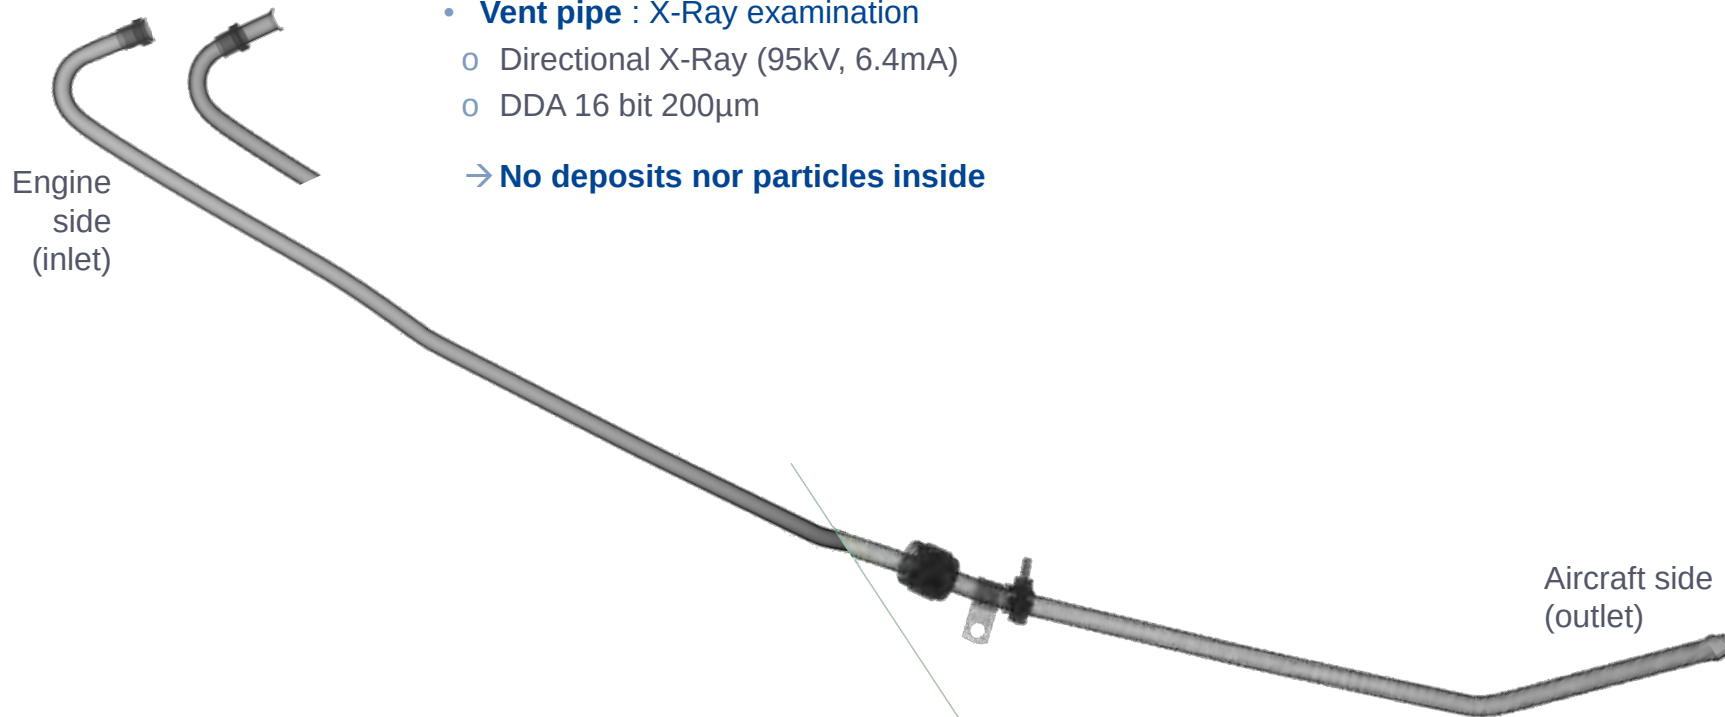
- **Vent pipe** : X-Ray examination
  - Directional X-Ray (95kV, 6.4mA)
  - DDA 16 bit 200µm

→ **No deposits nor particles inside**

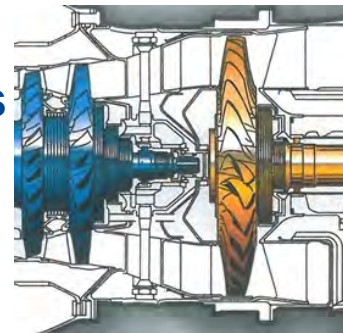
- Internal cavities around rear bearing chamber
  - No traces of oil on front face of rear bearing chamber
  - No significant traces of oil on internal cup plates
  - No traces of oil on Power Turbine's NGV in main air path or in the hollow vanes.
  - Light soot run off marks towards the three horizontal tubes and towards the main air path (behind the Power Turbine). No significant "swirl" patterns.
- **No significant signs of oil out of rear bearing chamber**
- **No signs of fire in the rear bearing chamber and cavities around it**

Light soot run-off marks  
No "swirl" patterns

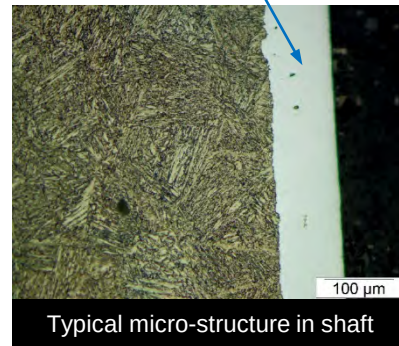
→ **Blue stains = coloration of chromium plating under heat**

→ **Rare blue colorations associated with heat coming from bearings and gear in normal static position/contact related to the shaft**

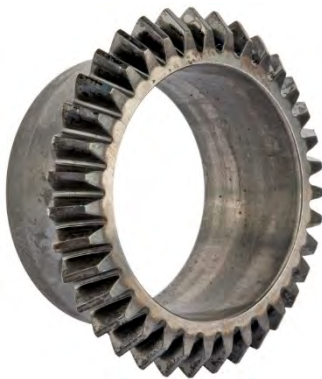
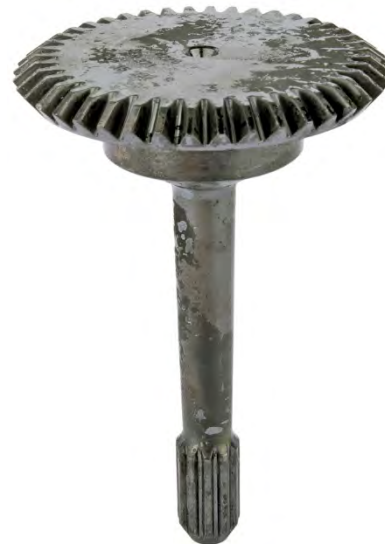
- **Bevel gear 35-42 teeth**
  - Surface deposit on both gears. Peels off easily.
  - Flanks and splines unremarkable with no findings to report

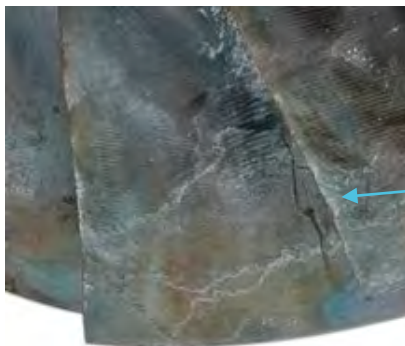
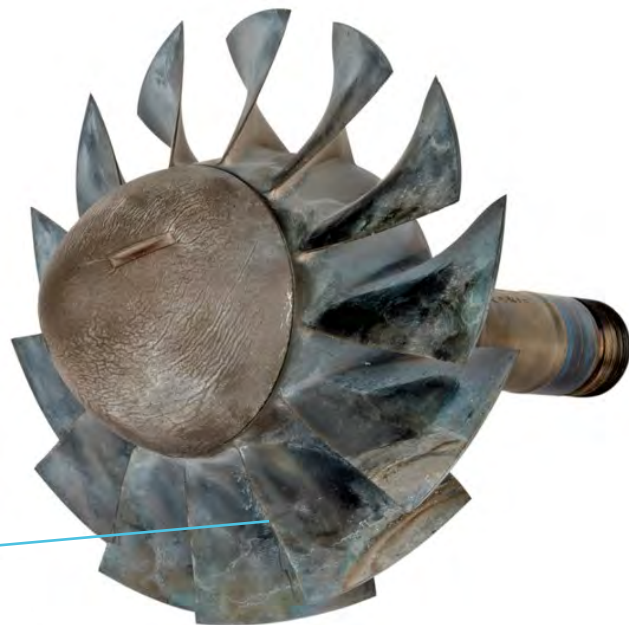
- Heat generated wrinkles on inlet cone
- Dark blue coloration of blades (titanium)
  - **Axial compressor exposed to high heat consistent with the post-crash fire**
- All leading edges rough with numerous small impacts
- All blades affected the same way
- No significant erosion
  - **Impacts due to homogenous grit-like ingestion**

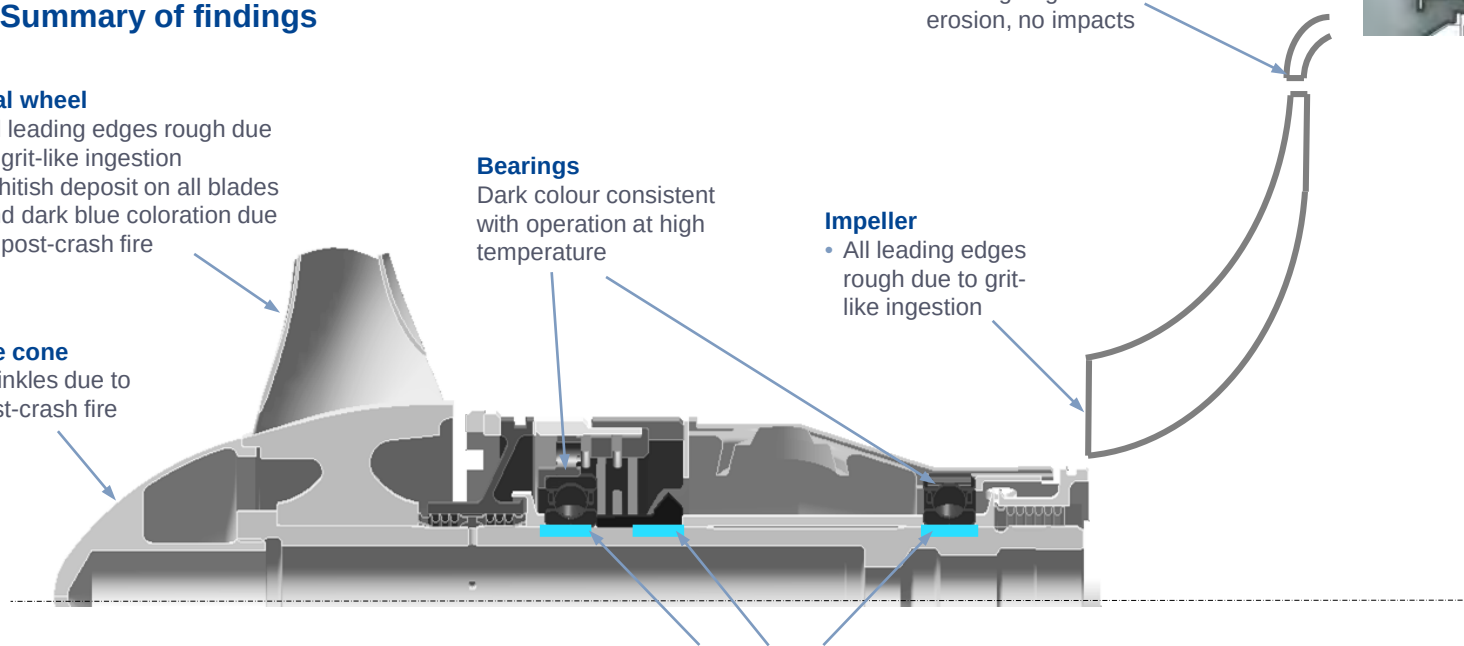
#### Axial compressor shaft

- 3 significant local colorations due to high heat transfer from bearings and gear
- No indication of relative rotation with the shaft of inner races and 35 teeth gear

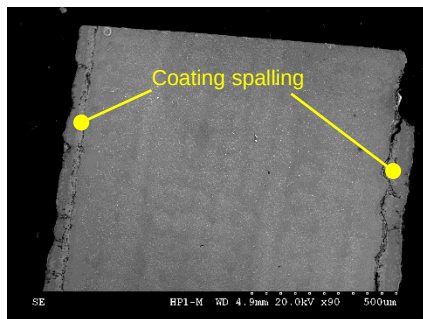
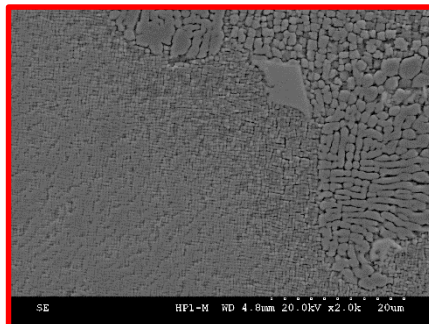
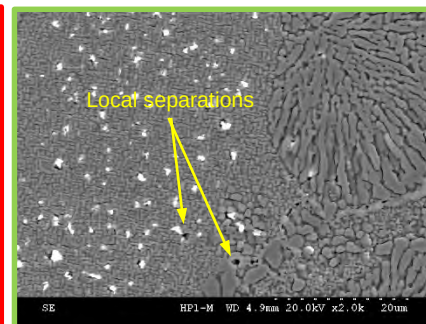
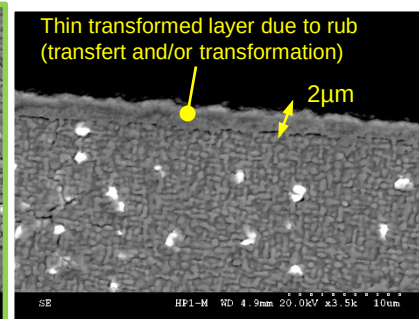
NGV1 HPT1 NGV2 HPT2

- Coating spalling near blade's tip
- Metallographic structure evolution from blade foot to tip indicative of metal temperature increasing towards the tip
- Local separations at grains' boundaries near the blade tips indicative of light creeping phenomenon
  - **HPT1 blades' condition in line with experience and does not indicate excessive usage beyond the normal range**
- Presence of thin layer of resolidified blade metal on tips
  - **HPT1 blades' tips condition indicative of sustained rubbing with shroud**

Rub on tip

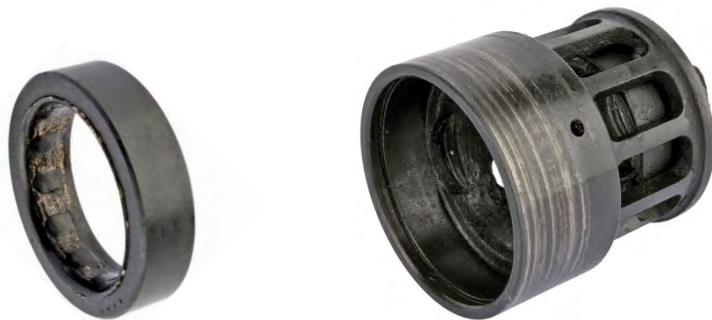
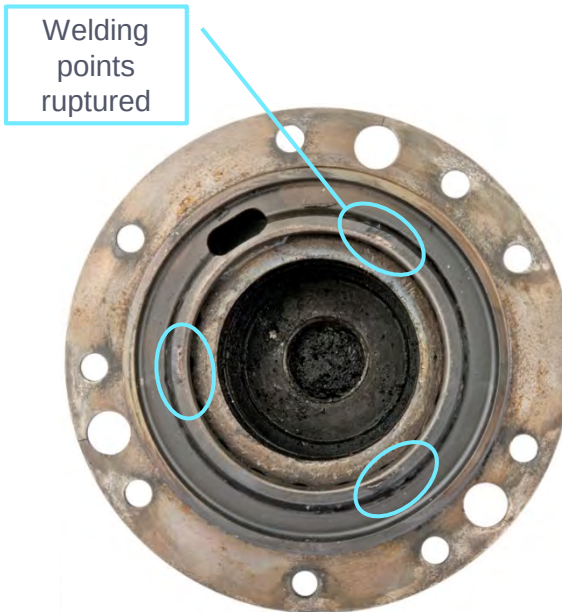
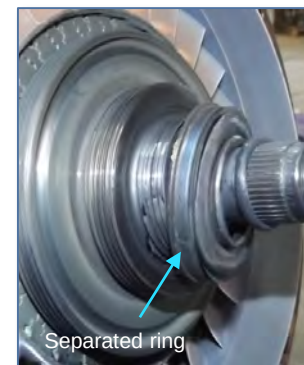
- **Main rear bearing assembly components**

| o Rear bearing seizure | o No significant amount of coking | o No significant amount of coking |
| o Rollers flattened<br>(see also following pages) | o Lubrication hole clear | o Small labyrinth's outer ring had separated. Three welding points ruptured. (see also following pages) |

- Bearing totally seized with all its rollers flattened due to rubbing with the inner race
- Separating cage showed plastic deformation with material pushed forward and backwards (see also photos on following pages). It shows signs of circular rubbing against the inner race.

→ Operation with seized rollers rubbing against the inner race

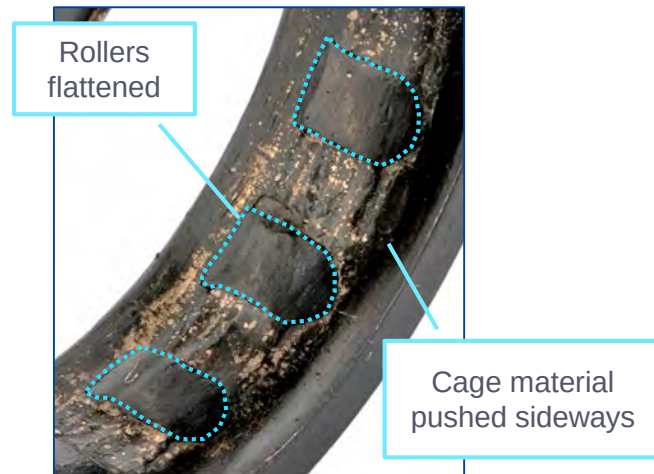
Rollers with  
flat tops

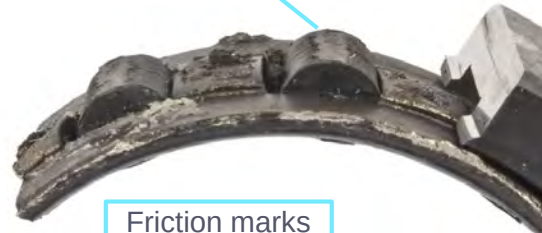
Friction marks  
on track

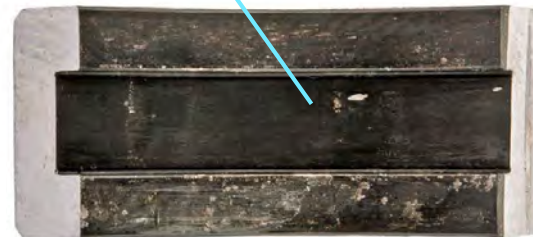
Cut-off section of outer ring

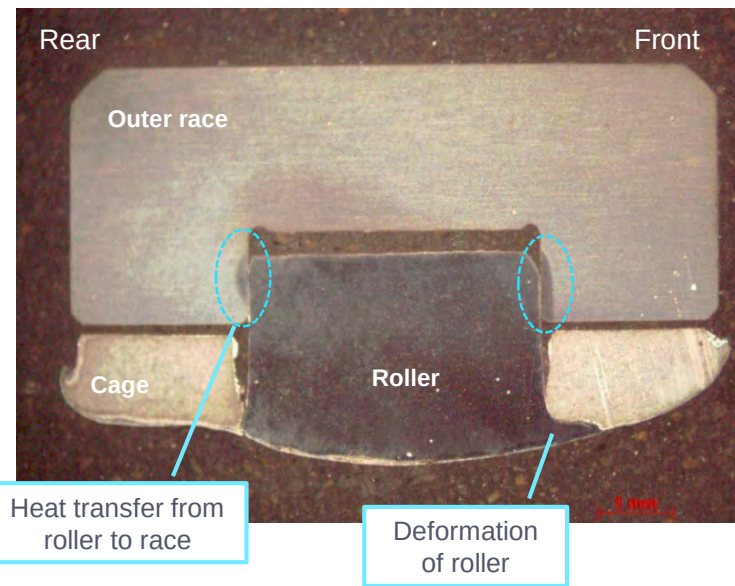
- A section of the bearing was cut and polished. It was submitted to a Nital etch surface treatment and examined with a SEM.
- For each component taken separately, the etch treatment showed uniform coloration thus indicative of homogenous temperature throughout each component. The colour difference between the roller and the outer race (same material) could indicate that the temperature experienced by the two components was different.
- The cut section shows the plastic deformation of the separation cage indicative of friction and high temperature
- Two darker local areas on the outer race are indicative of heat transfer by conduction from the rollers to the outer race.
- Deformation of the rollers with spread of material at the area that rubbed with the inner race.

→ **Seized rollers transferred rubbing heat to the outer race**

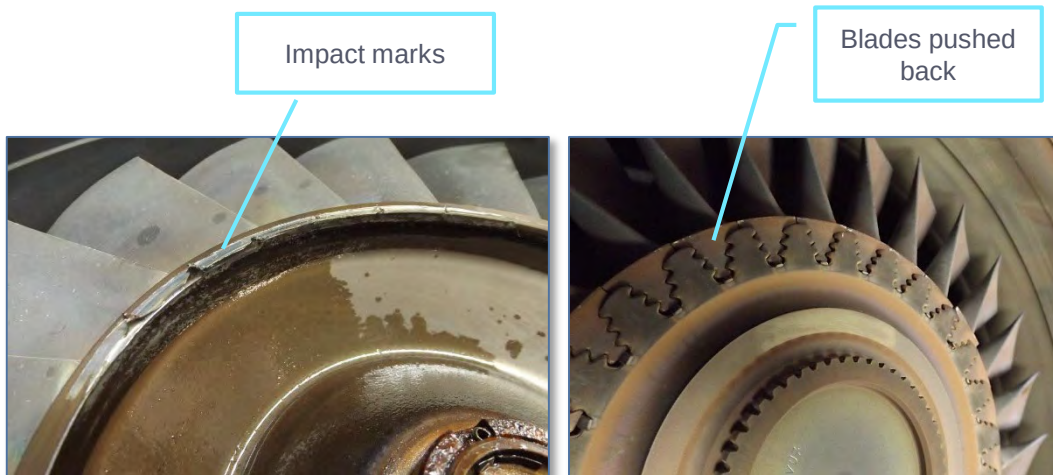
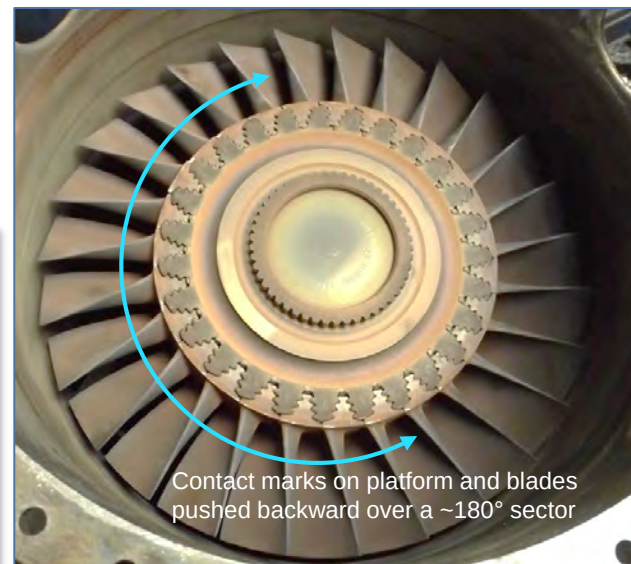
- Impact marks on front face of PT blades' platforms over a ~180° sector with blades pushed backwards and wire lock lifted
- Imprints in the back face of the PT\_NGV at places coinciding with the position of the PT blades' forward platforms

→ **The PT wheel impacted the PT\_NGV at standstill**

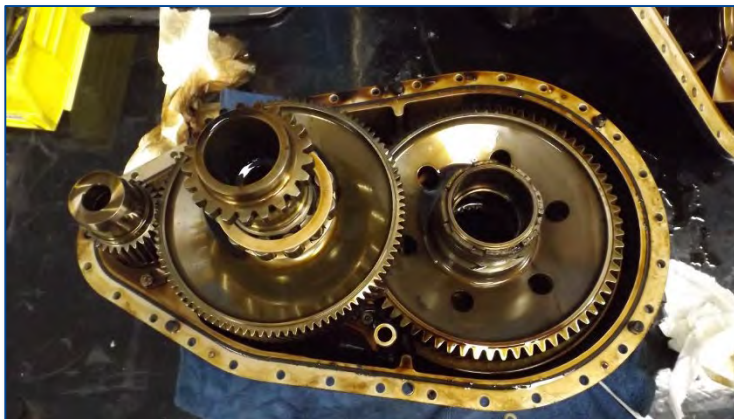
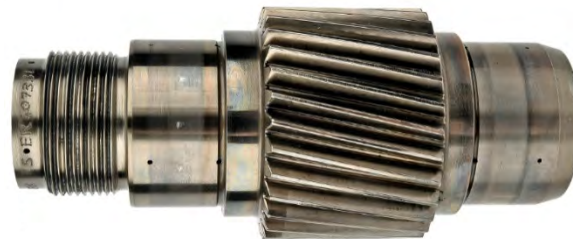
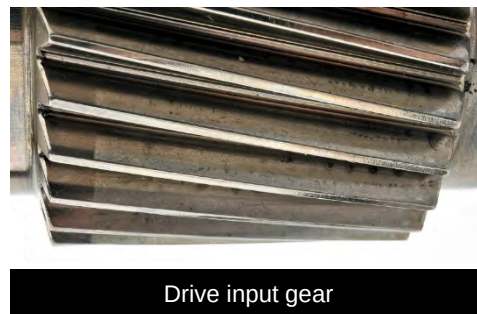
## □ Reduction gearbox

- The reduction gearbox was opened.
- No findings to report regarding the gears and the bearing races
- An oil sample was collected for analysis (see next page)
  - **No signs of operation with insufficient lubrication or with oil over-temperature**

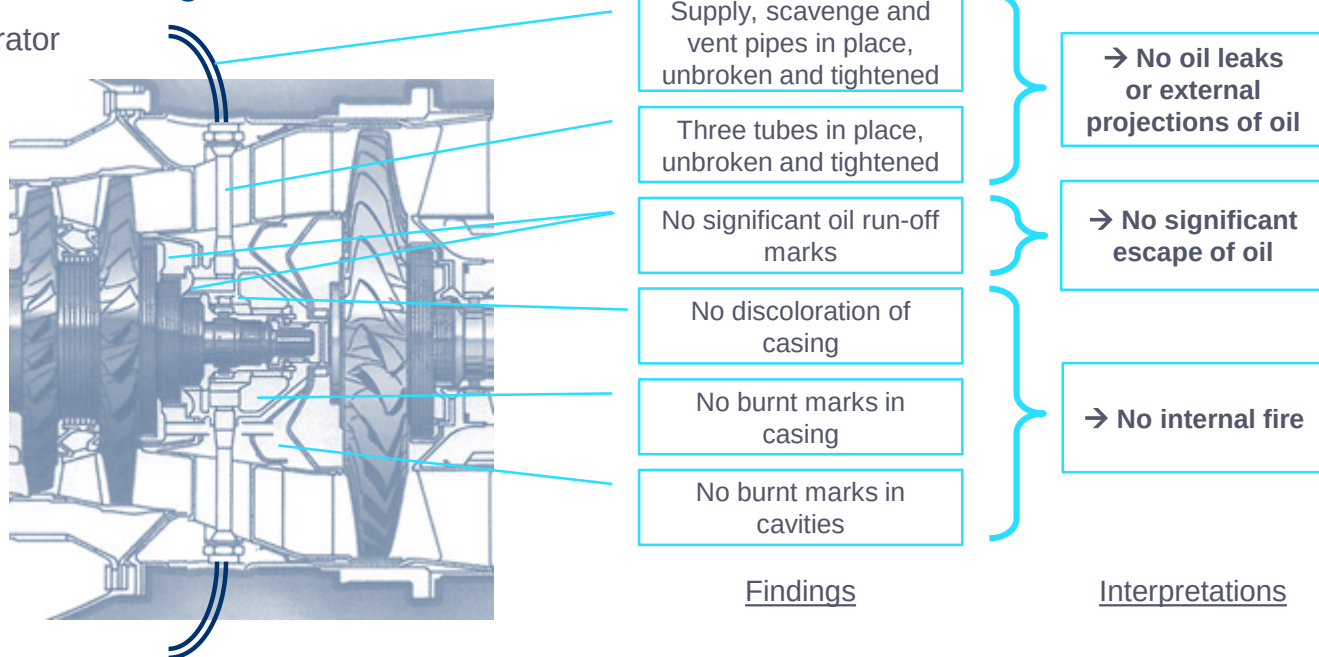
- Engine 2 : Gas Generator

→ No indications of internal fire in Engine 2's rear bearing environment

→ No external projection of oil on hot engine components around rear bearing's environment

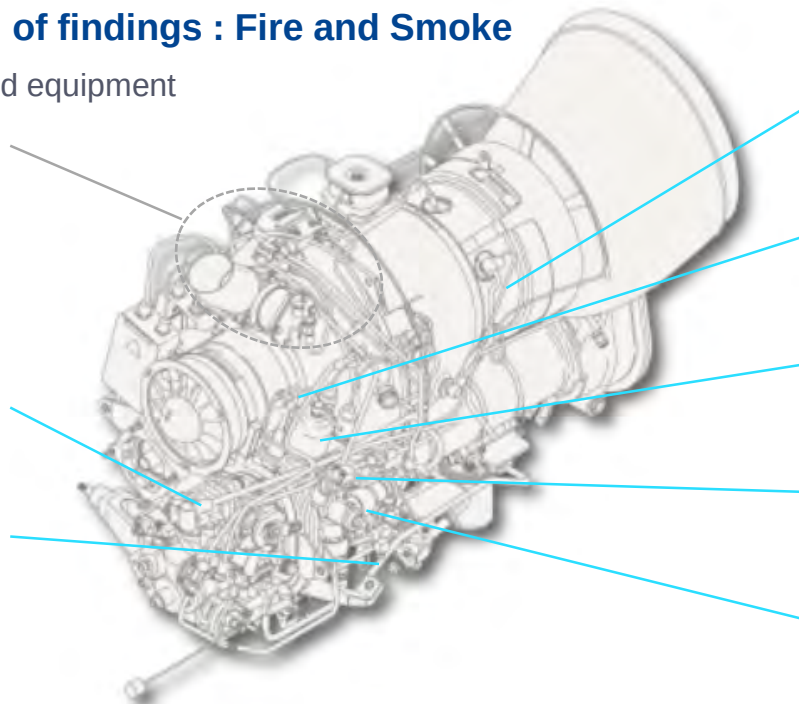
Fuel control unit place,  
unbroken and tightened

Fuel pipes in place, unbroken  
and tightened

Oil pipes to/from rear bearing in  
place, unbroken and tightened

Oil pipes to/from compressor in  
place, unbroken and tightened

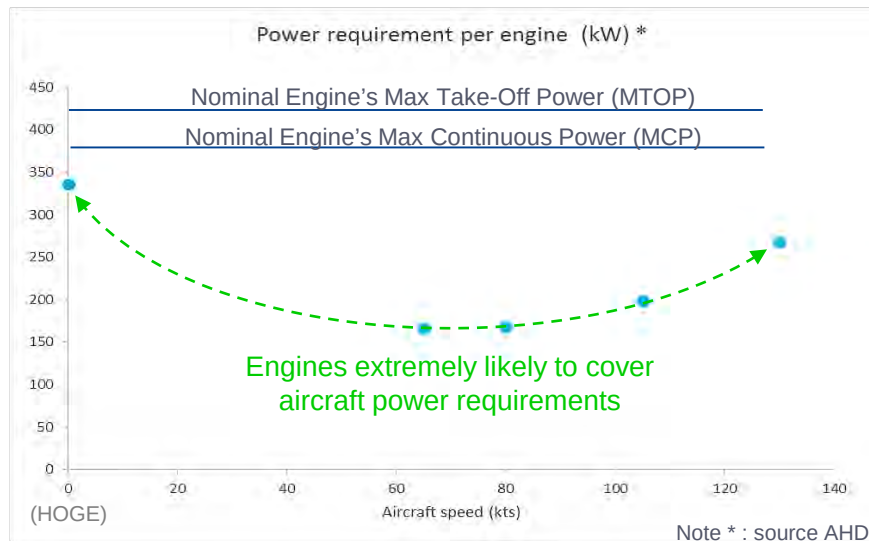
→ In the known flying conditions at the moment of the accident, it is extremely likely that both engines (in nominal conditions) were capable to meet AEO power requirements

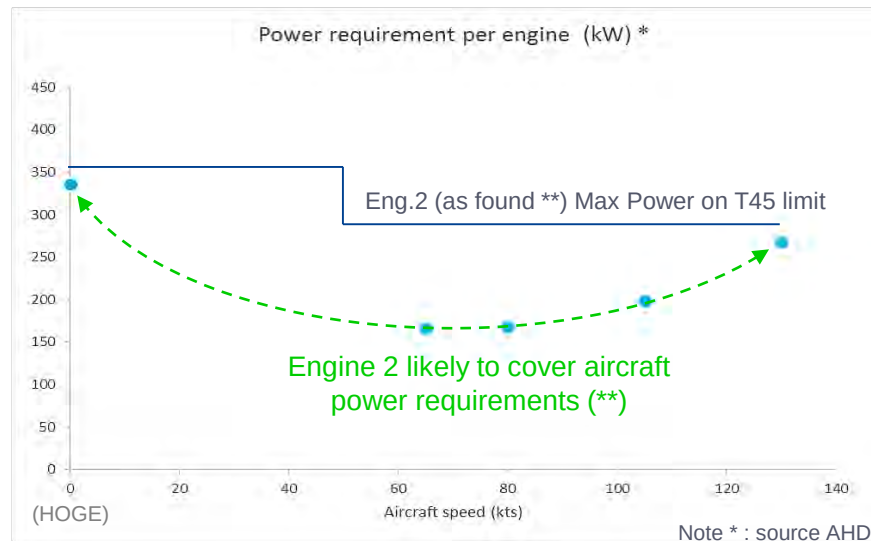
→ With Eng.1 nominal & Eng.2 as found (\*\*), it is likely that the aircraft AEO power requirements could be met

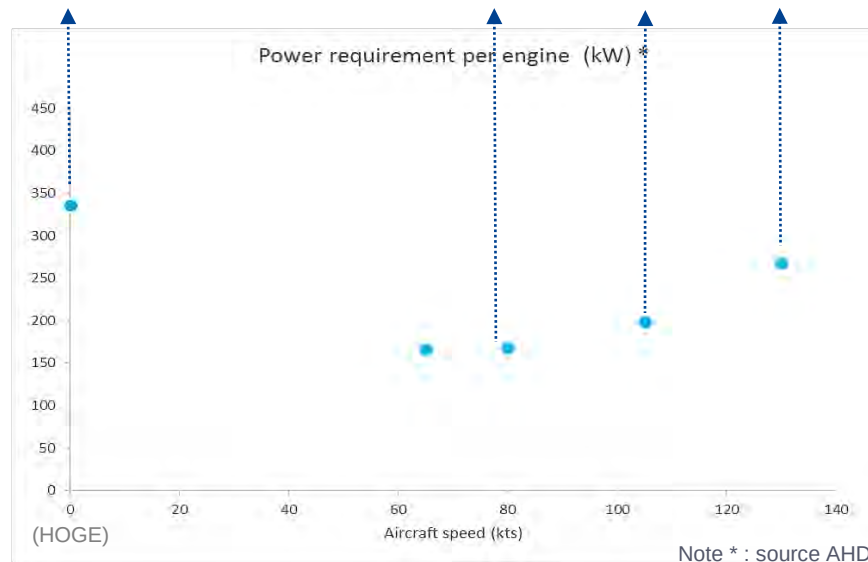
→ **It is extremely likely that the deterioration of Engine 2's bearing led to significant increases of T45 and slight decreases of NG**

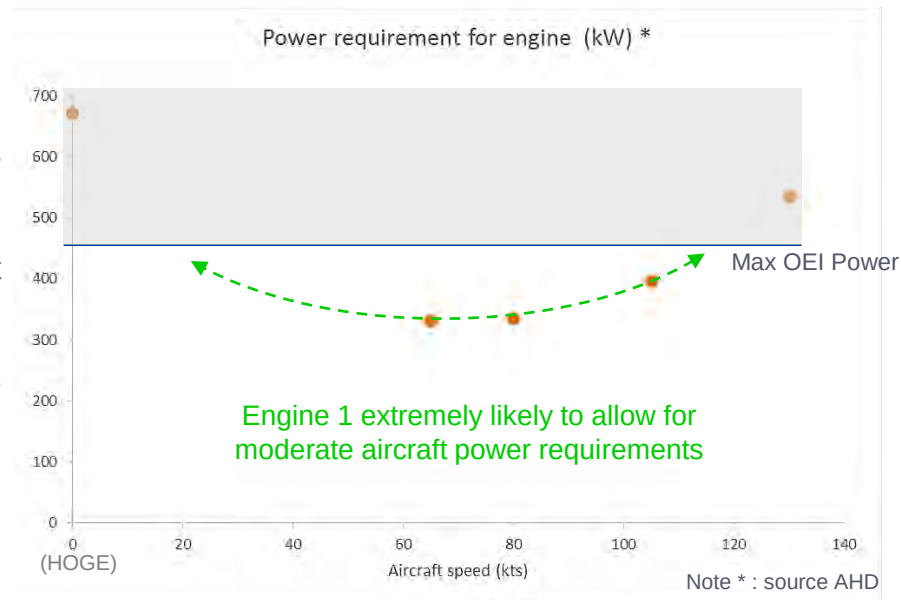
→ In the known flying conditions at the moment of the accident, it is extremely likely that Engine 1 (in nominal condition) would be able to meet moderate OEI aircraft power requirements

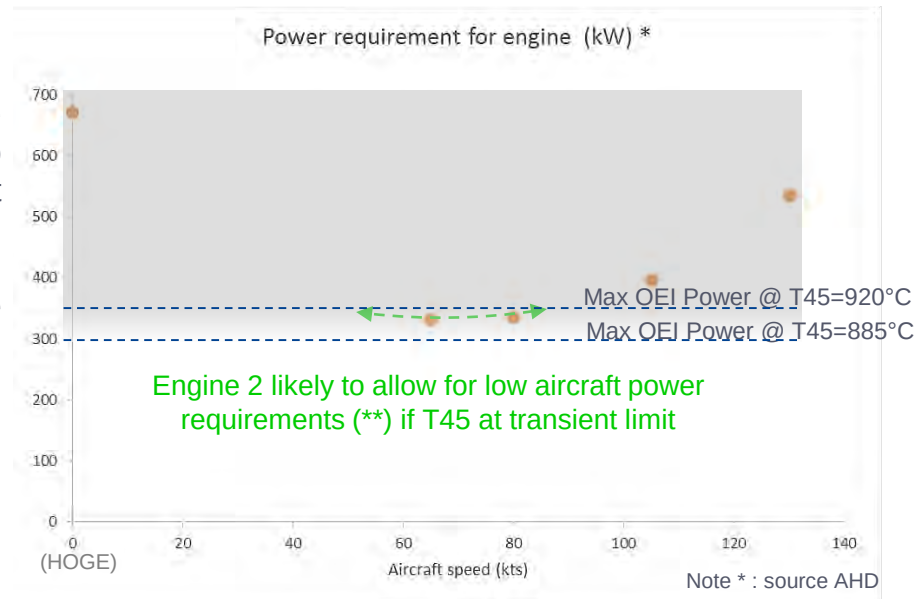
→ **In the known flying conditions at the moment of the accident, it is likely that Engine 2 (as found) would be able to meet low OEI aircraft power requirements(\*\*) if pilot allowed for T45 at the transient limit**
