## **Engine Investigation Report**

**Rolls-Royce Corporation  
Model 250-C47M  
Engine CAE-847837**

**High Line Helicopters, LLC  
Smethport, Pennsylvania**

**Accident date: 8 April 2018  
Wreckage exam date: 17-18 May 2018  
Report date: 20 June 2018**

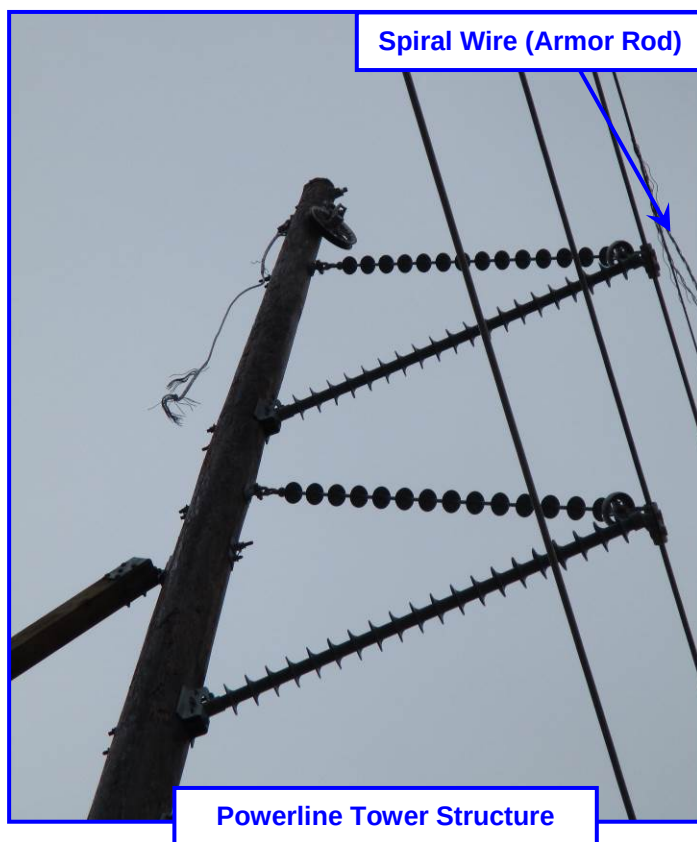
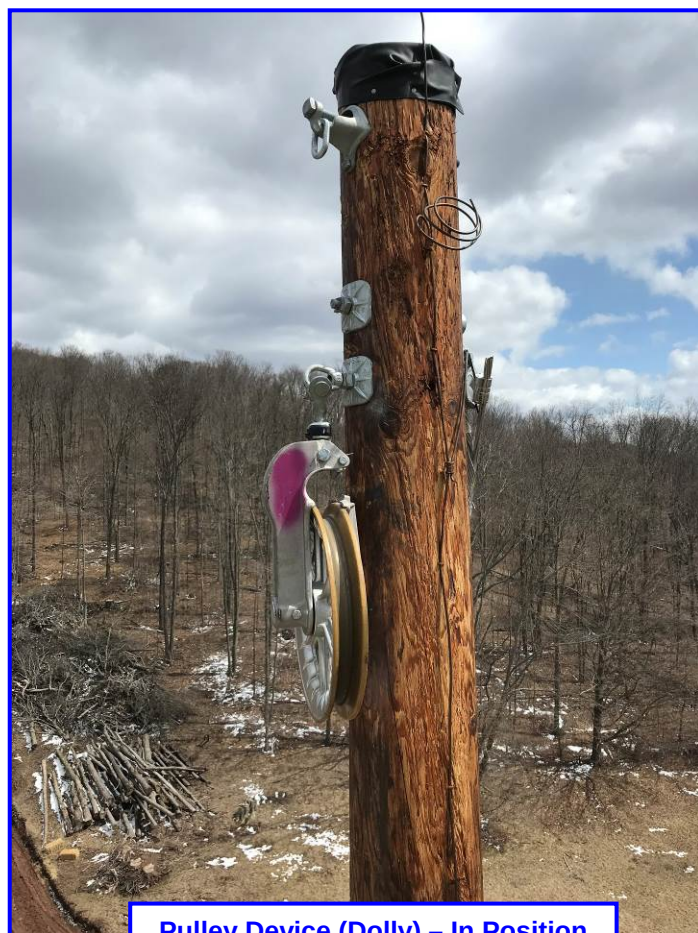
The safety strap was suspended from a cross-brace of the H-structure, and the hoist was found next to the fuselage; each appeared undamaged. Examination of the structure poles and the static line revealed signatures consistent with main rotor blade strikes. The dolly was in its swiveling mount and facing 180° from its operational position. Damage signatures to the pole above its mounting matched the dimensions of the dolly. The dolly was recovered from the top of the structure, and examination revealed it was intact except for the locking gate, which was fractured. The fracture surface displayed features consistent with overload. The dolly was retained for further examination at the NTSB Materials Laboratory.

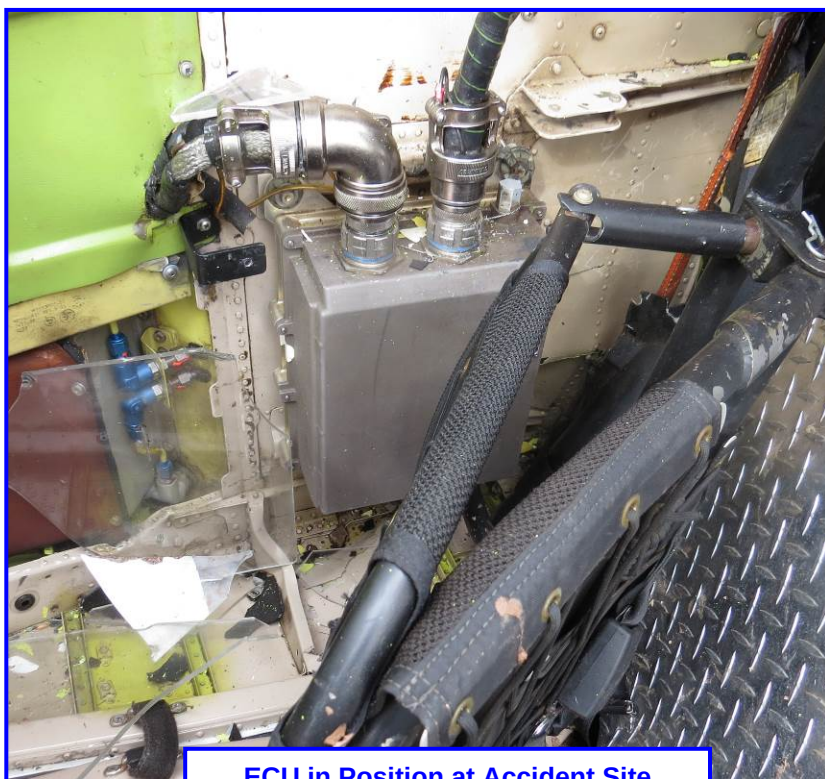
It was connected to a Rolls-Royce computer for downloading and examination of the ECU's memory. Data download was completed and a cursory review showed primary exceedance messages for Torque, followed almost immediately by Np (power turbine) & Nr (main rotor) speed exceedances. The control system responded by initiating Overspeed Activation sensing the overspeed of Np. The torque spike tracks along with a rapid rise in collective pitch.

Immediately following, the data shows a steep drop off in torque presumably from the loss of drive shaft connection between the engine and main rotor transmission resulting from the main rotor blades impacting static structure (power lines and/or utility stanchions).

The ECU data also showed drastic changes in throttle (PLA – power lever angle) position and at the same time a change in ECU control mode from Auto to Manual. The MD600N has an ECU AUTO/MANUAL switch on the collective pitch control. Although not confirmed, it's possible that the pilot's reactions to the helicopter's violent behavior were reactionary at that moment. This may also explain the abrupt drop in collective pitch at the same time the control mode was switched and the torque bottoming out.
