# **NATIONAL TRANSPORTATION SAFETY BOARD**

## **UAS Aerial Imagery Report**

### **A. ACCIDENT ERA18FA127**

Location: Crozet, VA  
Date: April 15, 2018

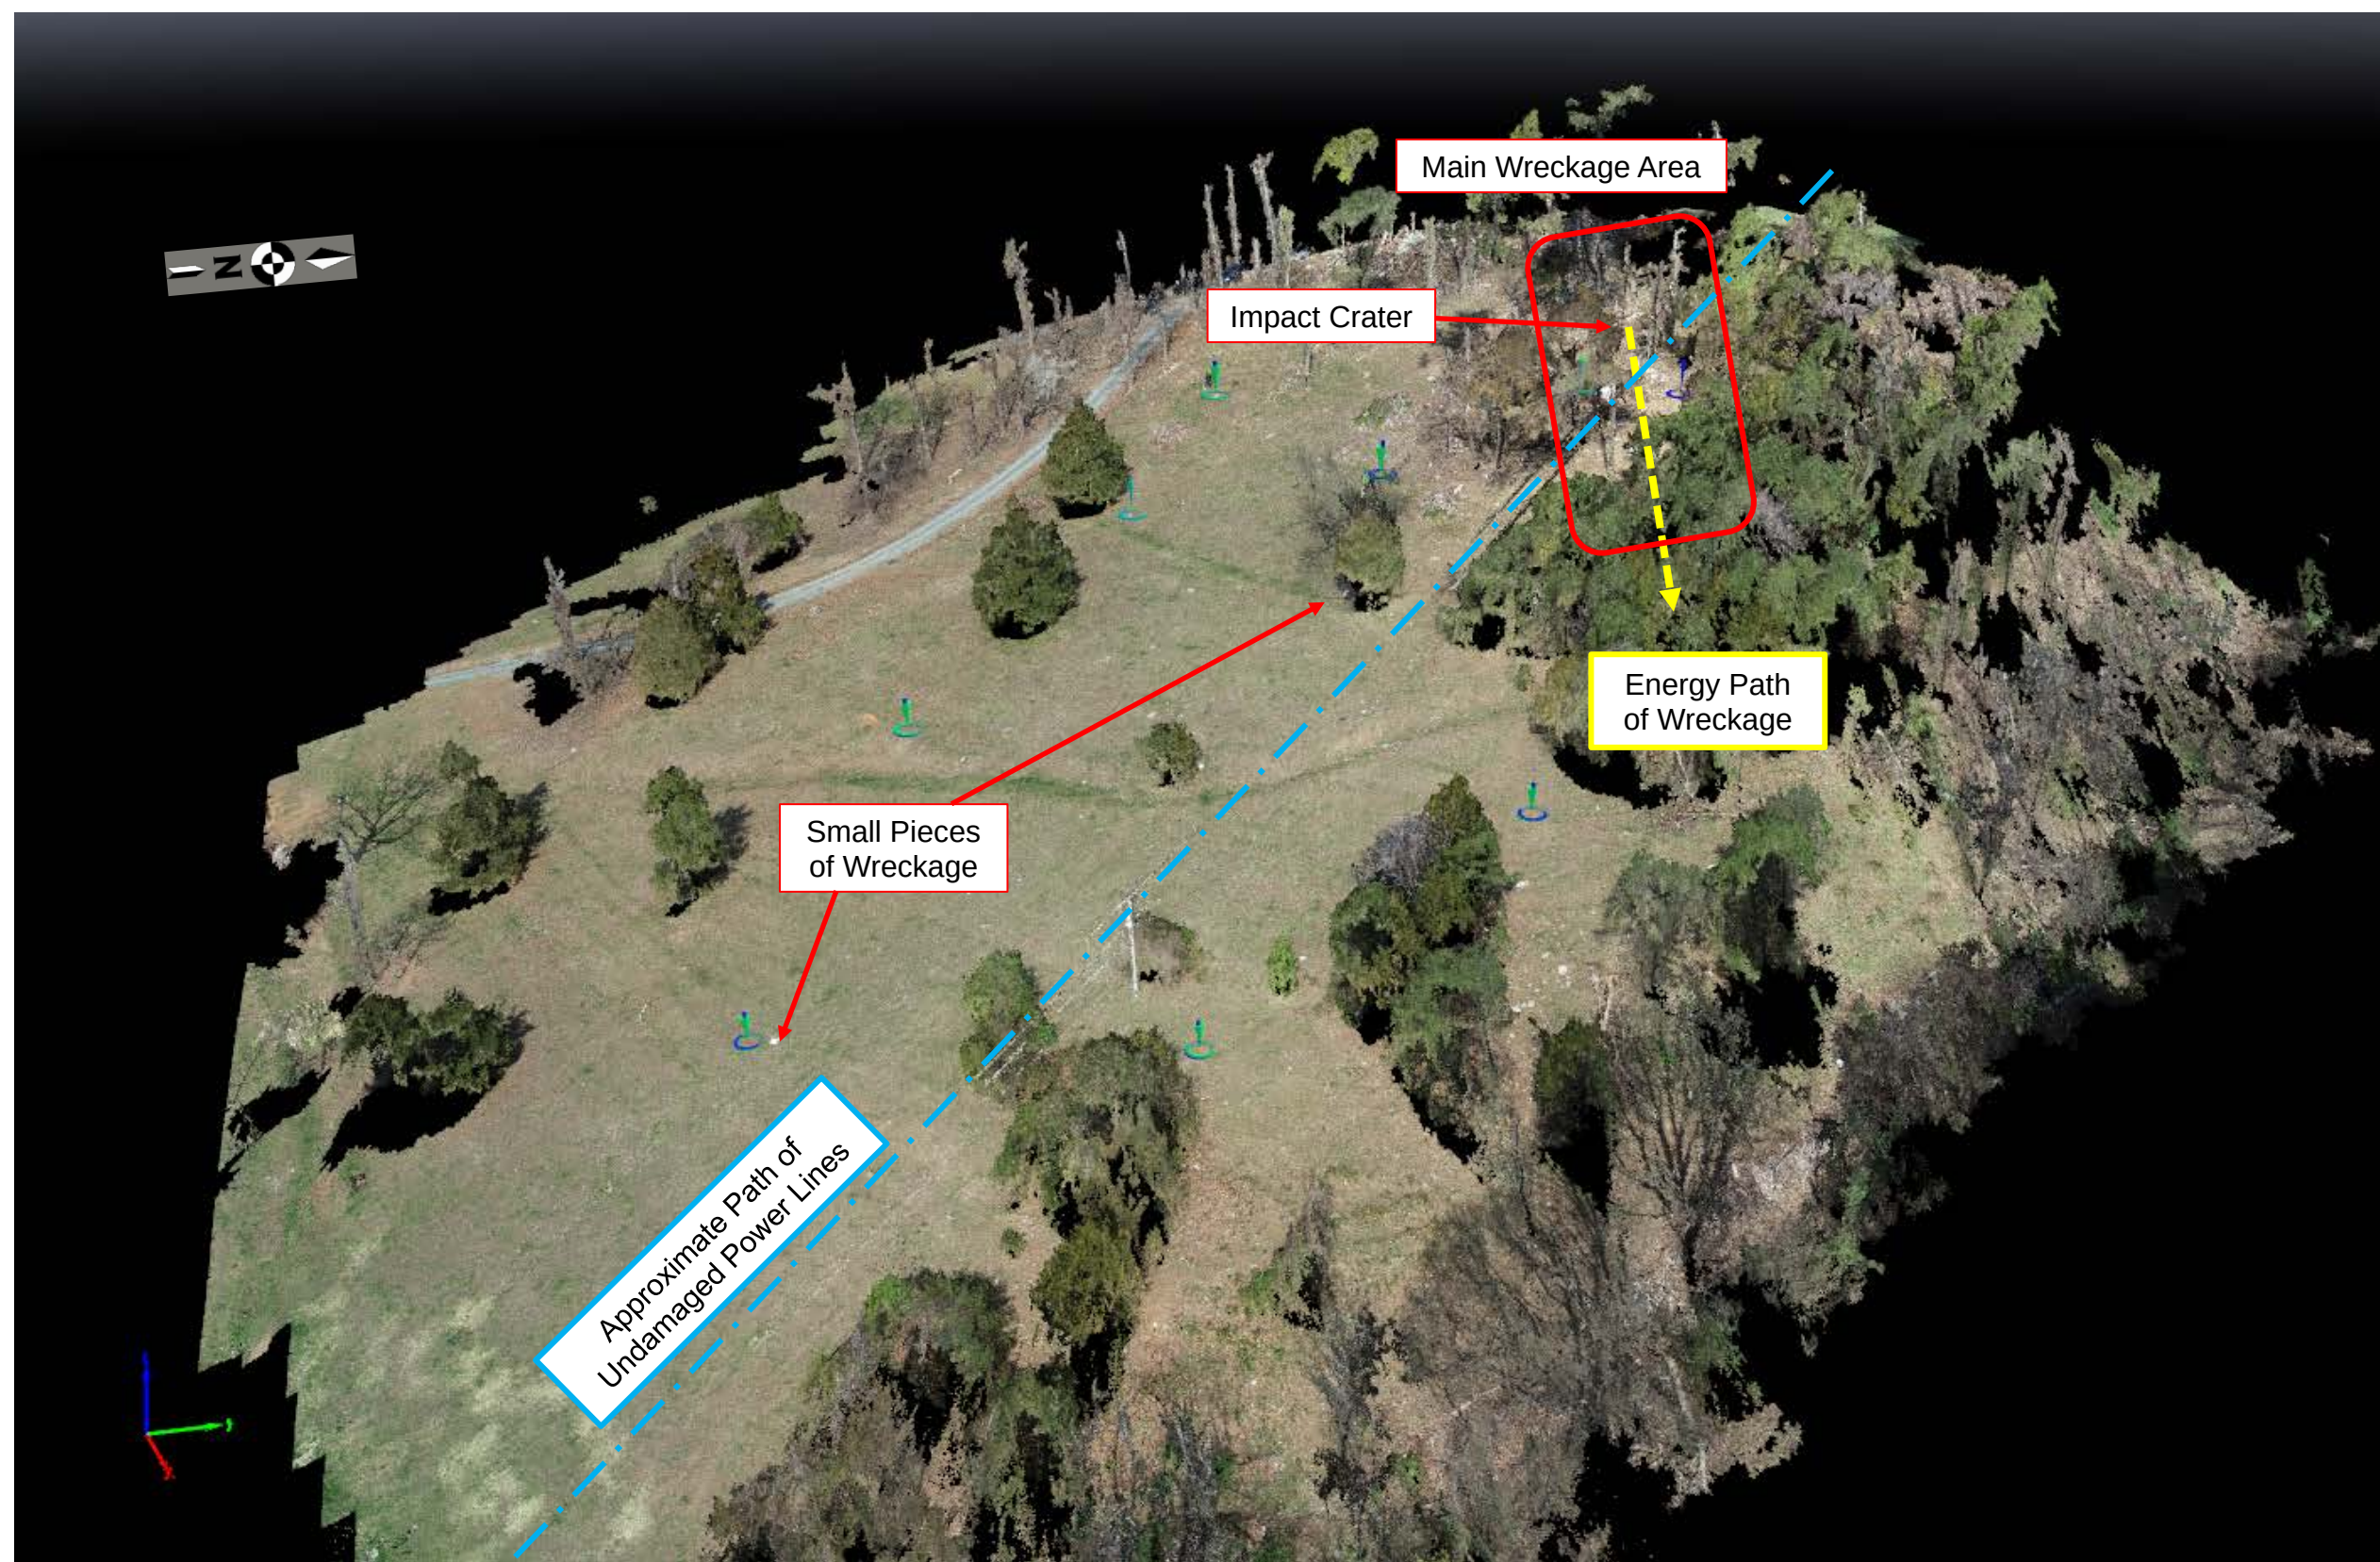
Figure 4 and Figure 5 contain screenshots of the orthomosaic map in Google Earth .kmz format. Figure 4 shows the overall accident site with showing the general direction of the energy path and the extent of smaller wreckage pieces. Figure 5 is an enlarged image around the main wreckage area.

Figure 5 – Orthomosaic of accident site overlaid on Google Earth zoomed in to show main wreckage area.

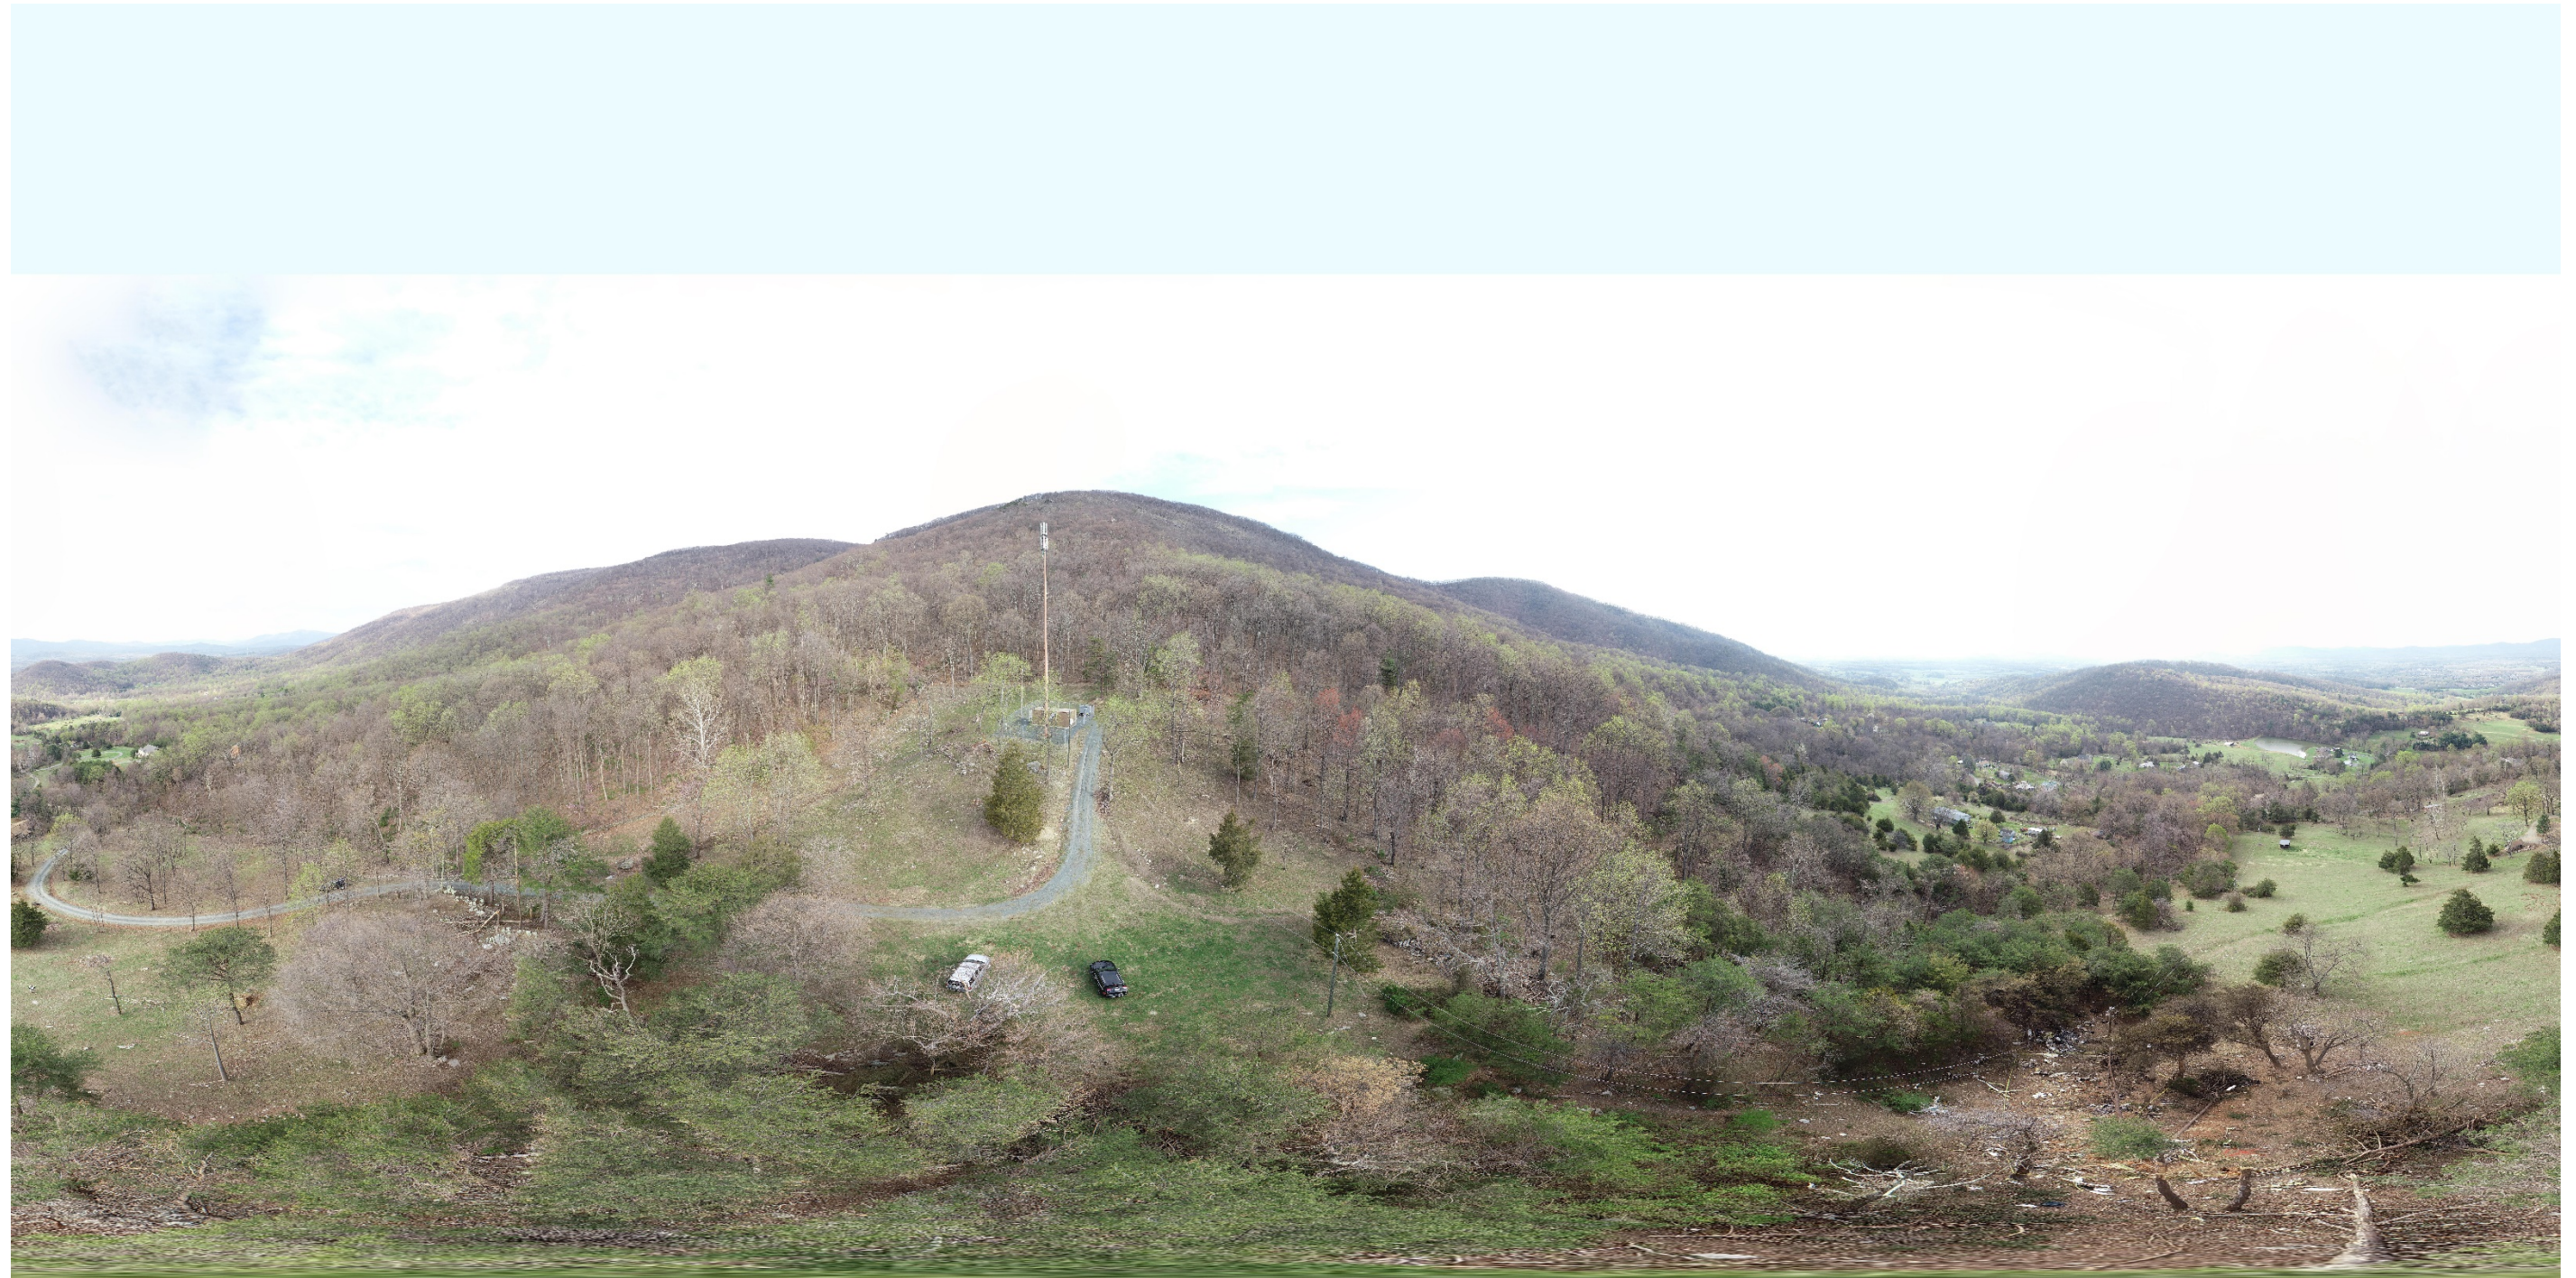
Figure 6 is a screenshot of the three-dimensional point cloud generated from the aerial imagery flights by the sUAS.

Figure 6 - View of the processed point cloud from Pix4D, Green/Blue markers are ground control points used in software
