# Continental Motors

## ENGINE EXAMINATION REPORT

| ENGINE MODEL | A65 |
| FILE NUMBER | 17-532 |

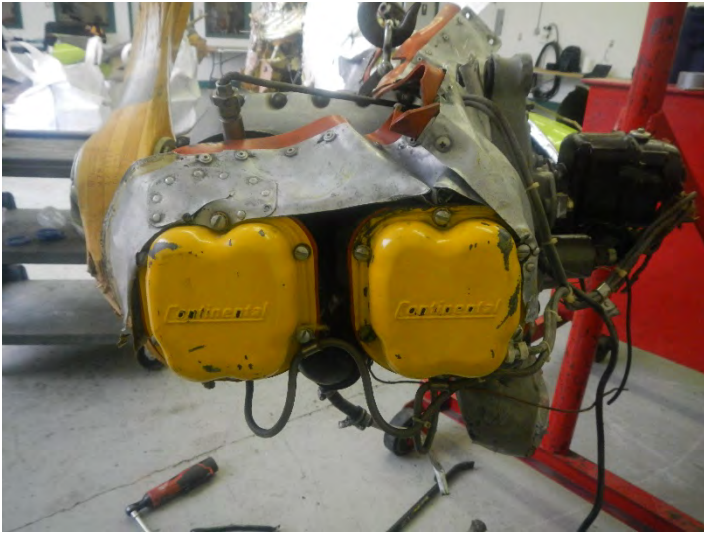
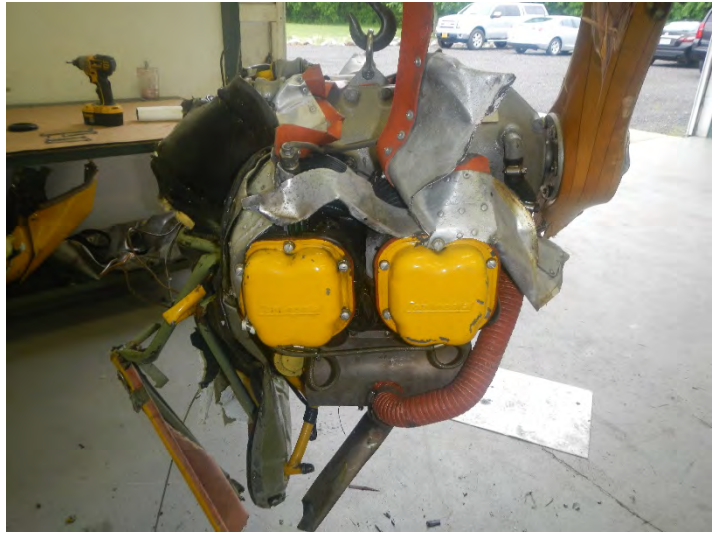
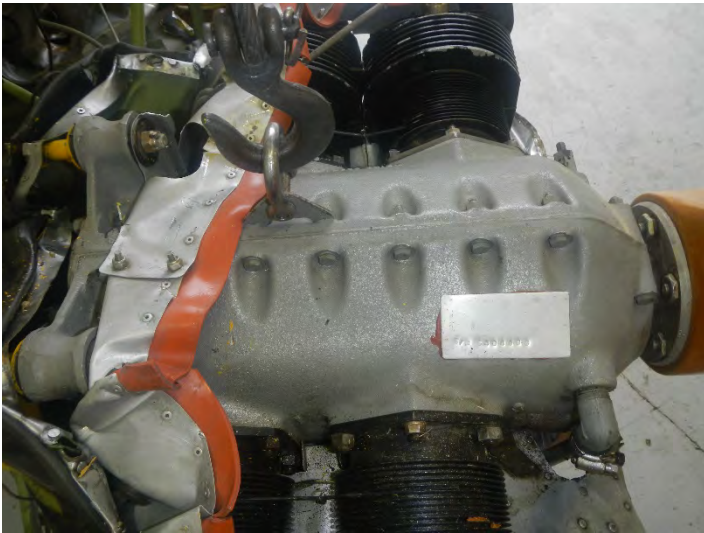
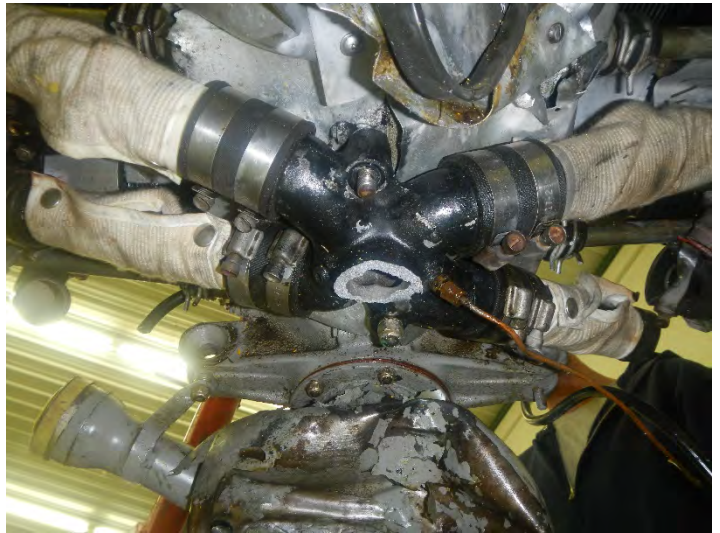
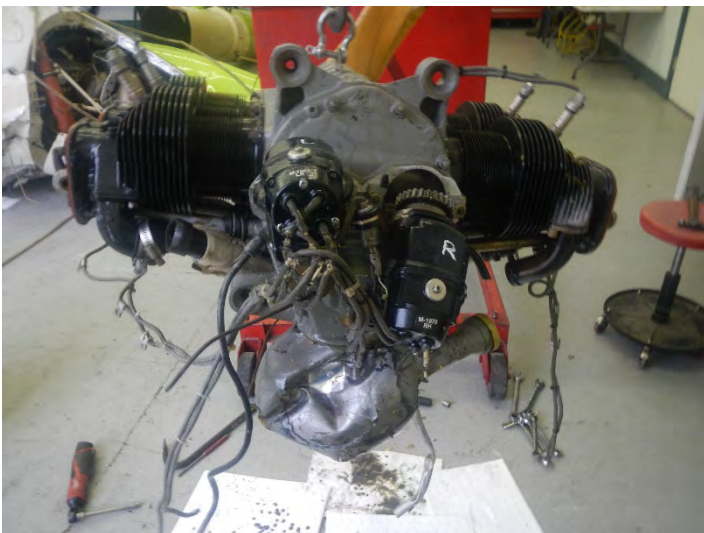
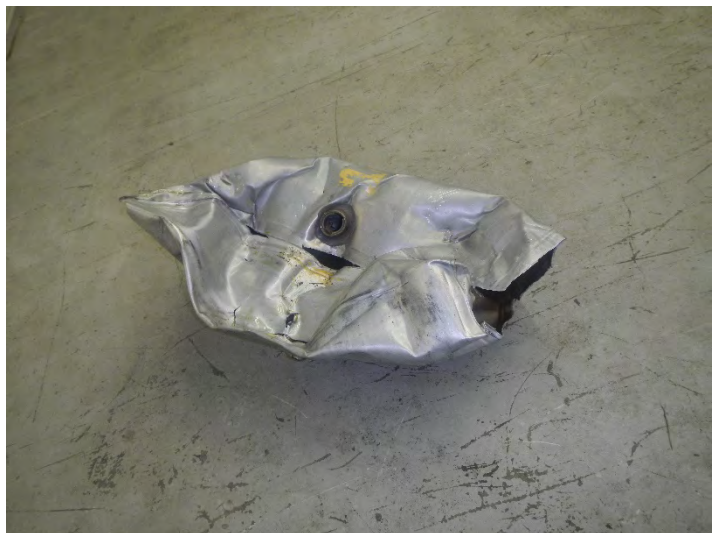
The engine was separated from the airframe, but the fuel tank, forward airframe structure, and firewall remained with the engine and were all symmetrically deformed around the backside of the engine. The propeller hub remained attached to the propeller flange and the spinner dome was flattened aft symmetrically. Both of the fixed-pitch wooden blades were separated, with the fractures of blade oriented aft. The carburetor mount was fractured and was previously examined by the NTSB IIC at the accident site.

The fuel tank, firewall, engine and airframe mounts, and exhaust systems were removed to facilitate examination of the engine. Upon removal of the firewall, it was noted that the magneto mounting flanges were fractured. The fuel tank was punctured and torn in multiple locations.
