# Continental Motors

## ENGINE EXAMINATION REPORT

| ENGINE MODEL | TSIO-550-C9B |
| FILE NUMBER | 18-188 |

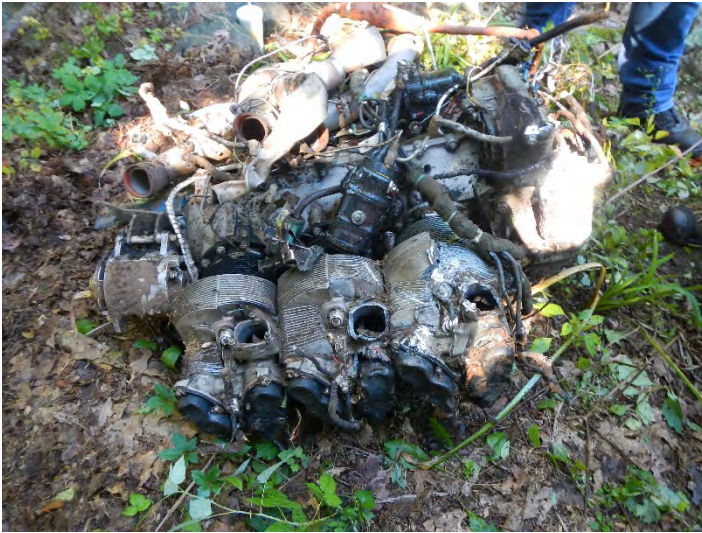
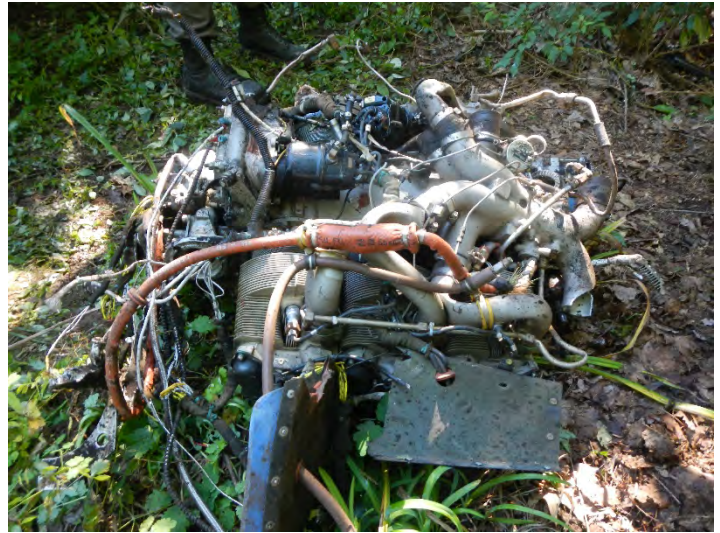
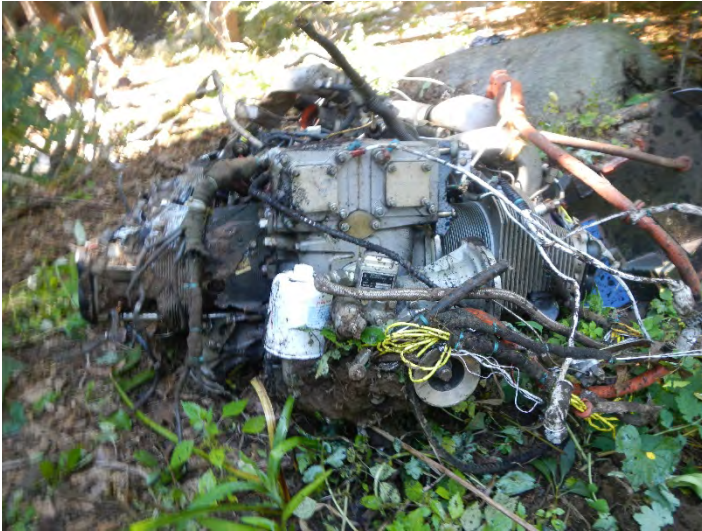
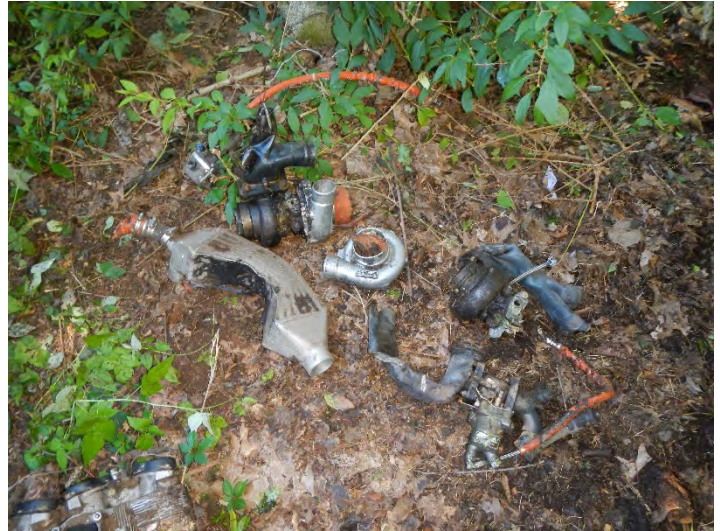
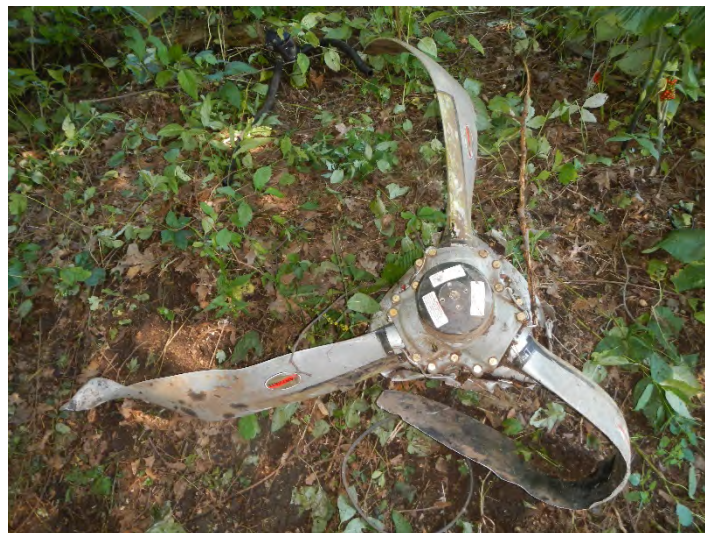
The engine was separated from the aircraft and came to rest in an upright position. The propeller, starter motor, intercoolers, turbochargers, and turbo charger components were separated from the engine. The left magneto was separated from the mounting pad but remained attached to the engine via the ignition leads. The left cylinders sustained significant impact damage that fractured numerous cooling fins, damaged the top sparkplugs, and displaced the #2 cylinder head in toward the engine centerline. The left intake tubes were separated from their cylinders. There were no external pre-accident anomalies noted with the engine or engine-related components.

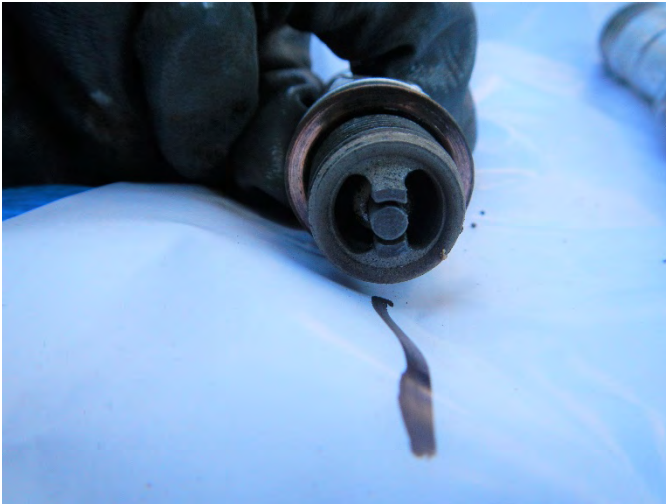
1T

The top sparkplugs were removed from the cylinders with the exception of the #2 cylinder, which was displaced and impinging on the fractured cooling fins. The bottom sparkplugs were examined utilizing a lighted borescope. All of the sparkplugs displayed normal wear and light combustion deposits with no signs of lead or carbon fouling.

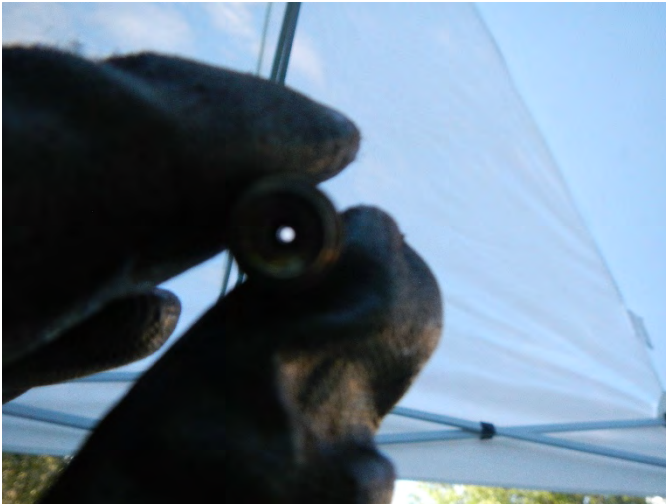
1

The left fuel injector nozzles were fractured and the right nozzles remained in place with the lines attached. The right fuel injector nozzles were free from obstructions. The portions of the fractured #2 and #6 nozzles were observed and were free from obstructions. The #4 nozzle was not observed.

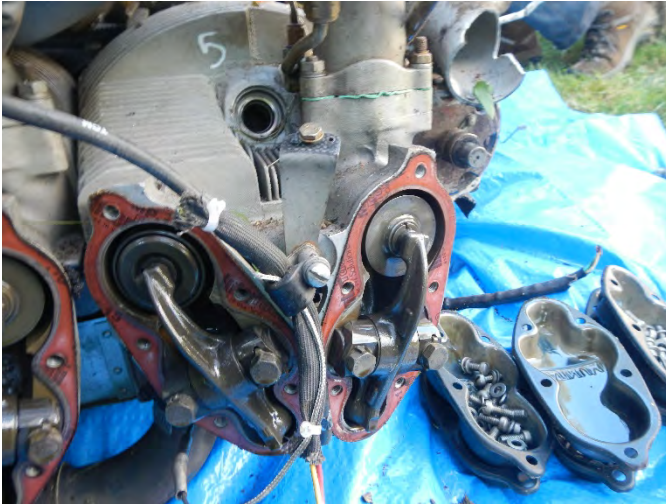
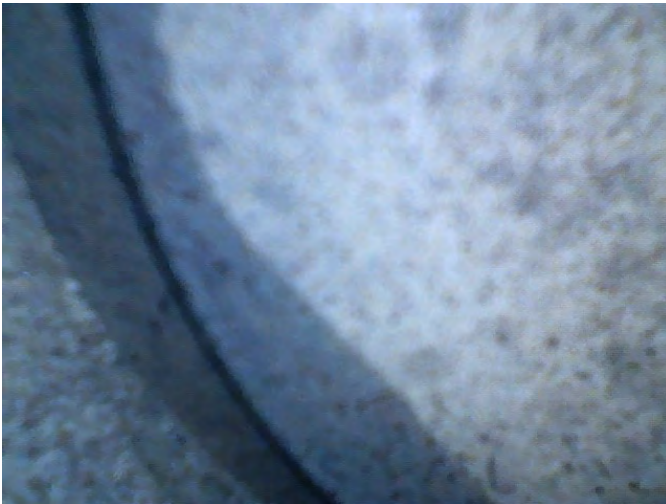
The cylinder remained attached to the engine with no external anomalies noted. Borescope examination of the cylinder revealed light combustion deposits with no pre-accident anomalies noted with the piston, barrel, valves or valve seats. Piston/connecting rod movement was confirmed during the partial rotation of the crankshaft.

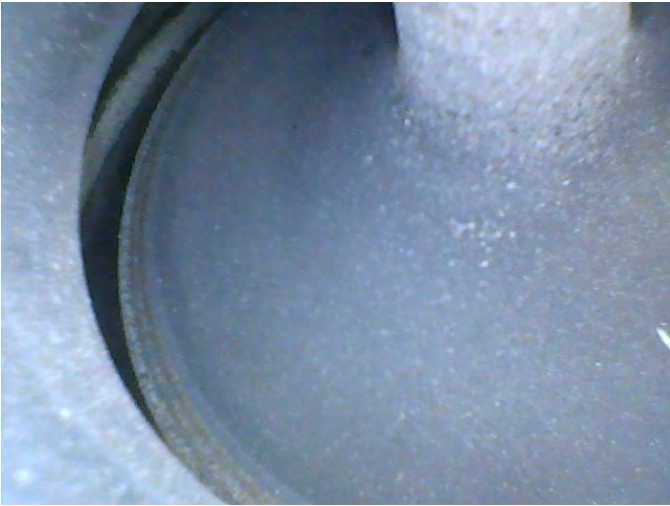
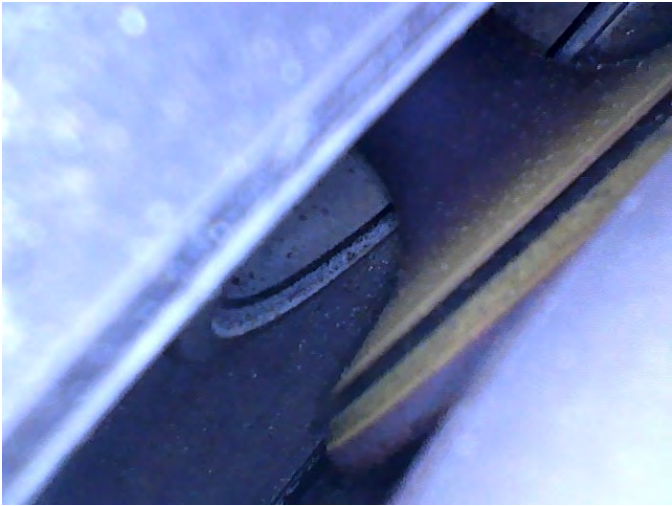
| Condition: | The cylinder remained attached to the crankcase but sustained significant impact damage that fractured and displaced the head toward the engine centerline. The intake and exhaust tubes were displaced from the cylinder and the sparkplugs were damaged. Only a portion of the cylinder's internal components was visible via borescope placement through the intake port. No pre-accident anomalies were observed with the observed components. | | |

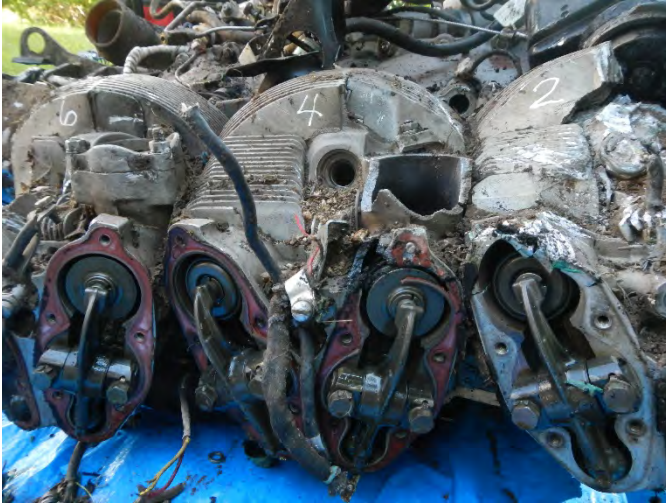
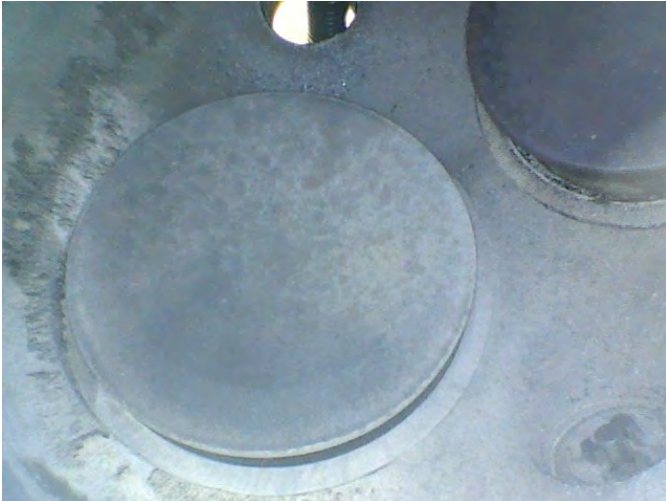
The cylinder remained attached to the crankcase. It sustained impact-related damage to the cooling fins, intake port, fuel injector, and top sparkplug. Borescope examination of the cylinder revealed light combustion deposits with no pre-accident anomalies noted with the piston, barrel, valves or valve seats. Piston/connecting rod movement was confirmed during the partial rotation of the crankshaft.

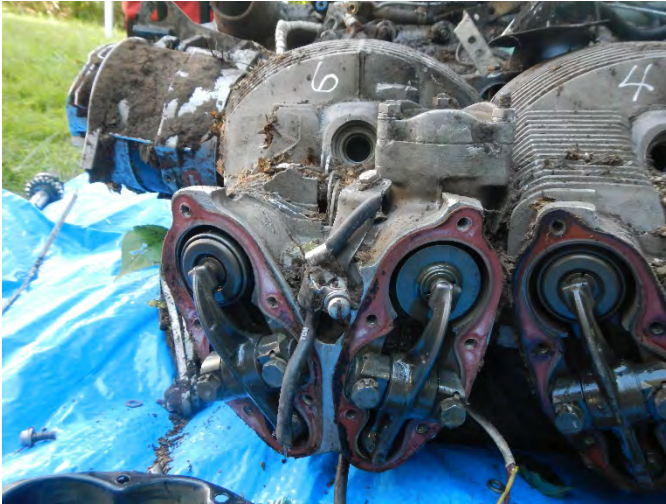
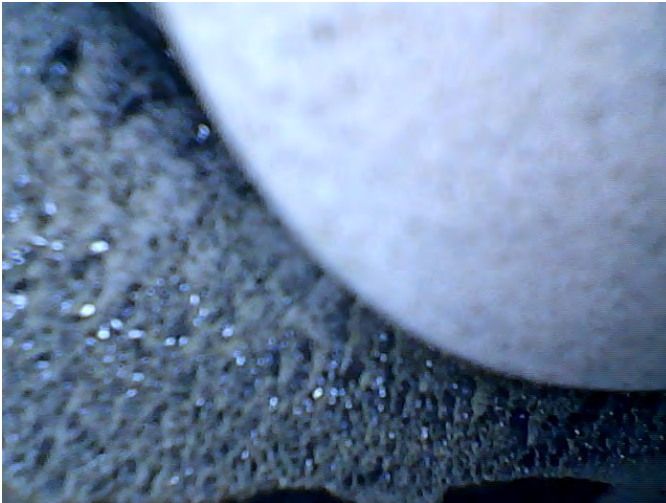
The cylinder remained attached to the engine with impact-related damage sustained by the cooling fins, top sparkplug, fuel injector, and intake port. Borescope examination of the cylinder revealed light combustion deposits with no pre-accident anomalies noted with the piston, barrel, valves or valve seats. During the partial rotation of the crankshaft the cylinder produced thumb compression.

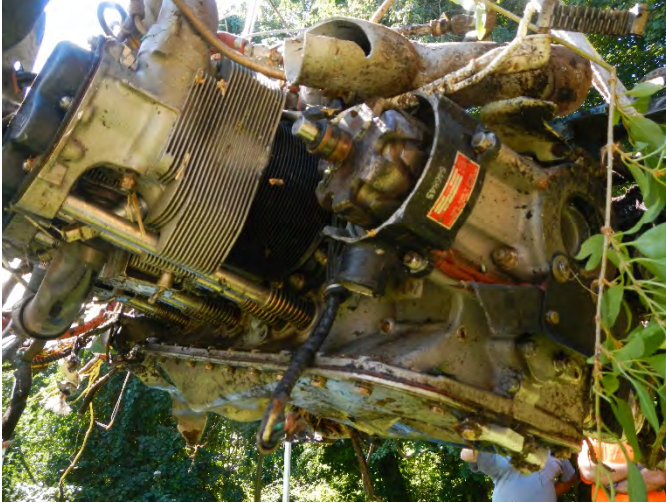
| Condition: | The engine-driven alternator remained attached to the front right side of the engine but sustained impact damage. It was not examined as part of this investigation. | | |

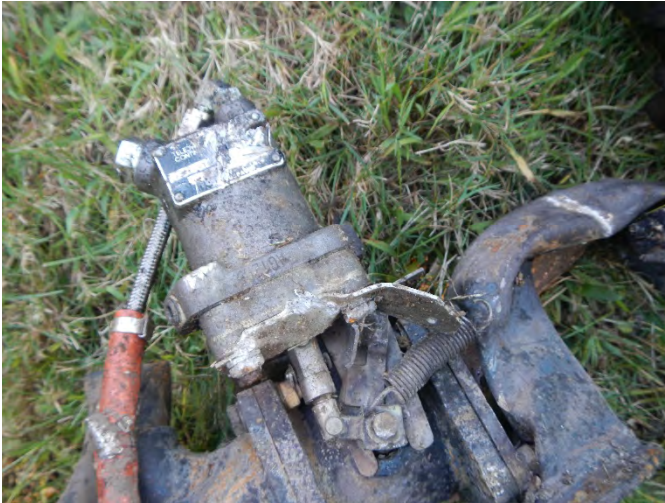
The waste gate actuator remained with a piece of exhaust. The actuating arm remained attached to the wastegate with no pre-accident anomalies noted.

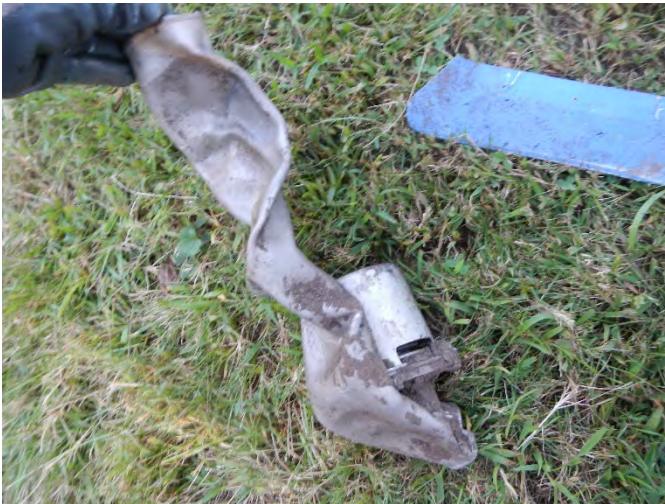
The overboost valve remained attached to a flattened and distorted piece of intake tubing. No pre-accident anomalies were noted with the poppet valve.

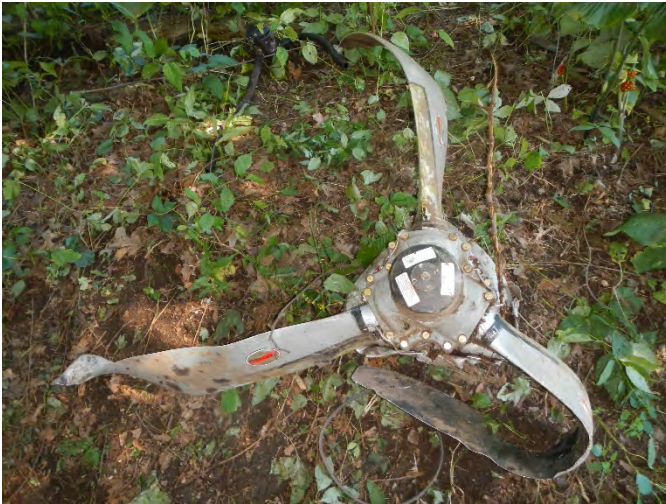
The three-bladed propeller hub remained intact and all three blades remained attached to the hub. All of the blades rotated independently within the hub, indicative of pitch change link fractures. The blades were arbitrarily labeled A, B, and C for descriptive purposes. Blade A displayed chord-wise paint burnishing, significant blade twisting toward low pitch, and s-bending on the trailing edge. Blade B was bent in half with impact-related damage on the trailing edge. Blade C was bent aft, twisted toward low pitch, with slight s-bending on the trailing edge. Two tree branches were observed at the accident site that displayed an angular cut with gray paint transfers.
