## **NATIONAL TRANSPORTATION SAFETY BOARD**

# **ENGINE EXAMINATION**

**ERA18LA038**

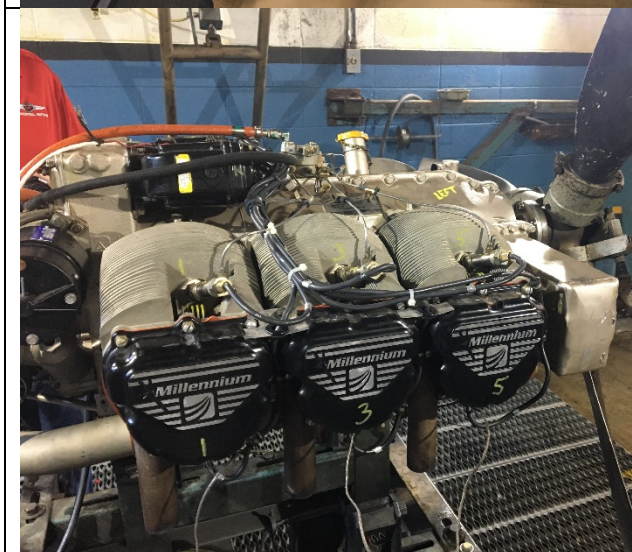
Several additional lines, such as fuel, oil lines were connected to the engine

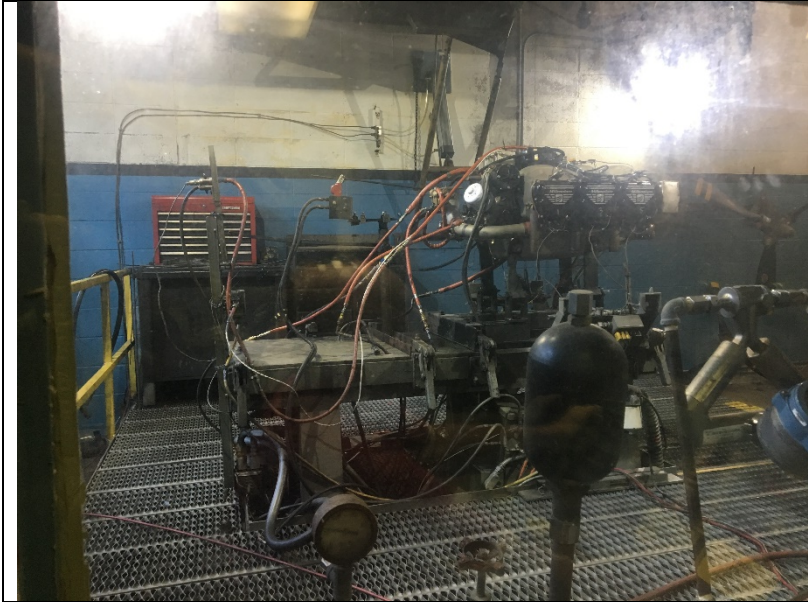
A fix-pitch, test propeller was installed on the engine, and the engine was placed in an engine test cell.

Engine during test run.
