**NATIONAL TRANSPORTATION SAFETY BOARD**  
**Office of Aviation Safety**  
**Washington, D.C. 20594**

**AIRWORTHINESS GROUP CHAIRMAN'S FACTUAL REPORT**

**NTSB No: ERA18LA053**

Operator: Global Sky Air Charter Corporation  
Aircraft: Sikorsky S-76A++, Registration N911FK  
Location: Islamorada, Florida  
Date: December 15, 2017  
Time: 0652 eastern standard time

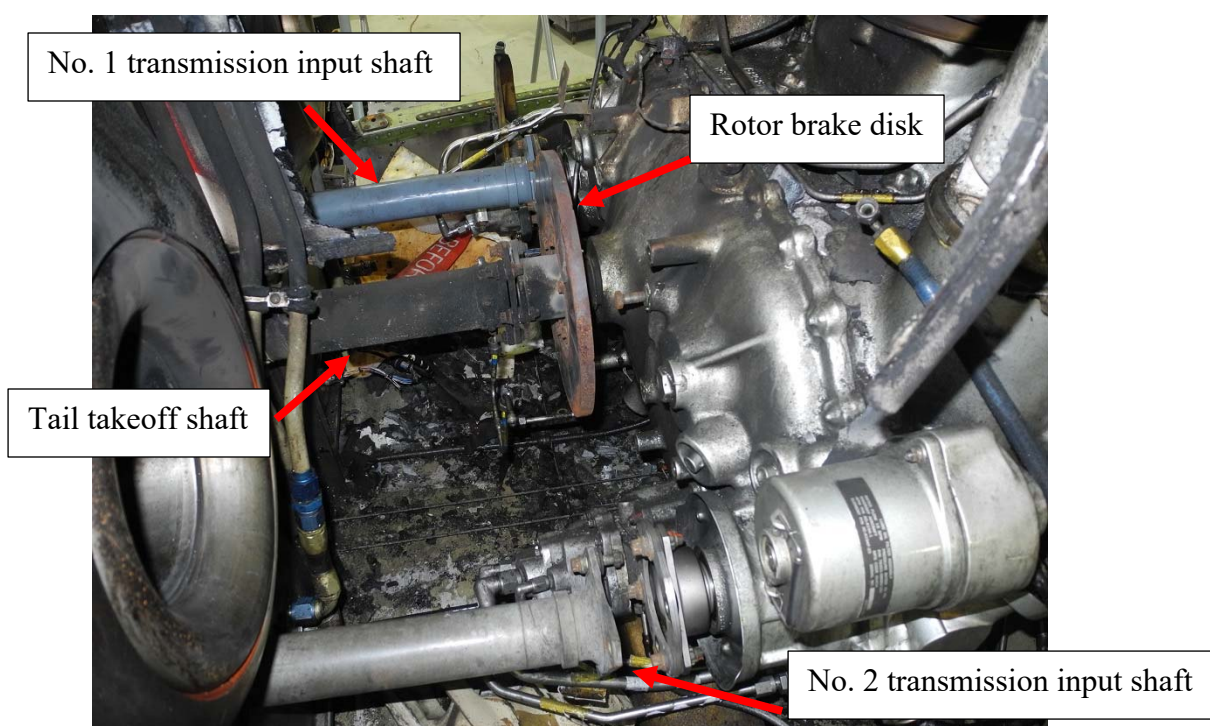
**Figure 3. The transmission input shafts, rotor brake disk, and tail takeoff shaft.**

The rotor brake disk remained installed on the tail takeoff pinion. Raised material was observed on the rotor brake disk surface. The raised material had the appearance of brake pad material fused to the rotor brake disk surface. Soot deposits were observed on the exterior of the No. 1 tail rotor drive shaft. A hydraulic fluid level was not present when observing the sight gauge for the rotor brake accumulator.
