## Engine Investigation Report

**Rolls-Royce Corporation  
Model T63-A720  
Engine AE-405936**

**Model: Bell OH-58C  
Registration: N942SC  
Serial: 68-16872**

**Accident Date: 29 January 2018  
Investigation Date: 22 February 2018  
Engine Test Date: 6 March 2018  
Report date: 21 March 2018**

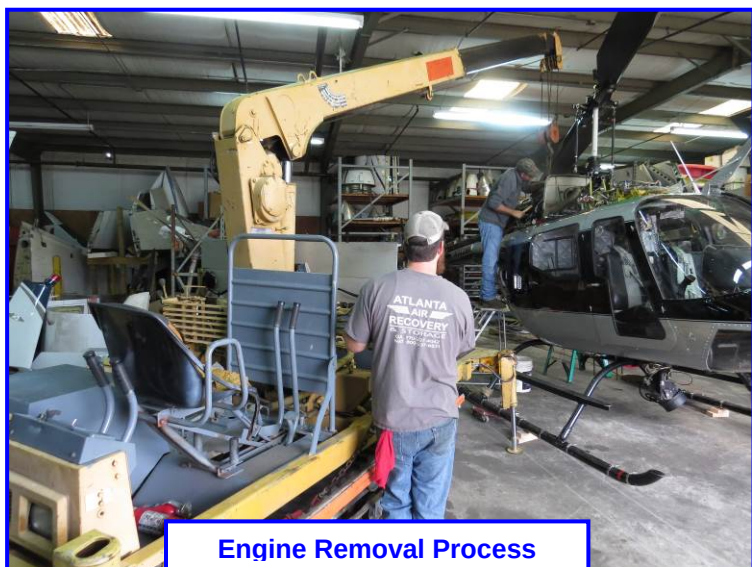
Based on the initial findings and circumstances of the event, the NTSB-IIC recommended the engine be removed and prepared for test run at Keystone Turbine Services.

Engine Removal Process

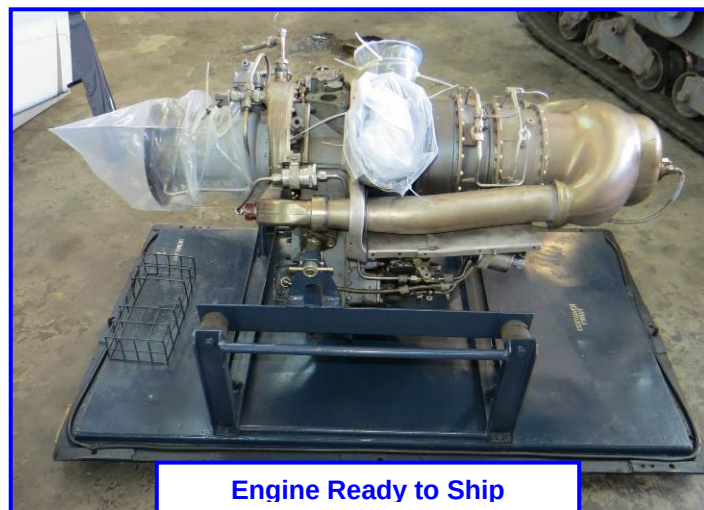
Engine Ready to Ship
