# Continental Motors

## ENGINE EXAMINATION REPORT

| ENGINE MODEL | IO-550-A3B |
| FILE NUMBER | 18-286 |

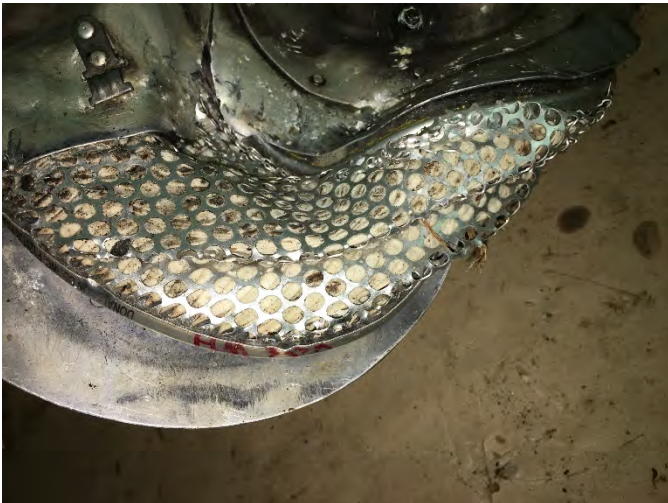
## INDUCTION SYSTEM

The intake shroud and filter were flattened, but remained intact with no obstructions noted with the intake filter. The throttle body and the throttle shaft were fractured.

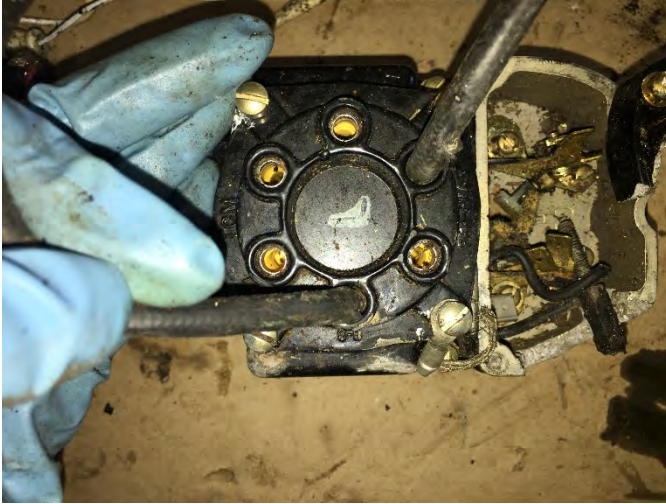
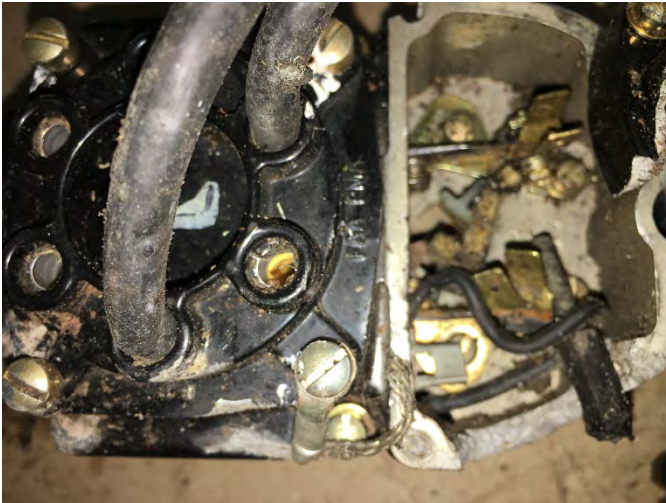
### LEFT MAGNETO

The magnetos were separated from their mounts and the mounting area was separated from the engine. Remnants of fractured magnetos were located in the debris. The top half of the left magneto was observed. The distributor gear remained intact and the teeth were undamaged. The drive shaft/magnet and windings were not observed. Remnants of ignition leads remained attached to the distributor cap. Only the capacitor and points portion of the right magneto was observed. The #1, #3, #5, and #6 top sparkplugs were removed from their respective cylinders. The #5 and #6 top sparkplug barrels were fractured. Examination of the observed electrodes revealed no evidence of carbon or lead fouling with normal wear conditions.

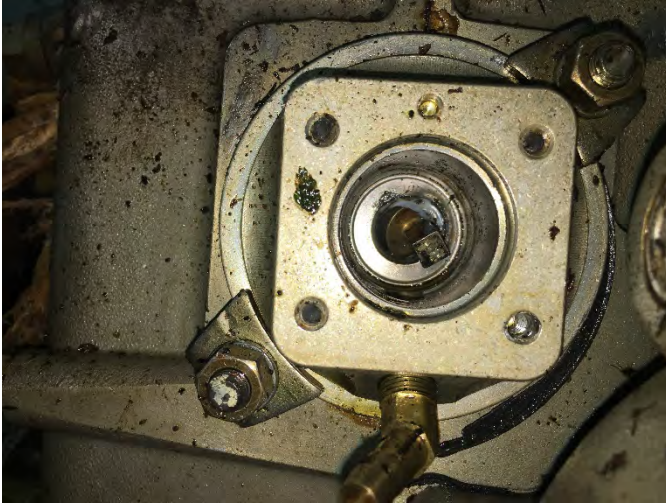
#### FUEL PUMP

The fuel injection system was separated from the engine. The engine-driven fuel pump was separated from the backside of the engine, but its deformed drive coupling remained inserted into the crankshaft gear and pump adapter. Only the engine-driven fuel pump cap (aneroid bellows and low pressure relief valve set screw) were observed. The throttle body was fractured and the fuel metering unit was separated. The throttle and mixture control levers were deformed and a portion of the mixture shaft was pulled from the housing and bent. The fuel fittings were fractured. Removal of the inlet screen revealed it was clear with no obstructions observed. The fuel manifold valve was not

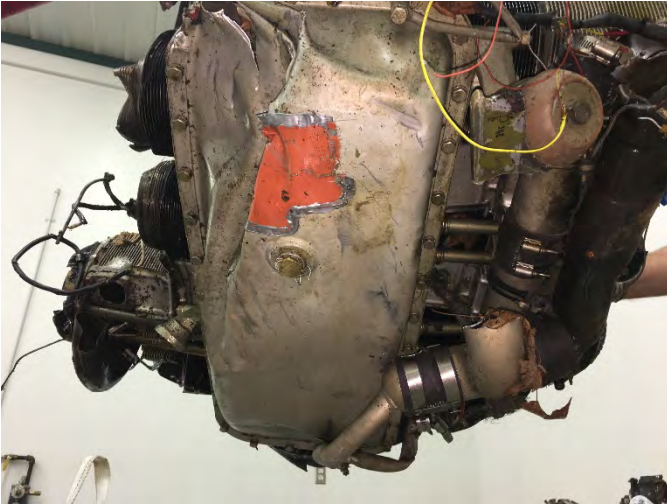
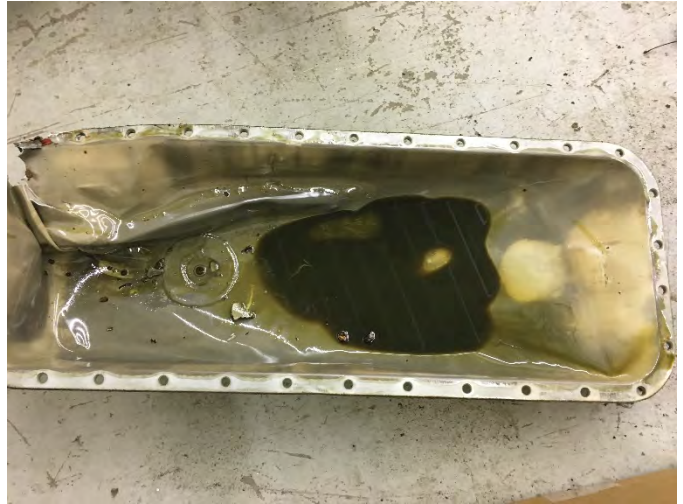
#### OIL SUMP

The engine was separated from the aircraft and was lying on the floor of the aircraft recovery facility in a bag. The alternator and propeller were separated, the left aft side of the oil sump was torn and displaced to the right. The top side of the accessory end of the engine was fractured and all of the accessories were separated with the exception of the starter adapter and oil pump. The intake filter, throttle body, and left side intake tubes were separated from the induction system. The #2 and #4 exhaust risers were separated from the engine. The #2 and #4 cylinder heads were fractured and separated from the barrels, both of which sustained tearing and bending deformation damage. The remaining cylinders sustained impact related damage of varying degrees. The magneto mounting pads were separated from the engine and the magnetos were separated. A hole was observed in the crankcase over the #1 cylinder; however, the edges of the hole were deformed inward. Though the engine sustained significant impact-related damage, there was no sign of operational discoloration or pre-accident operational distress.

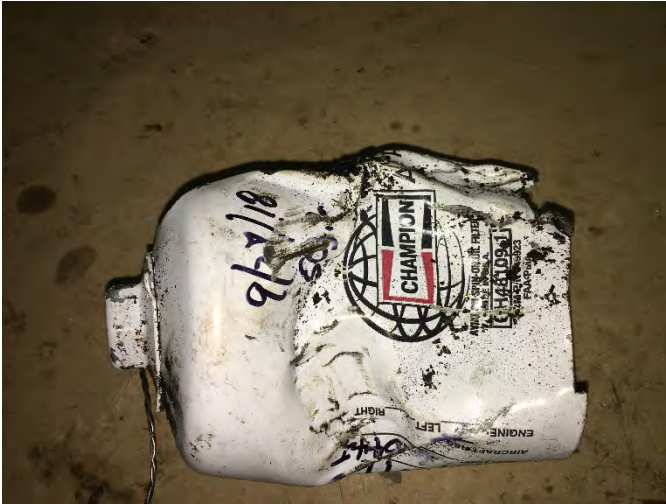
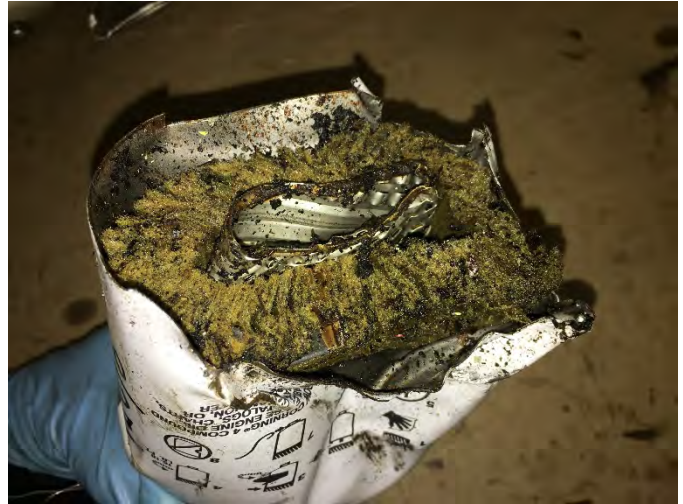
### OIL FILTER

The engine total time at the time of the accident is unknown. An oil filter belonging to the left engine was found in the debris. A date of 09/27/2018 was hand-written on the side of the filter. The tach time written on the side of the filter was not legible due to the impact damage.

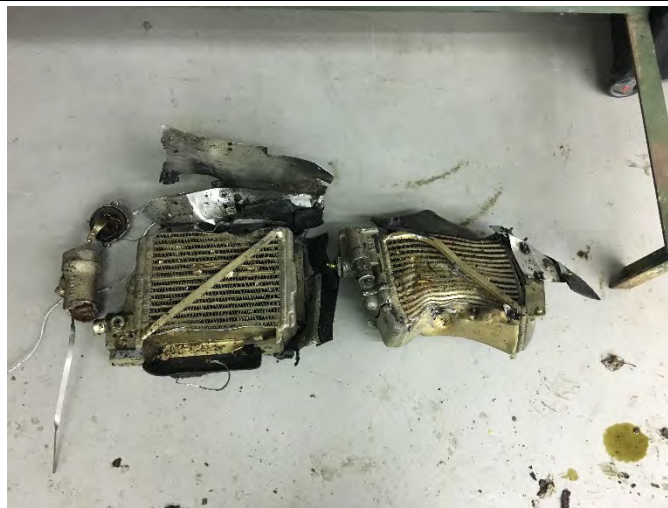
### OIL COOLER

NOTE: It was not clear to which engine the separated oil coolers belonged.

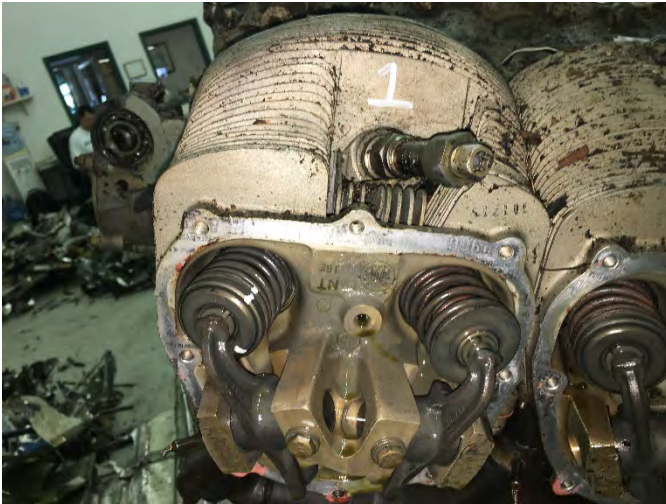
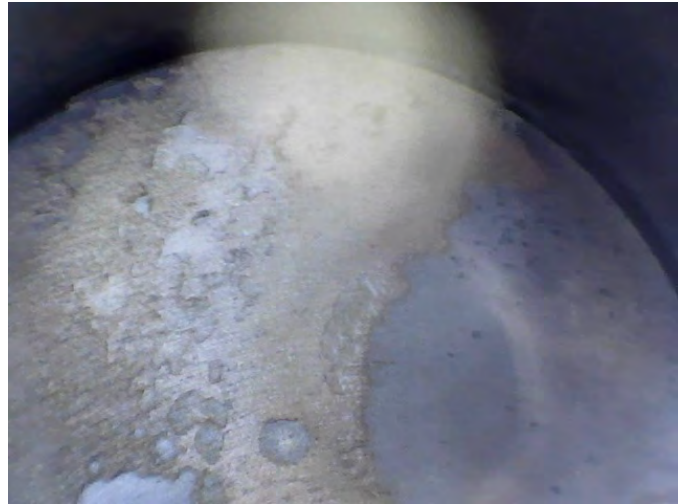
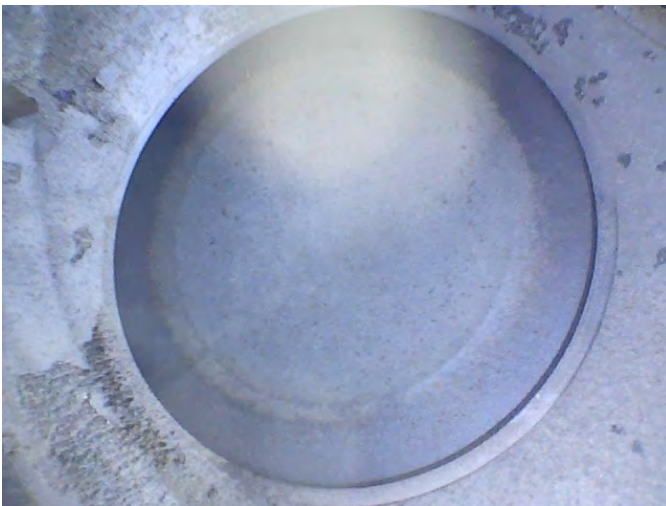
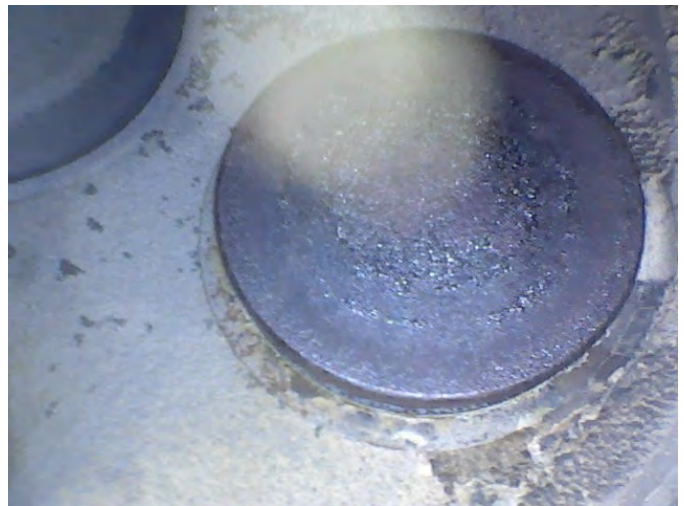
#### CYLINDER #1

The cylinder barrels remained attached to the crankcase. All of the cylinder heads sustained impact-related fracture damage with the left side sustaining the most damage. The #2 and #4 cylinder heads were fractured and separated from their respective barrels, and the barrels were torn and bent over the piston. The top sparkplugs were removed from the #1, #3, #5, and #6 cylinders and a borescope was used to examine/document the internal components. No pre-accident anomalies were noted with any of the pistons, barrels, cylinder heads, valves or valve seats.

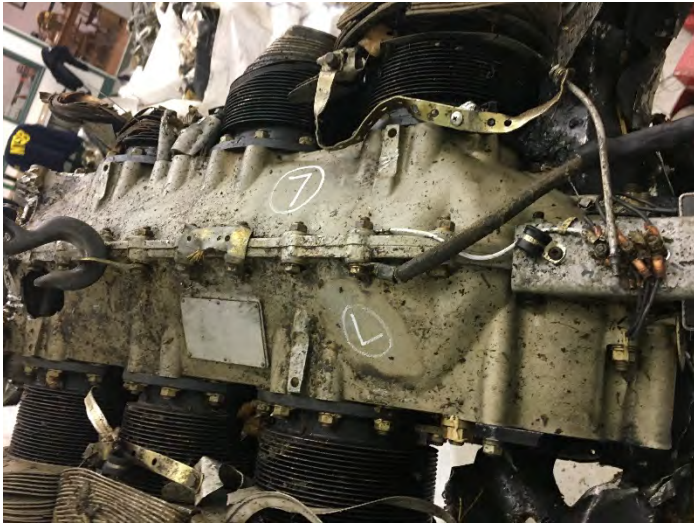
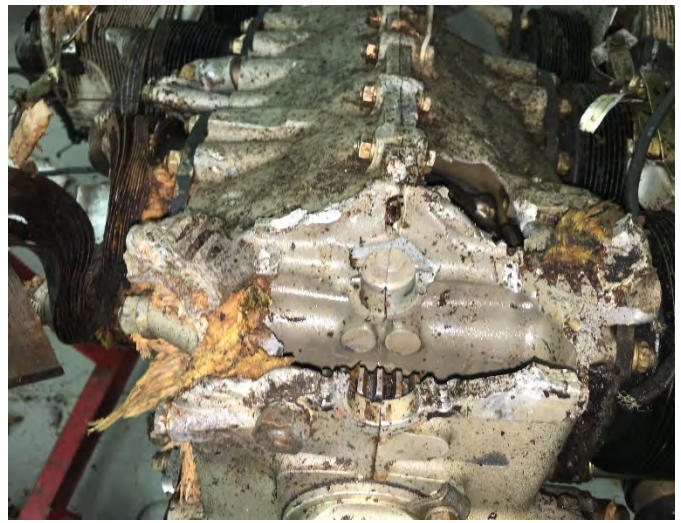
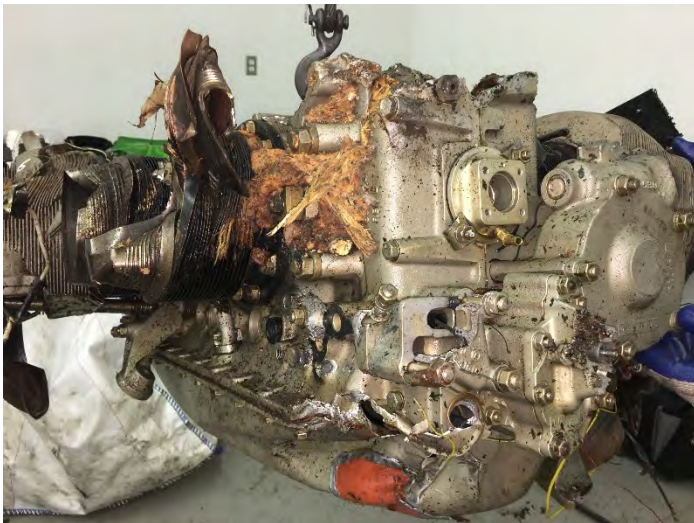
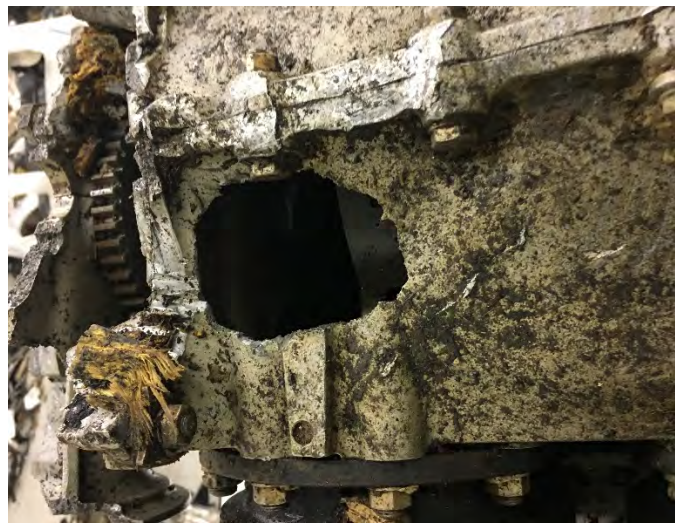
#### CRANKCASE

The impact-related damage precluded the functional testing of the engine and the engine-related systems; however, there were no pre-accident anomalies noted on the observed components. The deformation damage sustained by the crankcase and the #2 and #4 cylinders precluded the manual rotation of the crankshaft. The camshaft was visible through its entirety through the crankcase halves after the oil sump was removed and no pre-accident anomalies were noted with the camshaft lobes, cam gear, and bevel gear. The crankshaft, connecting rods, and counterweights were observed using a lighted borescope with no signs of discoloration or lubrication distress. Disassembly of the oil pump revealed that the gears were intact. Slivers of shaved metal were observed on the pump cap and on the gears, and areas of rotational scraping were noted on the housing walls, indicative of pump rotation at the time of impact. All of the components were intact with no internal pre-accident anomalies noted.

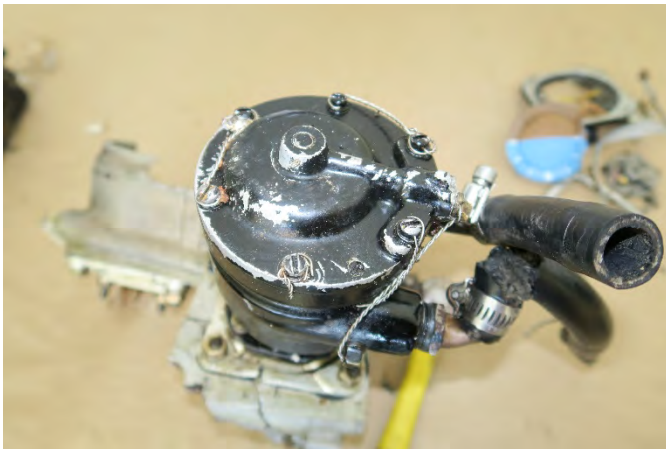
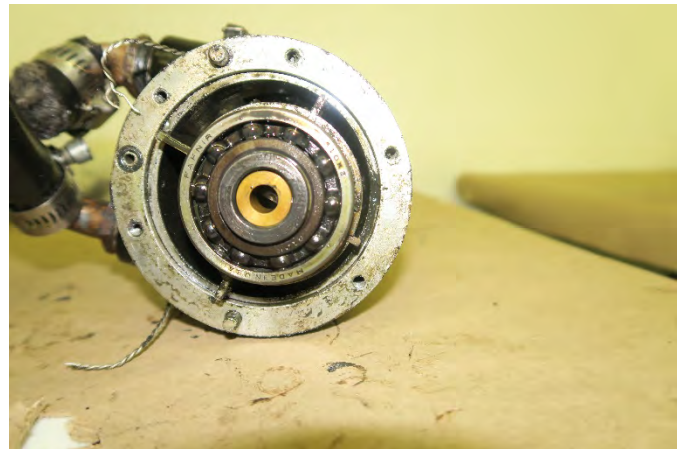
VACUUM  
PUMP

NOTE: It was not clear to which engine the separated vacuum pump belonged.

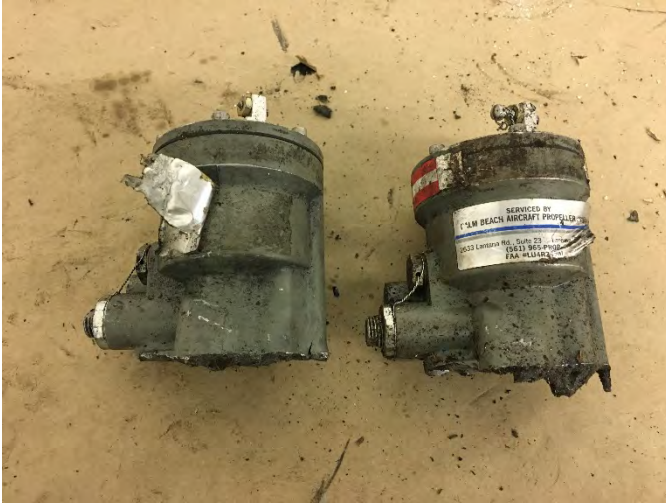
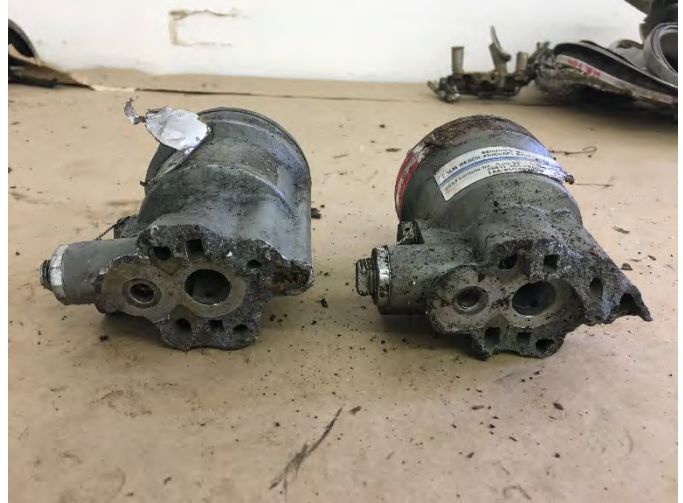
#### PROPELLER GOVERNOR

*NOTE:* It was not clear to which engine the separated propeller governors belonged.

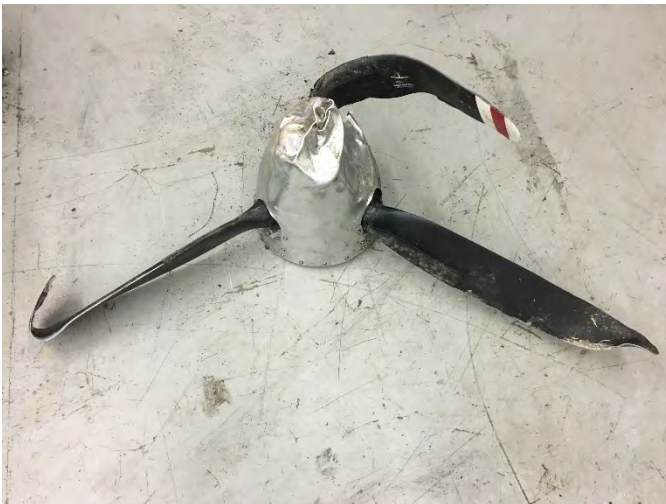
#### PROPELLER

The propeller was separated from the crankshaft and the stripped propeller bolts remained with the crankshaft flange. All three blades remained attached to the hub, but all could rotate freely within the hub indicative of pitch change link fractures. Blade #1 was bent forward almost 180° with some chord-wise paint burnishing near the tip. Blade #2 was twisted 180° toward low pitch at the tip. Blade #3 was bent forward 180° at the tip.
