# Continental Motors

## ENGINE EXAMINATION REPORT

| ENGINE MODEL | IO-550-A3B |
| FILE NUMBER | 18-286 |

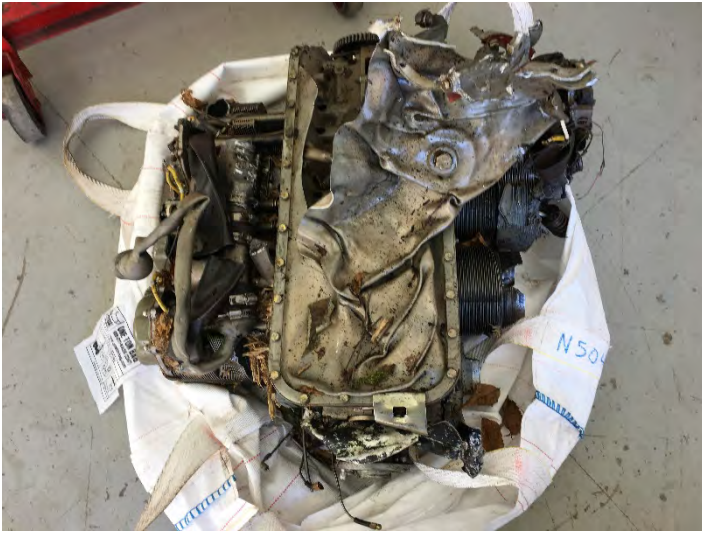
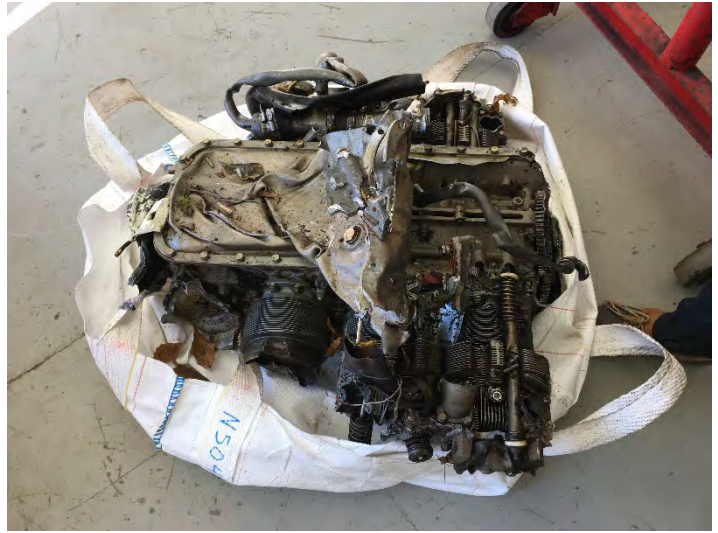
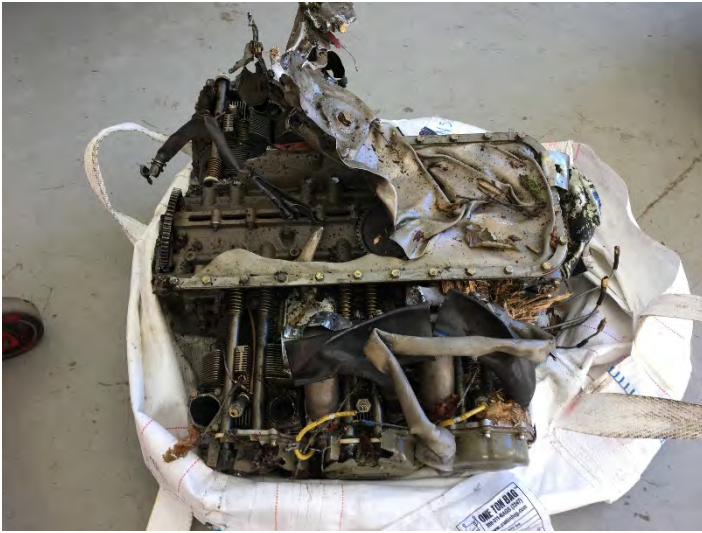
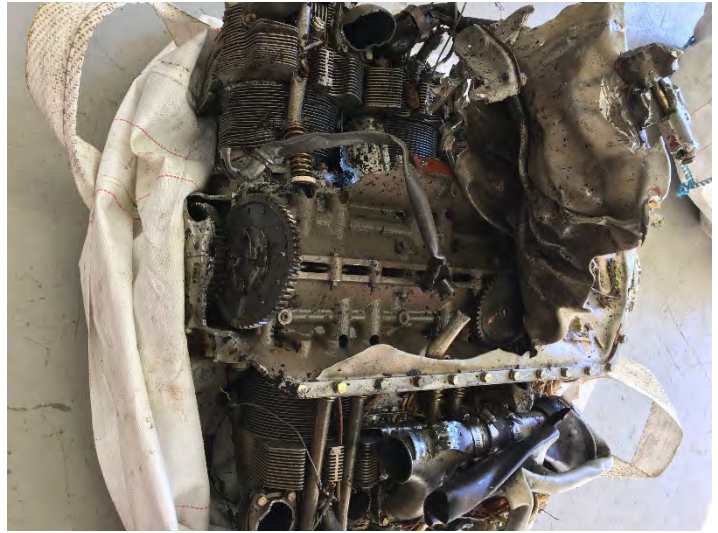
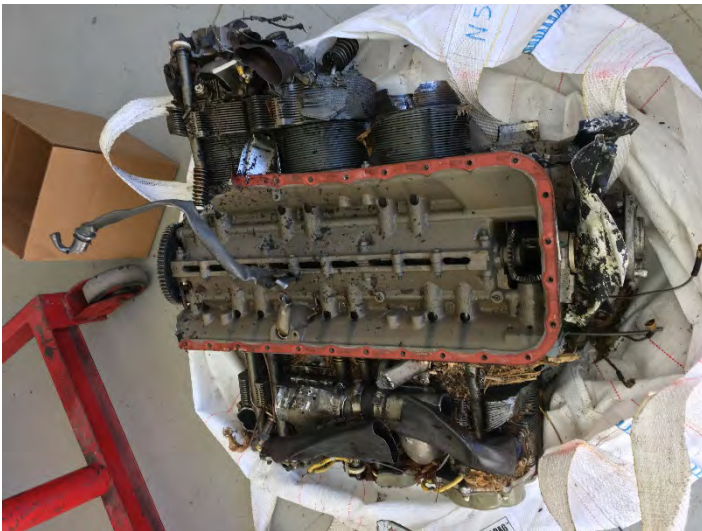
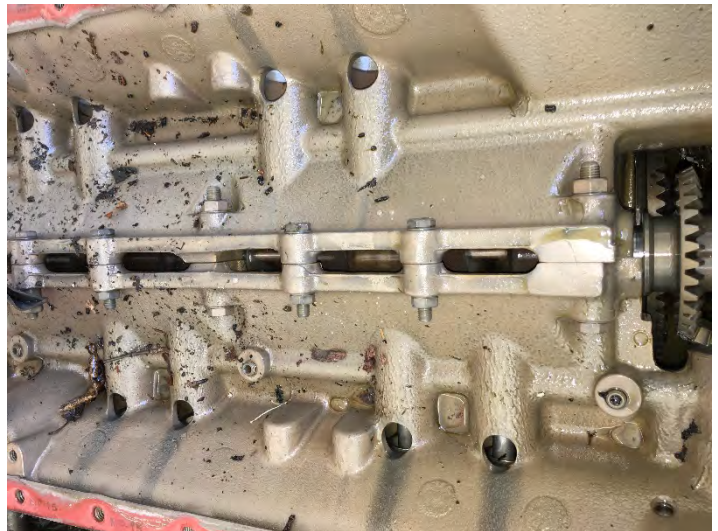
The engine was separated from the aircraft and was lying on the floor of the aircraft recovery facility in a bag. The engine was upside down, the alternator and propeller were separated, the oil sump was torn and displaced, the accessory end of the engine was fractured and all of the accessories were separated. The induction system was separated from the engine with the exception of the deformed balance tube. Only two exhaust risers remained attached to the engine (the #2 and #4). All of the cylinder heads were fractured with the #5 cylinder head separated from the barrel. The magneto mounting pads were separated from the engine and the magnetos were separated. Though the engine sustained significant impact-related damage, there was no sign of operational discoloration or pre-accident operational distress.

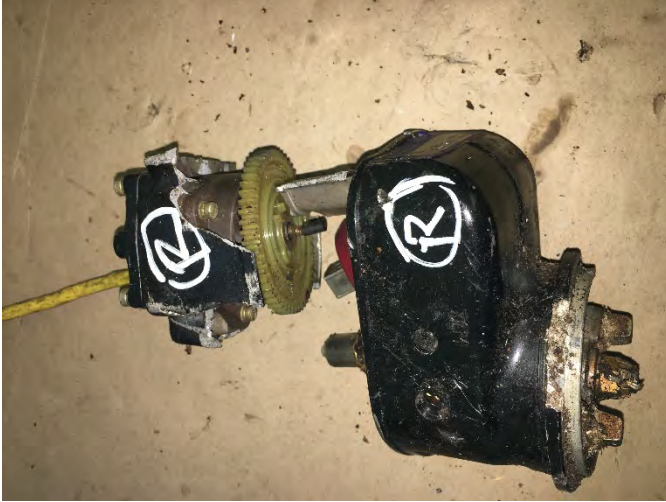
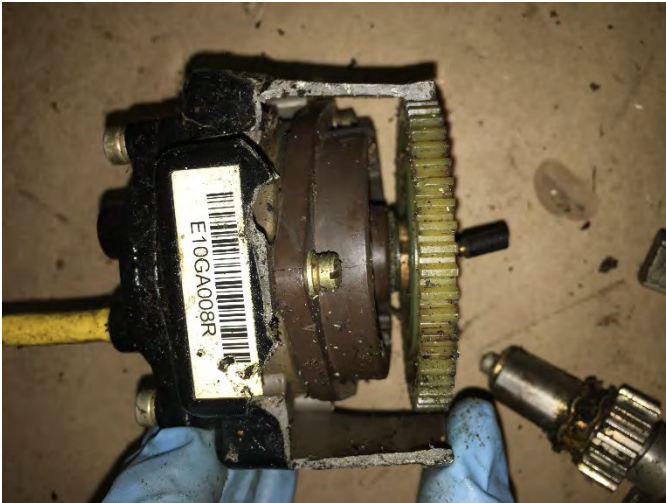
### LEFT MAGNETO

examination of the cylinders. There was no sign of carbon or lead fouling with any of the sparkplug electrodes. Both magnetos were located within the debris. The left magneto housing was fractured. The drive shaft was bent, the windings remained attached to the housing, and the distributor gear remained intact with no pre-accident anomalies noted with the gear teeth (some impact-related deformation damage was noted on a few teeth, but no abnormal wear). The right magneto remained intact but sustained significant impact-related damage that fractured the housing and prevented rotation of the drive shaft. The points were intact, and no pre-accident anomalies were noted through the vent hole for the distributor gear teeth.

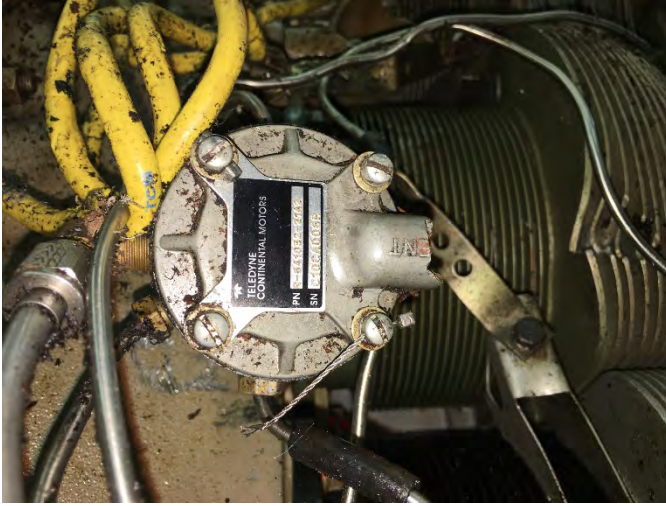
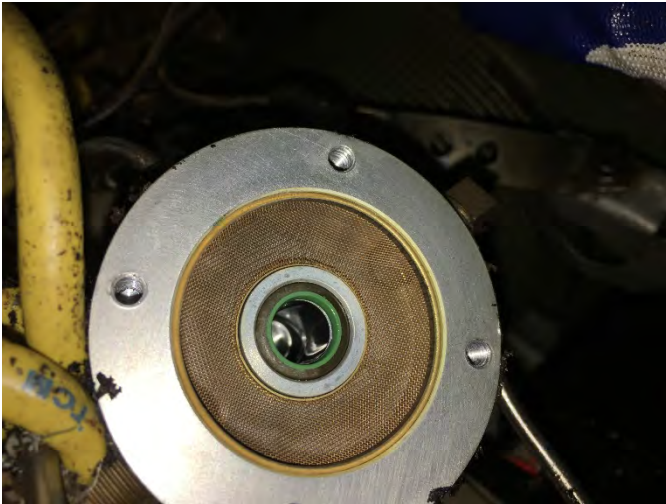
## FUEL MANIFOLD VALVE

The fuel manifold valve cap was removed and residual fuel was found in the housing. The screen was clear and the plunger remained attached to the diaphragm. No pre-accident anomalies were noted.

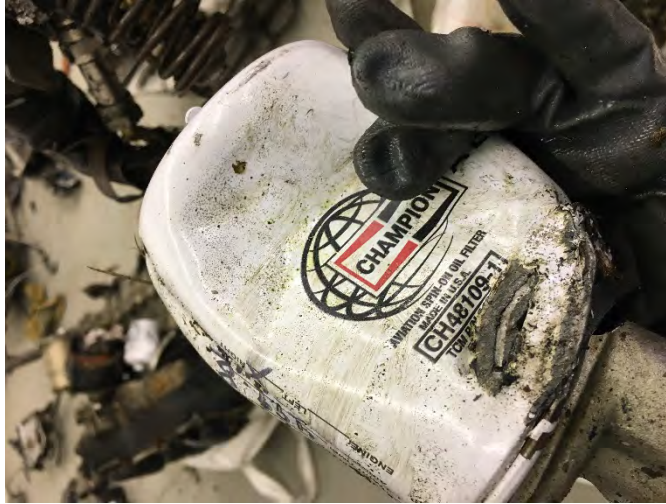
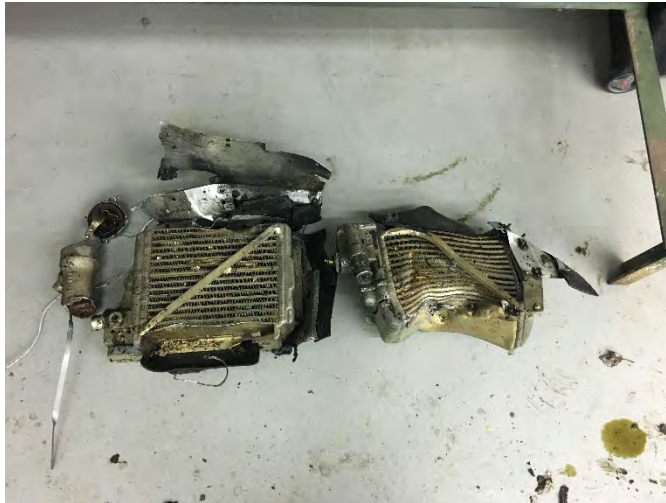
**OIL COOLER**

*NOTE:* It was not clear to which engine the separated oil coolers belonged.

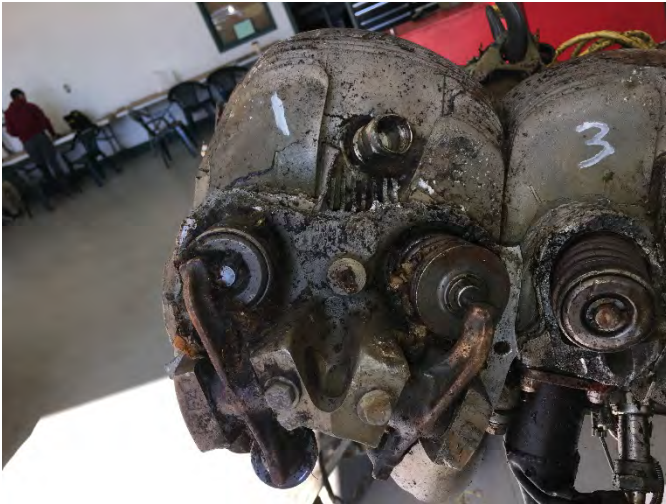
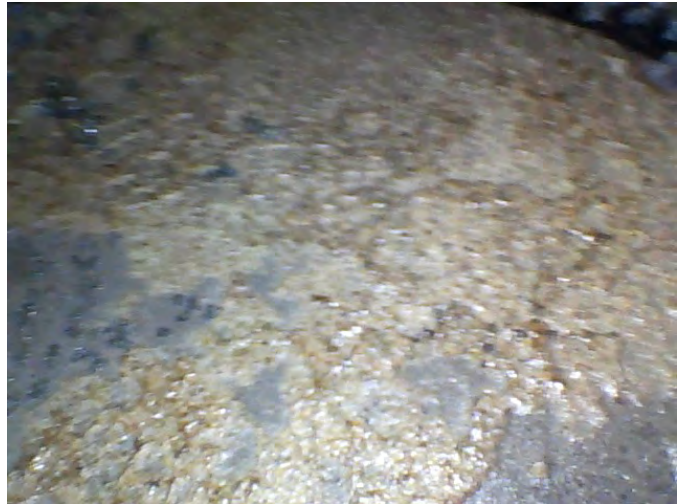
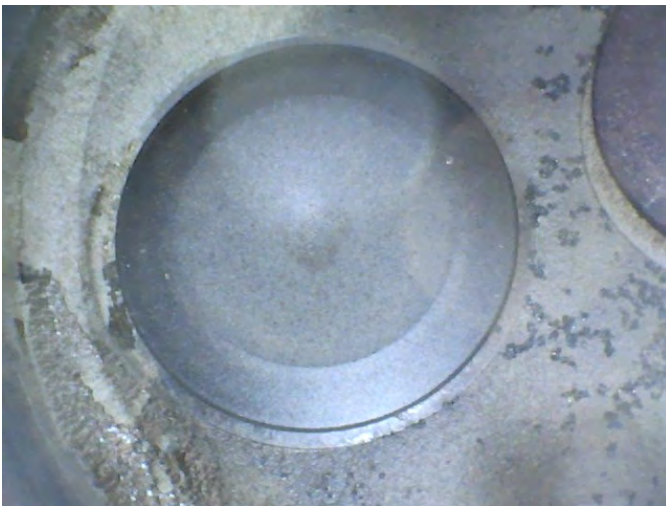
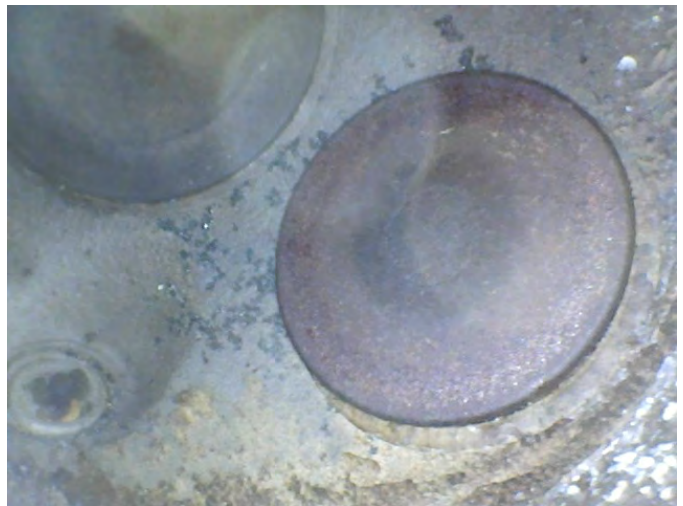
### CYLINDER #1

The cylinders remained attached to the crankcase. All of the cylinder heads sustained impact-related fracture damage with the right side sustaining the most damage. The #5 cylinder head was fractured and separated from the barrel, and the barrel was torn in one area and bent over the piston. The #3 cylinder head was fractured and the rockers were separated. The top sparkplugs were removed from their respective cylinders and a borescope was used to examine/document the internal components. No pre-accident anomalies were noted with any of the pistons, barrels, cylinder heads, valves or valve seats.

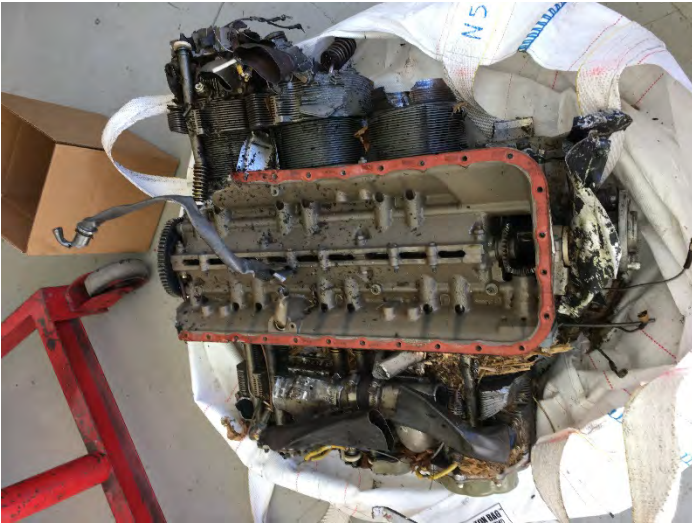
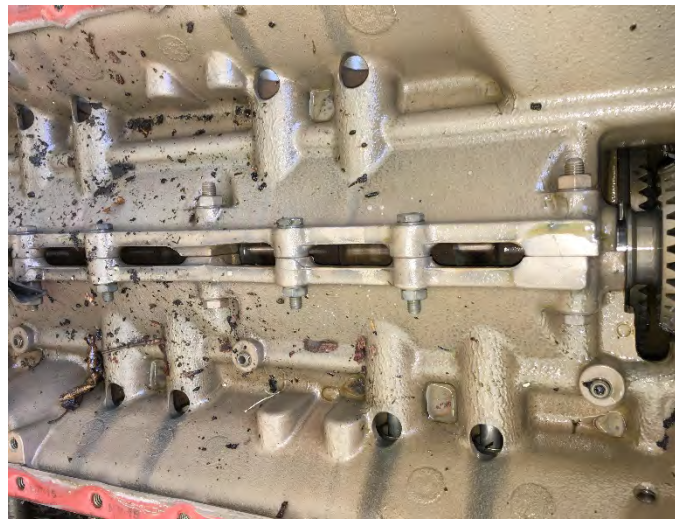
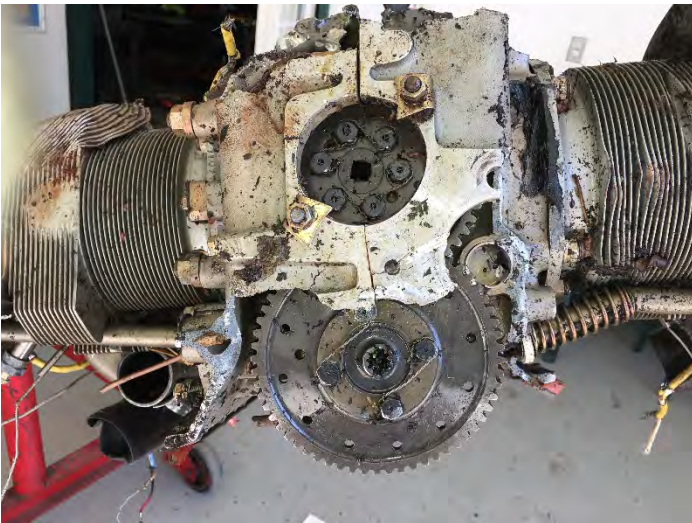
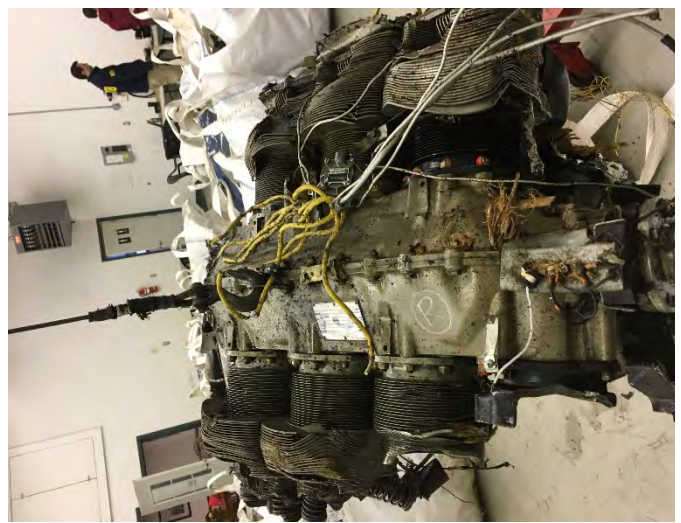
#### CRANKCASE

The impact-related damage precluded the functional testing of the engine and the engine-related systems; however, there were no pre-accident anomalies noted on the observed components. The deformation damage sustained by the crankcase, #5 cylinder, and camshaft gear precluded the manual rotation of the crankshaft. The camshaft was visible through its entirety and no pre-accident anomalies were noted with the camshaft lobes, cam gear, and bevel gear (the camshaft gear was bent and fractured on the bottom side). The crankshaft, connecting rods, and counterweights were observed using a lighted borescope with no signs of discoloration of lubrication distress. All of the components were intact with no internal pre-accident anomalies noted.

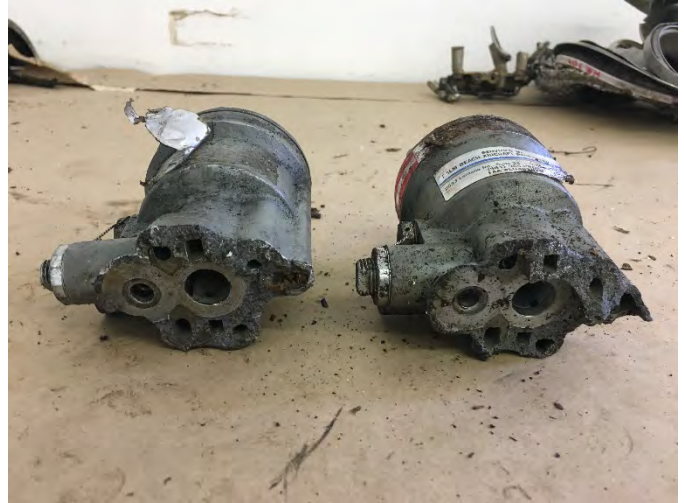
#### PROPELLER GOVERNOR

*NOTE:* It was not clear to which engine the separated propeller governors belonged.
