## ENGINE EXAMINATION REPORT

| ENGINE MODEL | IO-550-N8B |
| AIRCRAFT REGISTRATION | N8448J |
| FILE NUMBER | 18-294 |

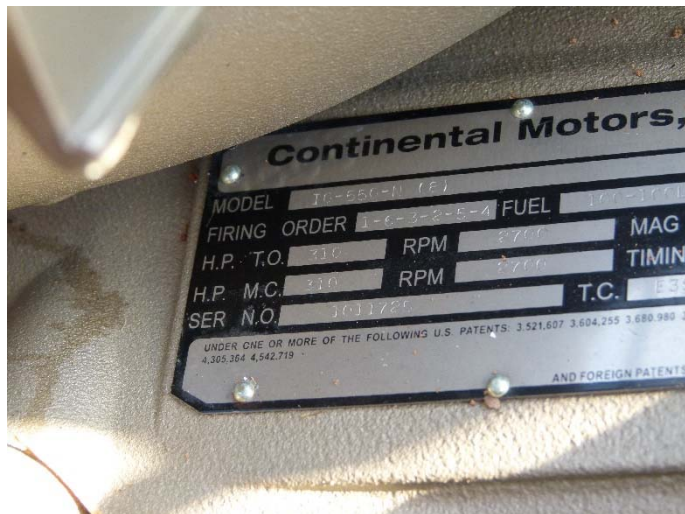
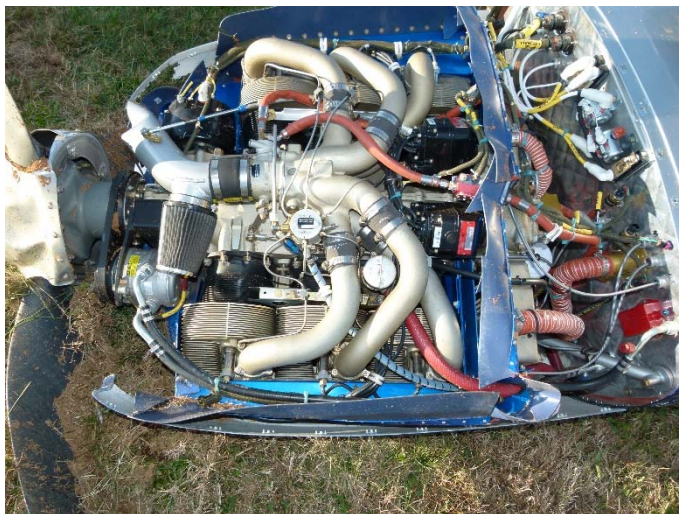
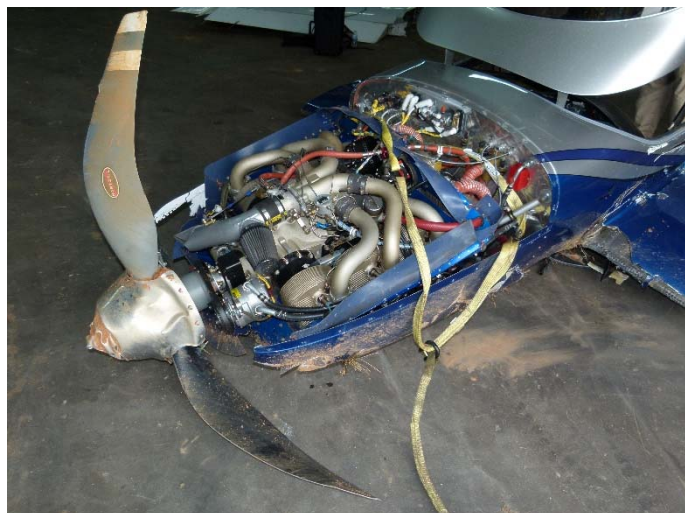
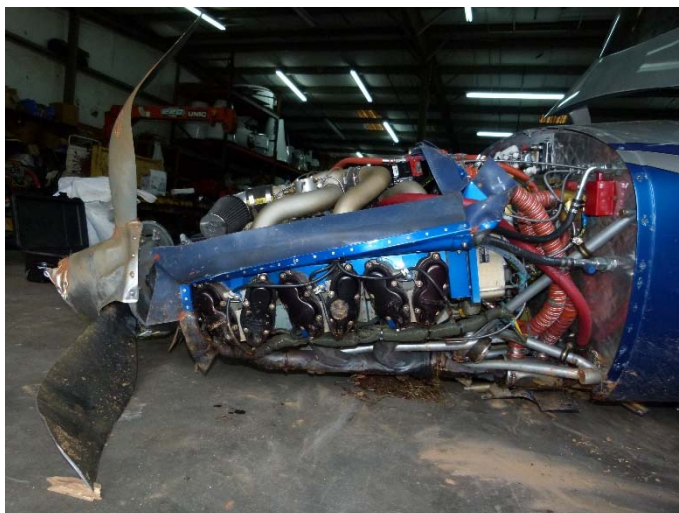
The engine remained attached to the airframe. The oil sump was crushed and breached. The exhaust system exhibited impact damage.

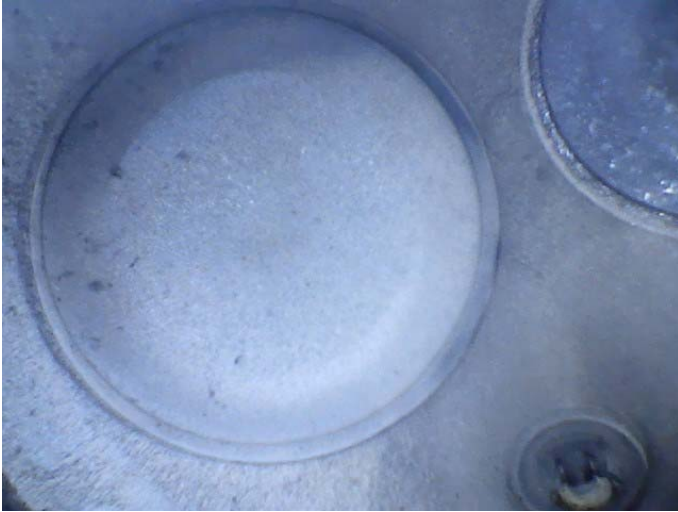
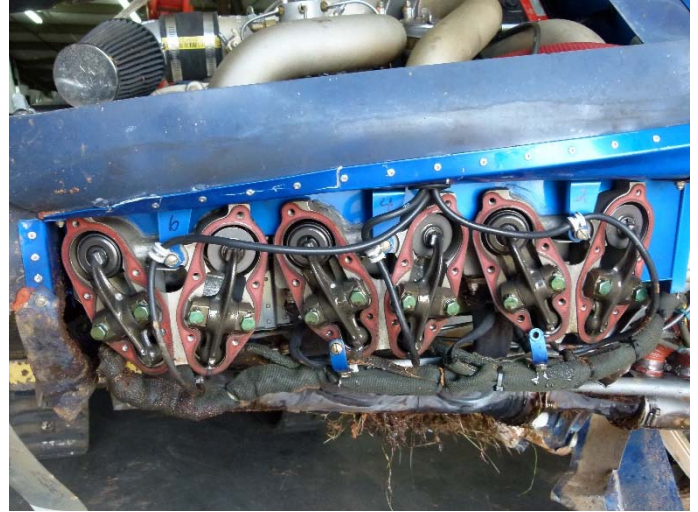
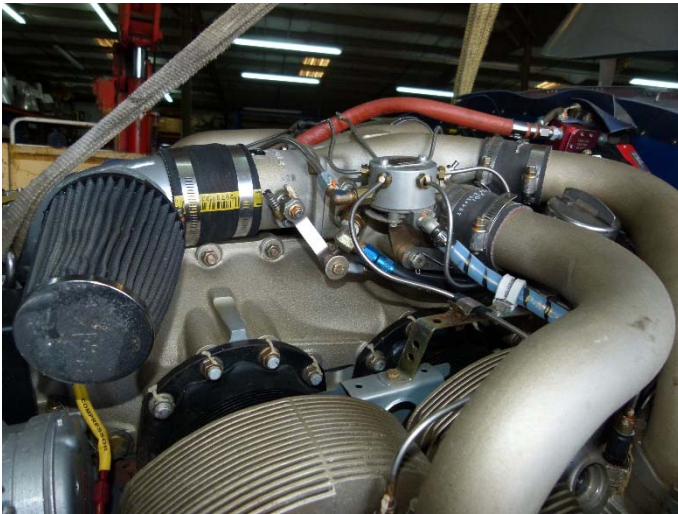
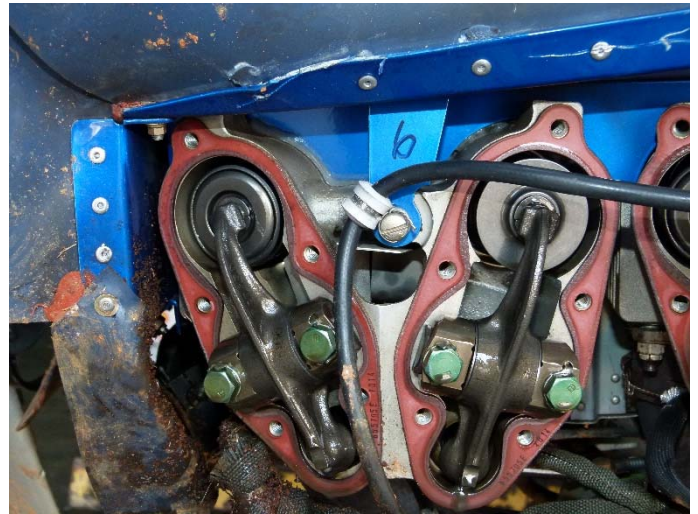
The top spark plugs were removed and exhibited light colored combustion deposits. The spark plug electrodes exhibited normal – worn out signatures when compared to the Champion Check A Plug chart. The cylinder combustion chambers were inspected with a lighted bore scope and no anomalies were noted.

The fuel pump remained attached to the engine and was removed. The drive coupling was intact, and the fuel pump drive turned freely by hand. When the fuel pump drive was rotated the pump discharged a small amount of fuel. The fuel nozzles were removed and found to be free of obstruction. The throttle and mixture control arms moved freely by hand from stop to stop.

The engine was rotated by hand using the propeller. The magnetos produced spark on all six top ignition leads. Thumb compression and suction was noted on all six cylinders with proper valve movement established. Continuity throughout the engine and accessory section was established.
