## 2. FINDINGS OF TURBOCHARGER MODEL TE0659, PART NUMBER 406610-9025, SERIAL NUMBER BK0170 – LEFT SIDE

### 3. FINDINGS OF TURBOCHARGER MODEL TE0659, PART NUMBER 406610-9025, SERIAL NUMBER XKO14123 – RIGHT SIDE

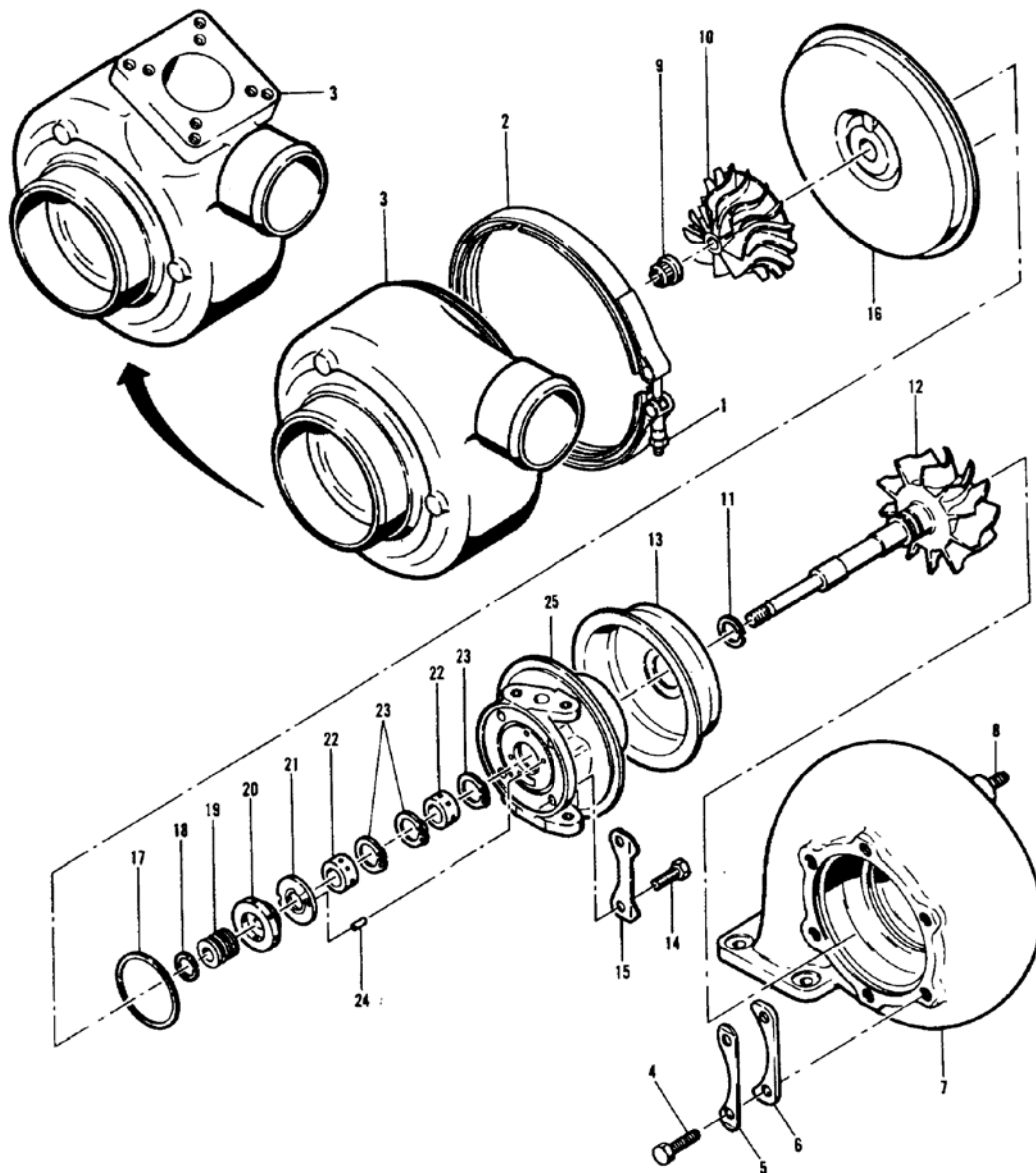
Figure 1 is an illustrated parts breakdown for the TE0659 series of turbochargers.

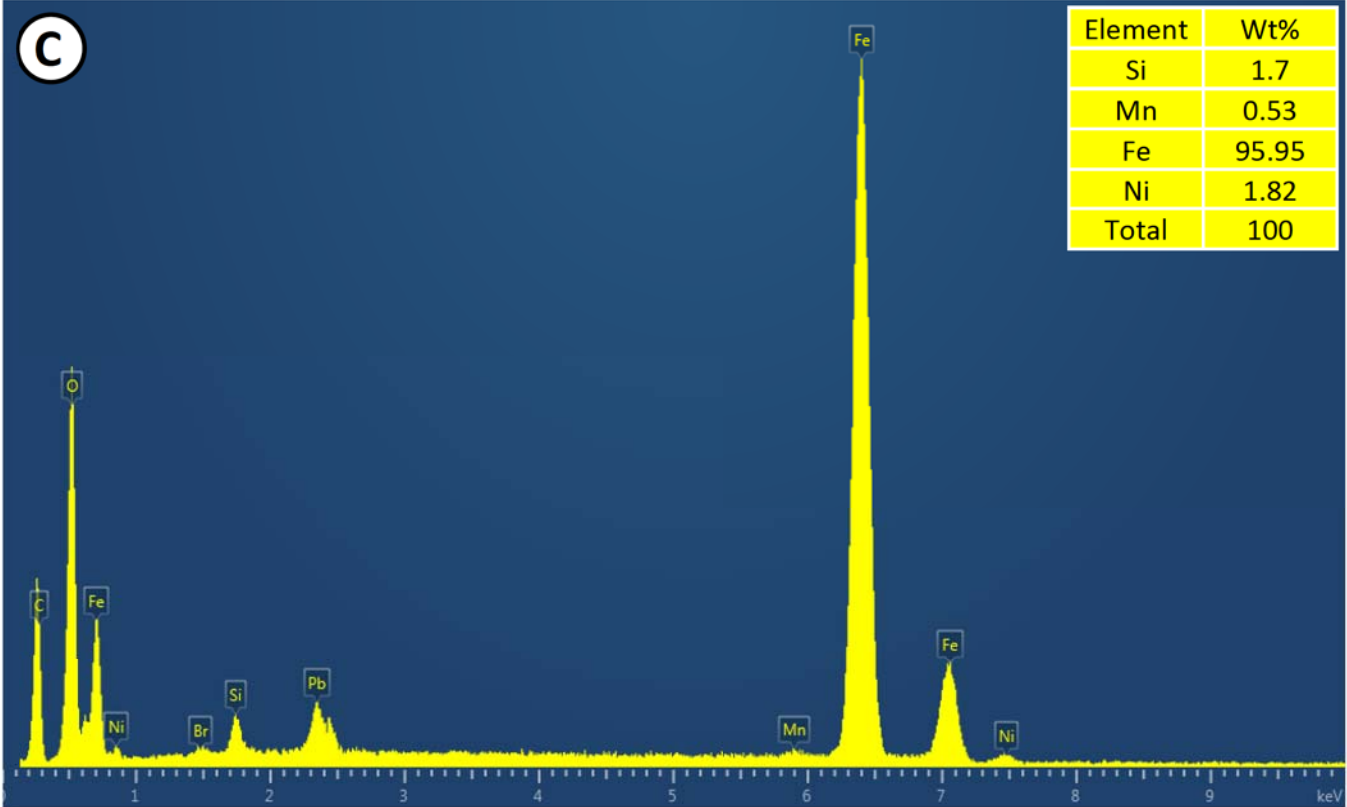
**Figure 6.**  
(A, B) BSE SEM images of the LH Behind Turbine Heat Shield (wheel shroud) Debris, reference Figure 3B. (C) EDX spectrum produced from the analysis of the area in (B) showing a high concentration of oxygen, carbon, and iron with lead and silicon and traces of bromine, manganese, and nickel. The iron rich material containing manganese and nickel was characteristic of a low alloy steel. The weight % composition shown has the carbon, oxygen, lead and bromine removed from the analysis to aid in identification of the alloy. The alloy could not be determined. The lead and bromine were likely contributed by the AVGAS 100LL.

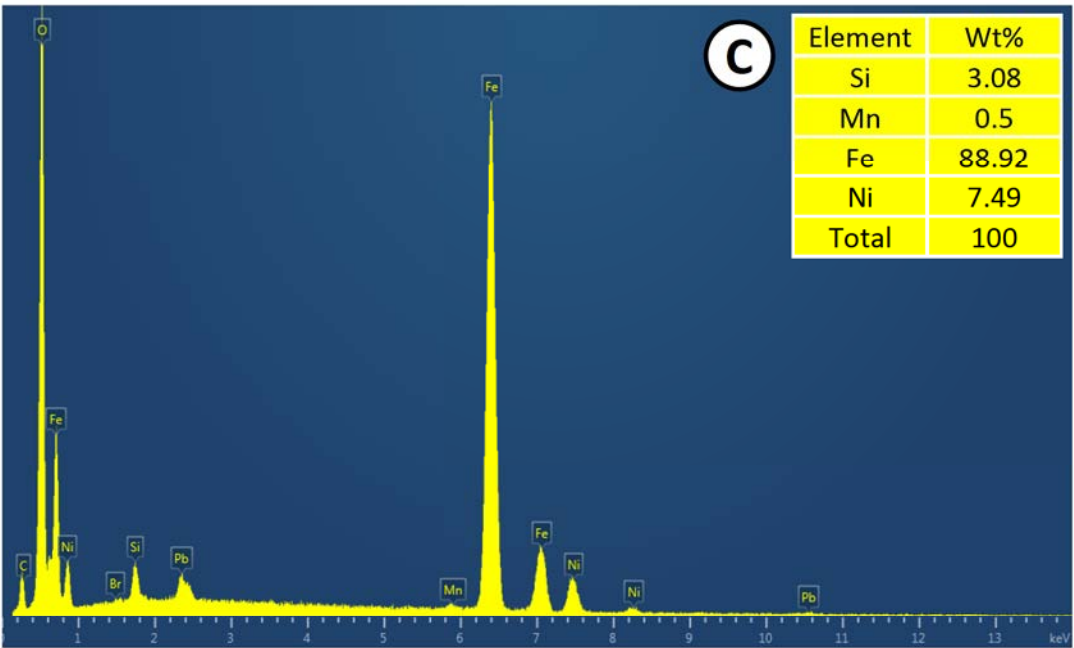
**Figure 7.**  
(A) BSE SEM image of the RH Debris Between Heat Shield (wheel shroud) and Center Housing Debris, reference Figure 3C. (B, C) EDX spectra produced from the analysis of the areas in (A) showing high concentrations of oxygen and iron with carbon, silicon, and nickel, and traces of bromine, manganese, and lead. The iron rich material containing manganese and nickel was characteristic of a low alloy steel with elevated nickel concentrations. The weight % composition in the upper right corners have the carbon, oxygen, lead, and bromine removed from the analysis to aid in identification of the alloys. The alloys could not be determined. The lead and bromine were likely contributed by the AVGAS 100LL.
