# NATIONAL TRANSPORTATION SAFETY BOARD

## MATERIALS LABORATORY FACTUAL REPORT

Report No. 19-046

Place : Tampa, Florida  
Date : April 4, 2019  
Vehicle : Robinson R44 II, N4046J  
NTSB No. : ERA19FA142  
Investigator : Daniel Boggs, ASI-ERA

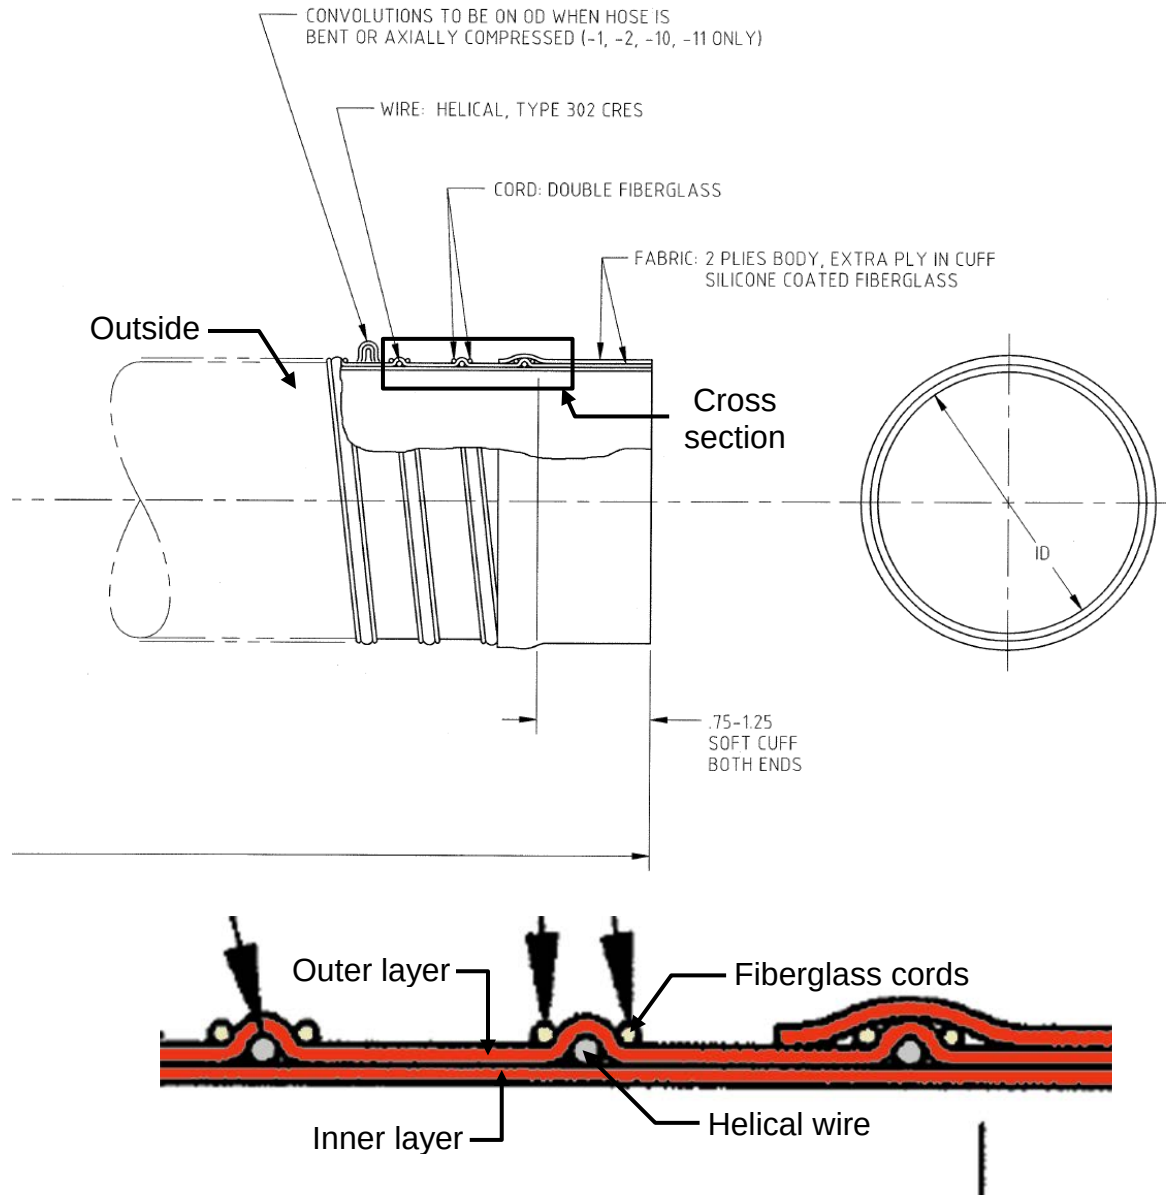
A schematic drawing of the duct assembly is shown in figure 2. It consisted of a tube section with an inner layer made from fiberglass cloth that was impregnated with a silicone rubber. A corrosion-resistant steel wire was wound in a helix over the top of the inner layer and an outer layer of rubberized silicone cloth was wrapped over the top of the wire, thereby embedding the wire in between two layers of rubberized cloth, as shown in the cross section view in figure 2. Two fiberglass cords were then wrapped around the outside of the tube, one cord on either side of the helical steel wire. Each end of the tube was terminated by a rubberized fiberglass cloth cuff.

**Figure 2:** Schematic drawing of the SCEET duct tube. The upper image shows the side view and axial view. The lower image shows a close up view of the cross section with labels for the individual components that make up the tube. Color has been added to the lower image for visualization purposes.
