# Technical document

## EPM examination

Document ID: **BEA2019-0208\_tec02**  
Registration number: **N572MD**  
Aircraft type: GUIMBAL - CABRI - G2  
Date of occurrence: 4th May 2019  
Place of occurrence: Near Kent Island (Maryland)  
Equipment examined:

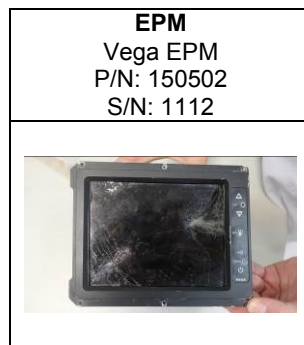
The EPM was inspected at the BEA to check its external and internal condition. The screen was broken and the casing was damaged. The seal on top of the Compact Flash card was broken. The main board was corroded, but the memory component was in good condition. The Compact Flash card was missing. The memory component was unsoldered using BEA infrared unsoldering machine under temperature monitoring. It was then soldered on a surrogate device at Véga Industrie facilities on November, 28<sup>th</sup> 2019. All the recorded data were directly displayed on its screen and were photographed.
