## ENGINE EXAMINATION REPORT

| ENGINE MODEL | IO-520-BA |
| AIRCRAFT MAKE & MODEL | Beechcraft F33A |

| EXAMINATION | | ACCIDENT DATA | |
|---|---|---|---|
| DATE | 08/09/2019 – 08/10/2019 | NTSB ACCIDENT # | ERA19FA240 |

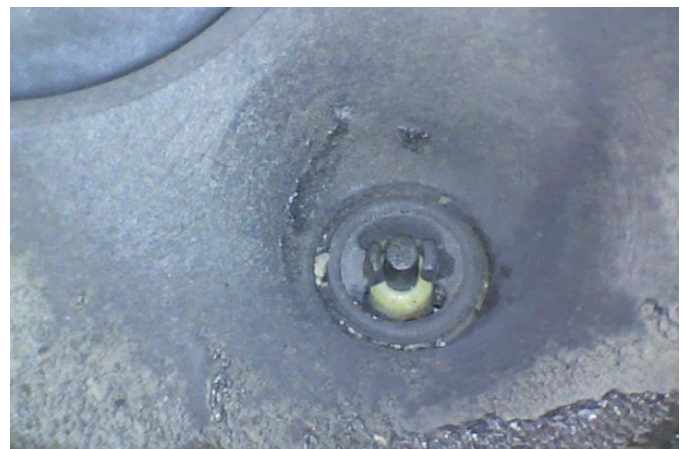
#1 Bottom Spark Plug

The #5 top spark plug had almost completely broken free from the engine; only the ground electrodes remained installed. The rest of the spark plugs remained installed in their cylinders and displayed varying amounts of impact damage. The top spark plugs were removed for inspection and the bottom spark plugs were inspected using a lighted borescope. The #5 bottom spark plug electrodes were obscured from view due to debris in the cylinder; the rest of the spark plug electrodes displayed normal operating signatures and most of the spark plugs were in a normal worn-out condition when compared with Champion Aviation Service Manual AV6-R. There were no anomalies noted that would have prevented normal operation.
