**NTSB File No. ERA19LA057**  
**Cirrus SR22T, N597CP, Kennesaw, GA 11/29/18**

**Hartzell Engine Technologies**  
**Turbocharger Examination Report**

**Turbocharger Examination**

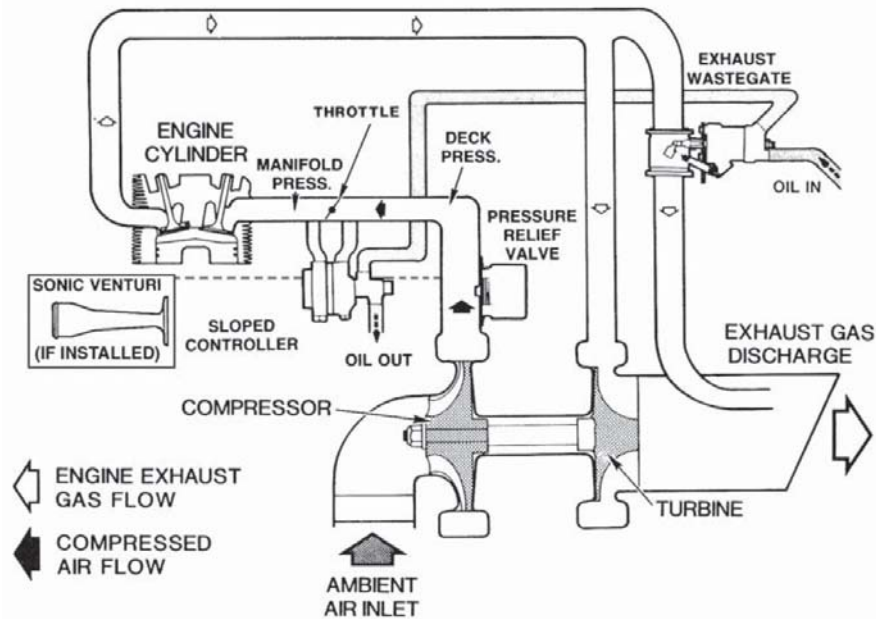
Figure 1: Sloped Control Turbocharger System

The TSIO-550-K1B engine on the Cirrus SR22T uses a Slope Control Turbocharger System with two, low-mounted turbochargers and a scavenged oil system. The sloped controller is designed to maintain the rated deck pressure at wide open throttle, and to maintain a reduced deck pressure at part-throttle settings. The controller senses both deck and manifold pressure and monitors the differential between them. If either the deck pressure or differential pressure rises above predetermined values for a given throttle setting, the controller opens the exhaust bypass valve, thus lowering compressor speed and output. A system schematic is shown in Figure 1.
