**ERA19LA074**

**Diamond DA20– N346MA**

**NTSB ENGINE EXAMINATION FIELD NOTES**

**Examination Date: May 7-8, 2019**

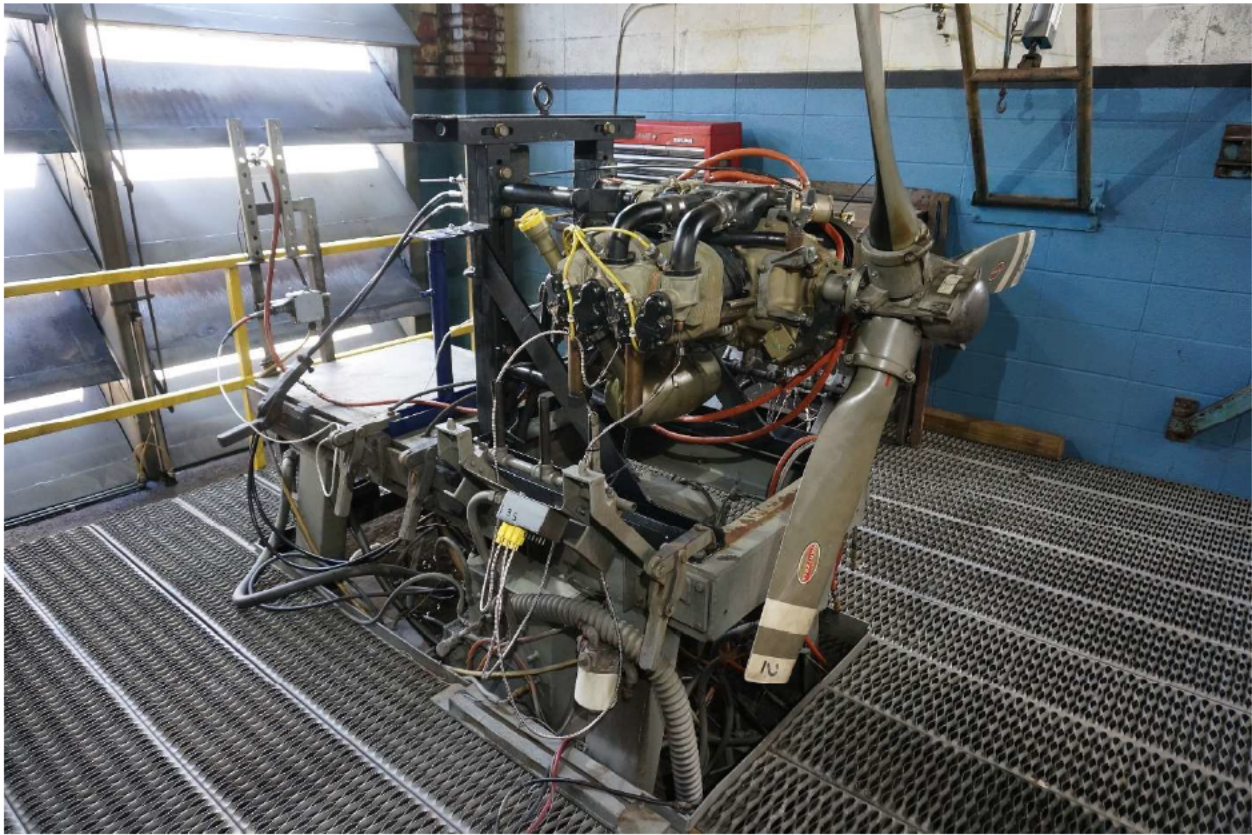
Picture 5. Engine in Test Cell

During the initial test run, the engine ran very rough, and would not idle. By increasing the test stand fuel boost pressure, the engine would remain running. As the fuel boost pressure was increased, the metered fuel pressure did not increase appreciably.
