## ENGINE EXAMINATION REPORT

| ENGINE MODEL | IO-470-L |
| AIRCRAFT REGISTRATION | N323MT |
| FILE NUMBER | 18-373 |

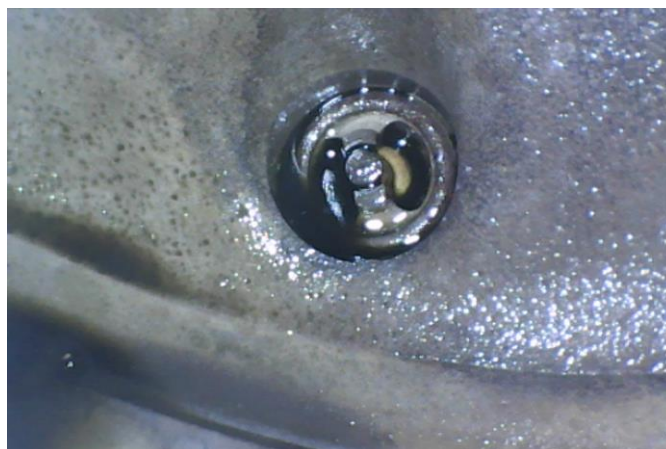
#1 Bottom Spark Plug

All of the spark plugs remained installed in their cylinders and were undamaged. The top spark plugs were removed, and the electrodes were visually inspected; the bottom spark plug electrodes were inspected using a lighted borescope. All of the electrodes displayed normal operating and most of the spark plugs were in a normally worn out condition. There were no anomalies that would have prevented normal operation noted.

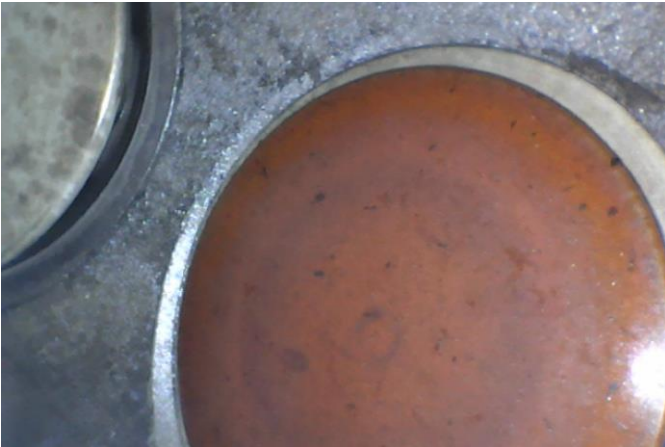
#1 Exhaust Valve

The valve heads were inspected using a lighted borescope; the valve heads displayed normal operating and combustion signatures. The valve springs and stems displayed normal operating and lubrication signatures. During crankshaft rotation all of the valves operated normally. There were no anomalies observed.

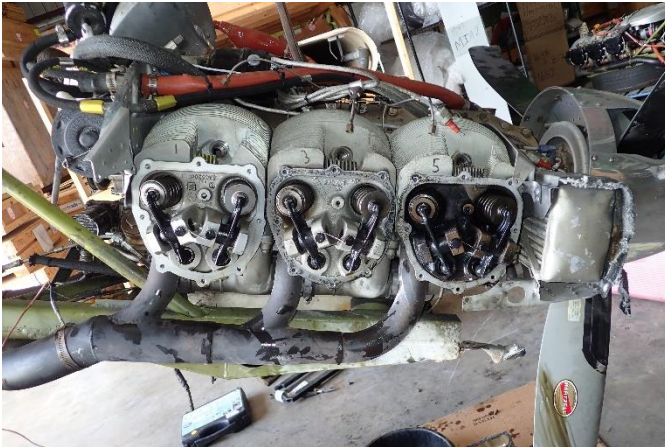
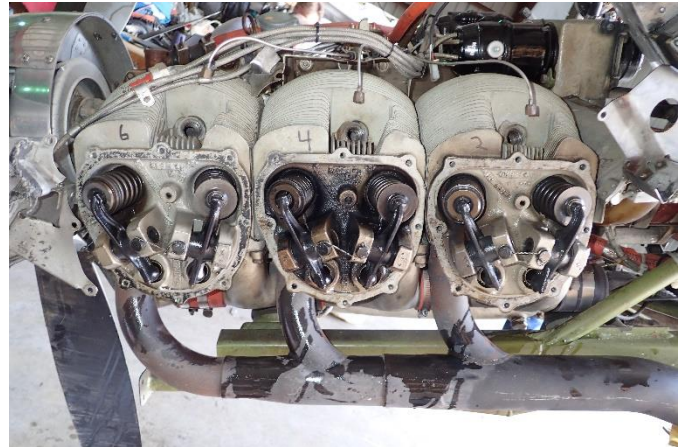
All of the rocker arms remained secured to their installation points and were undamaged. The rocker arms displayed normal operating and lubrication signatures. During crankshaft rotation all of the rocker arms operated normally. There were no anomalies observed.

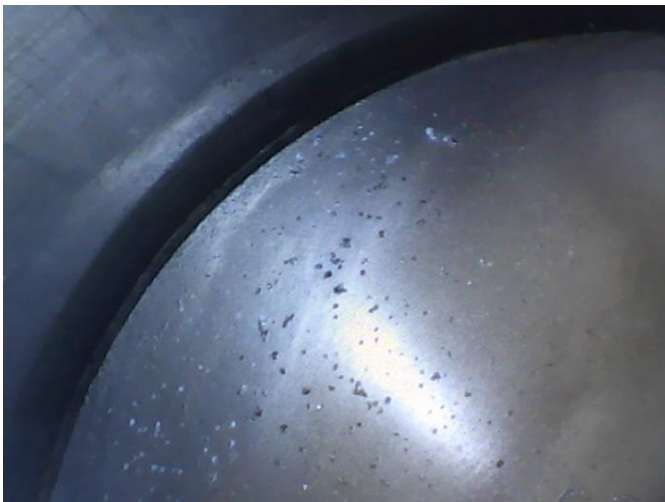
#1 Piston

All of the piston faces were inspected using a lighted borescope; the piston faces displayed normal operating and combustion signatures. During crankshaft rotation all of the pistons operated normally. There were no anomalies observed.

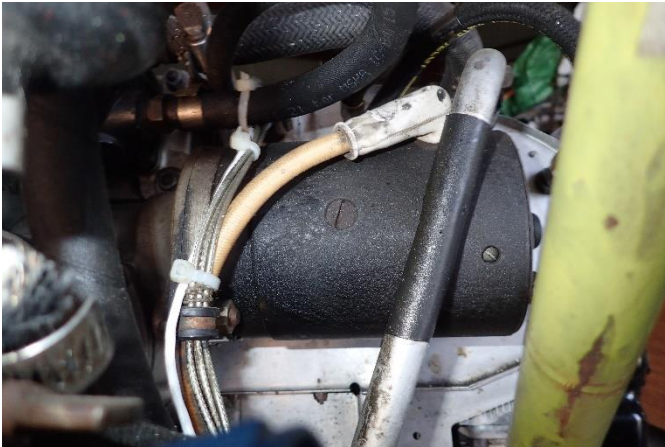
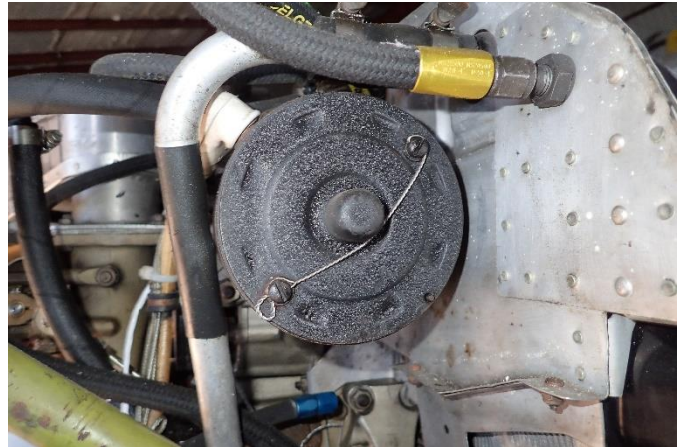
The starter remained attached to the starter adapter and was undamaged. There were no anomalies observed.

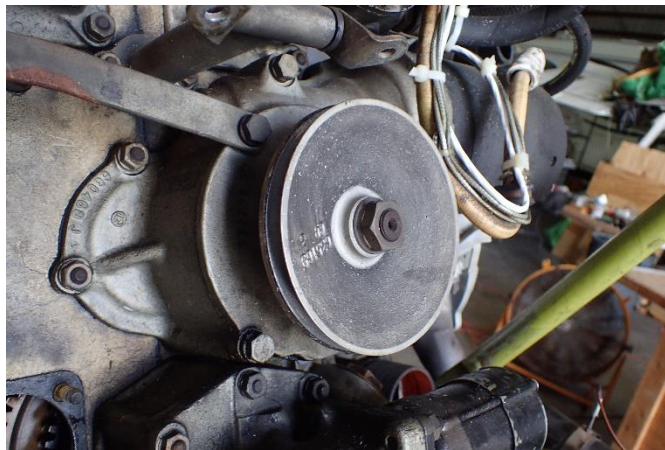
The starter adapter remained attached to its installation point and was undamaged. There were no anomalies noted with the starter adapter.

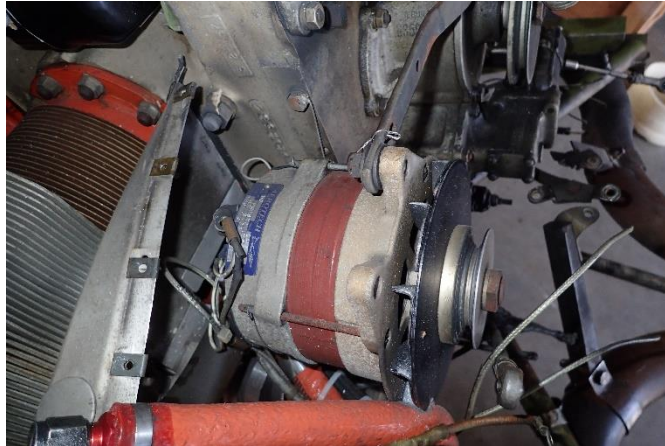
The alternator remained attached to its installation point and was undamaged. The alternator belt remained secured and the alternator drive was capable of rotation. There were no anomalies observed.

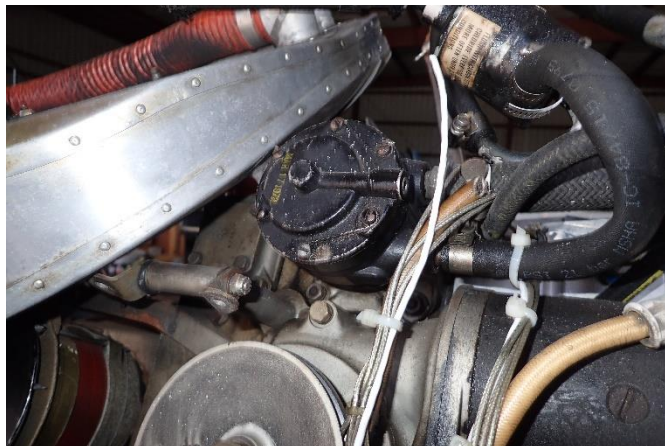
The vacuum pump remained attached to its installation point and was undamaged. There were no anomalies observed.

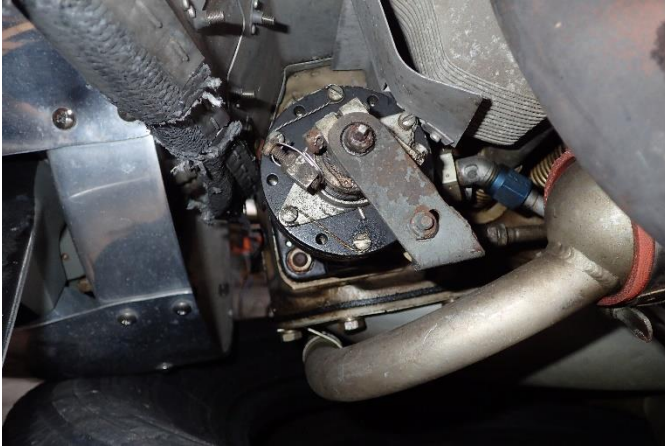
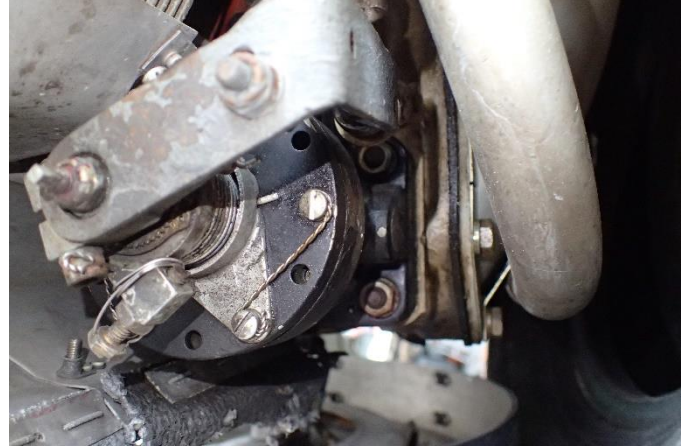
The governor remained attached to its installation point and was undamaged. The propeller control arm was capable of normal movement and there were no signs of oil leaks around the governor. There were no anomalies observed.

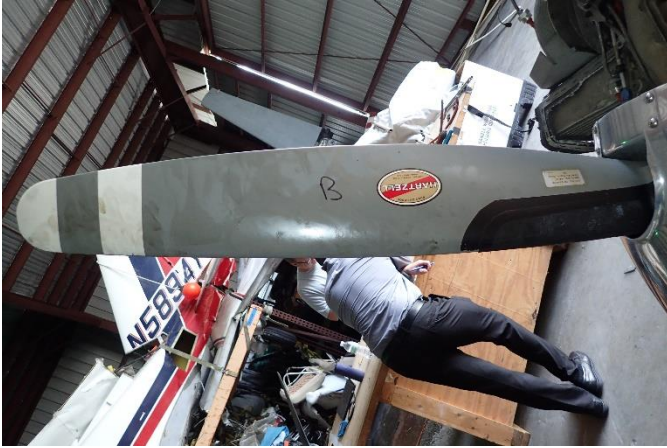
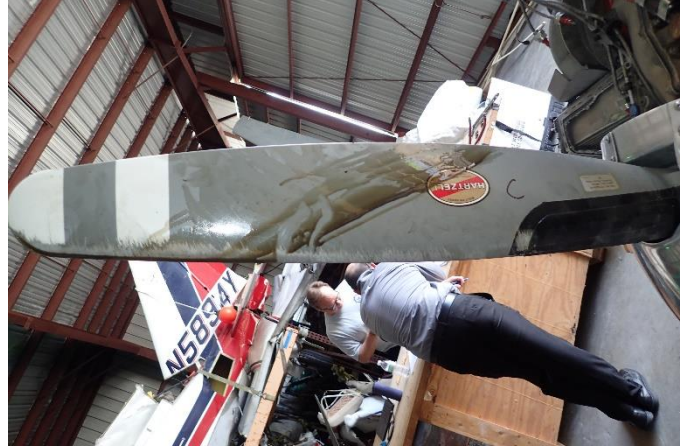
The three blade, constant speed propeller remained attached to the crankshaft and appeared to be in the feathered position. All three propeller blades remained within the hub and displayed minimal damage; the propeller blade marked "C" displayed minor chordwise scratches and leading-edge polishing, the other two blades were undamaged.
