## ENGINE EXAMINATION REPORT

| ENGINE MODEL | IO-470-L |
| AIRCRAFT REGISTRATION | N323MT |
| FILE NUMBER | 18-373 |

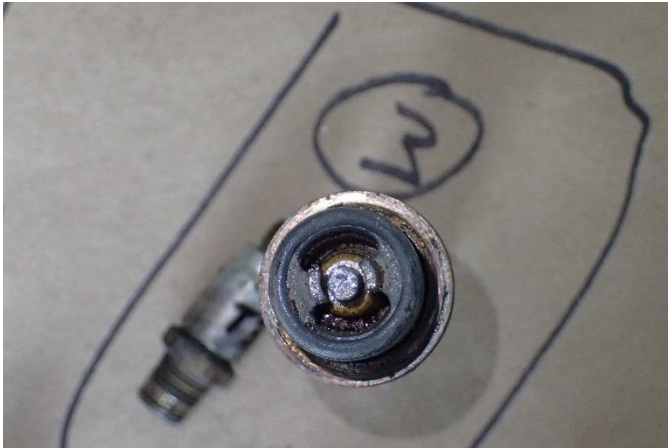
#3 Top Spark Plug

All of the spark plugs remained installed in their cylinders and were undamaged. The top spark plugs were removed, and the electrodes were visually examined; the bottom spark plug electrodes were examined using a lighted borescope. All of the electrodes displayed normal operating signatures and most of the spark plugs were in a normal worn out condition. There were no anomalies noted that would have prevented normal operation.

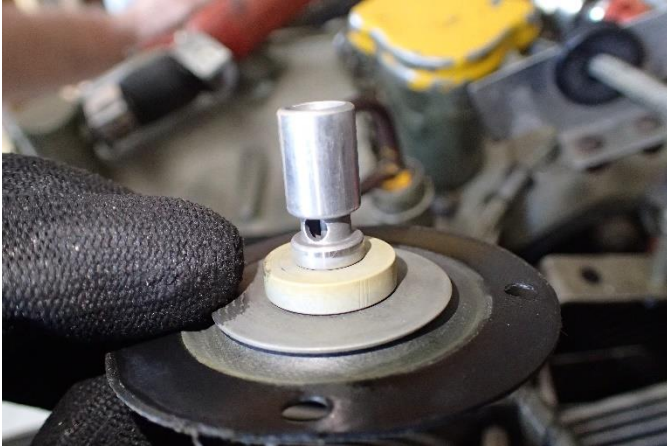
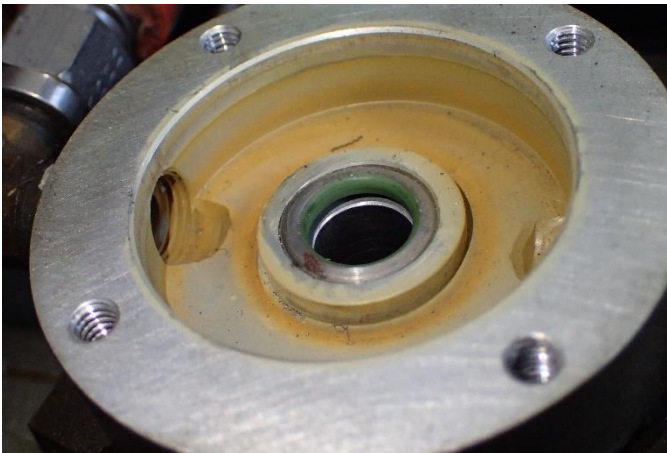
## FUEL MANIFOLD VALVE

The fuel manifold valve remained attached to its installation point and was undamaged. The manifold valve was disassembled, and the internal components were visually examined. The spring, plunger, and diaphragm displayed normal operating signatures and the screen was clear of contaminants. It was noted that the housing displayed a significant amount of discoloration that was orange in color.
