### **III. INFORMATION ON BRS SYSTEM IN ACCIDENT AIRCRAFT**

#### **A – Description of BRS-1350HS**

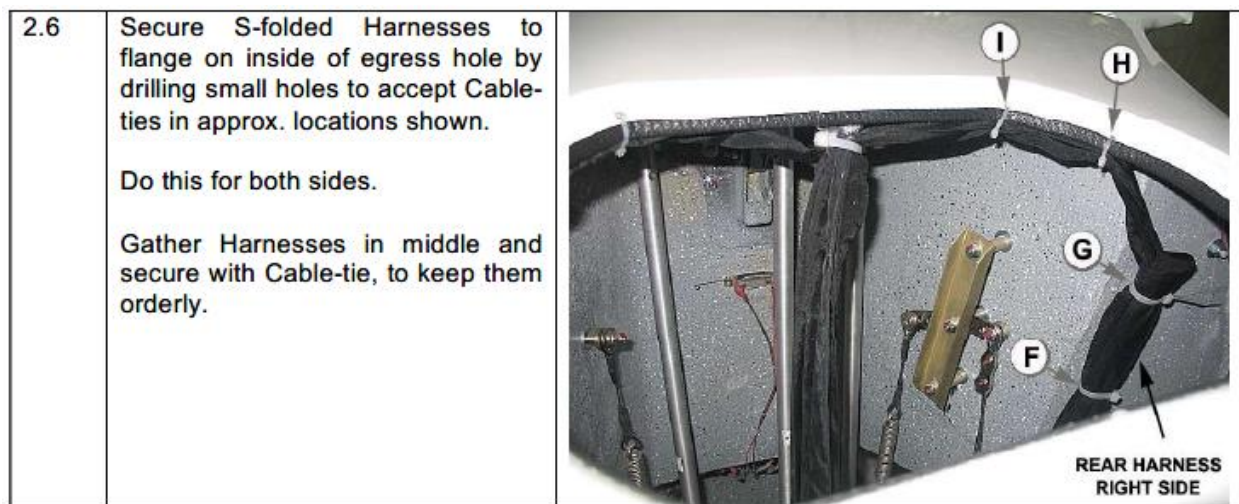
Section 2.6: Secure S Folded harnesses. Note that the harness should not block any part of the egress opening.

The S-folded Harnesses were improperly secured to the inside of the egress panel. The S-folded Harnesses improperly protruded into and blocked the egress opening. The S-folded Harnesses also improperly protruded into and blocked the opening of the parachute canister.

This condition fails to comply with BRS Parachute Installation Manual sections 2.6, 4.4, or 4.5. Similarly, this condition fails to comply with the BRS Pre-Flight Checklist advising that pilots should check that the parachute harnesses do not interfere with the firing of the rocket or extraction of the parachute.

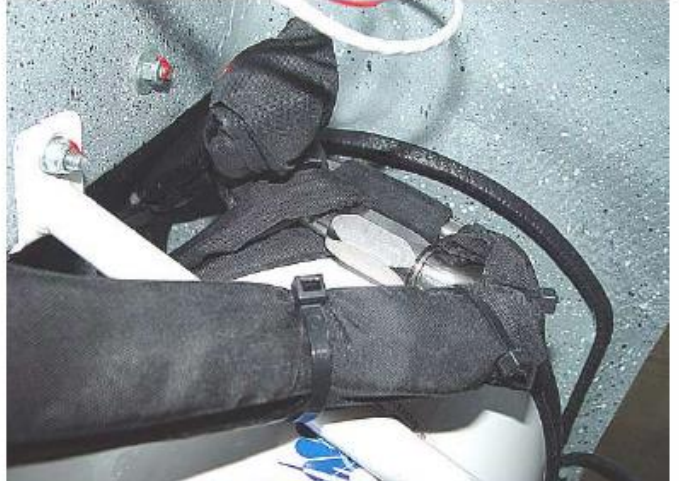
4.5: Connecting and securing Quick Link, and applying Loctite.

The ½ inch Quick-link that connected all four Harnesses to the parachute riser was improperly fastened. The nylon sheathing from the aircraft harness was caught in the threads and the barrel was improperly threaded. The barrel was only secured by about two rotations of threading. There was no Loctite 242 applied to the threads.

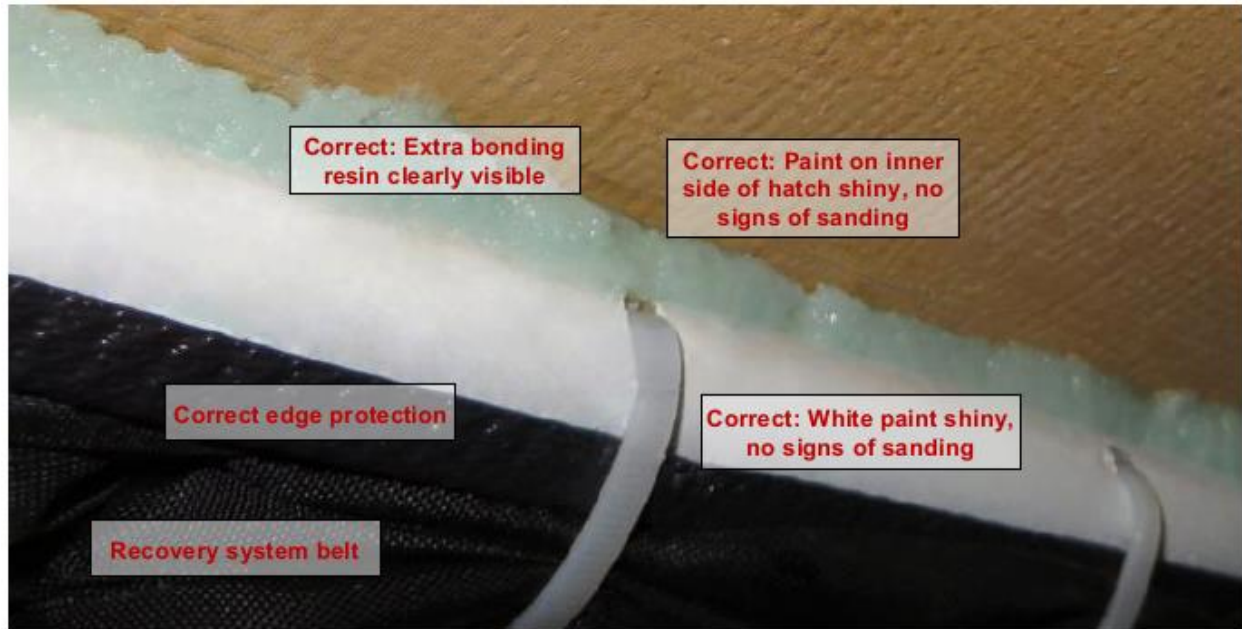
- In a correct installation, the lower edge of the fuselage flange that forms the extraction opening is covered with black plastic edge protection, and the black plastic edge protection cannot be easily slipped of the edge of the flange.
- In a correct installation, the surface of the inside of the egress panel, and inside of the hatch, should be painted and installed as shown:

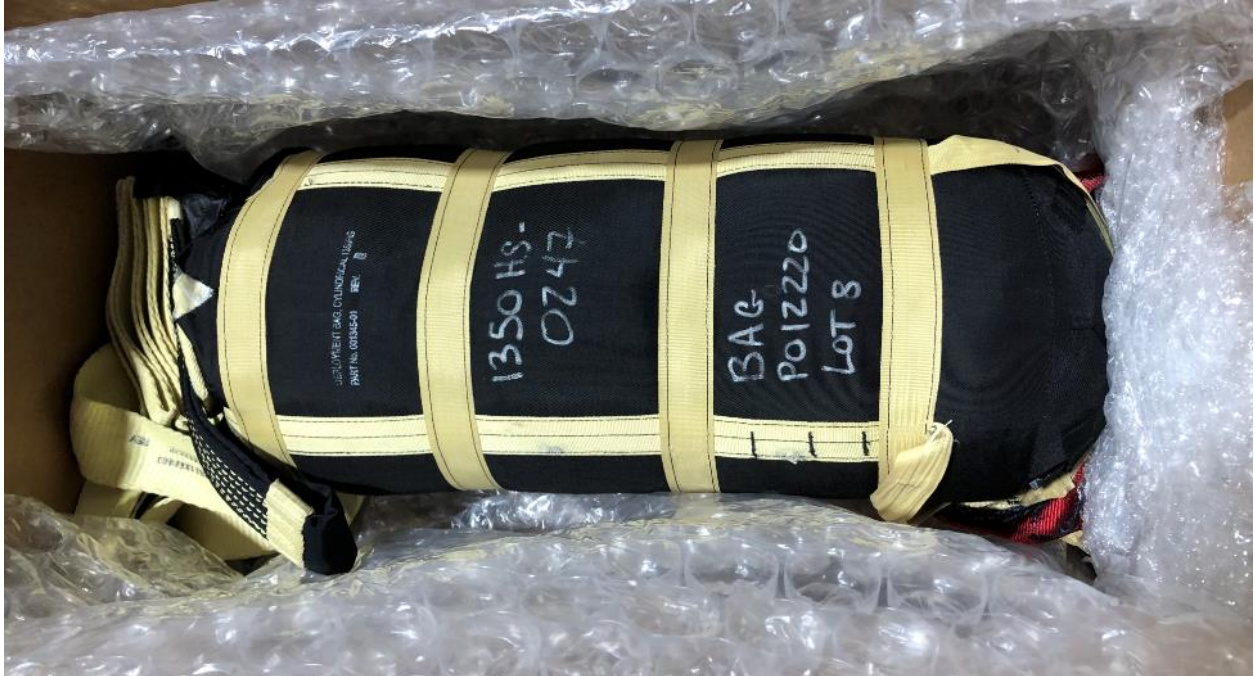
The parachute bag was marked PO1220 Lot 8.

These markings are consistent with the parachute bag information on record with BRS.

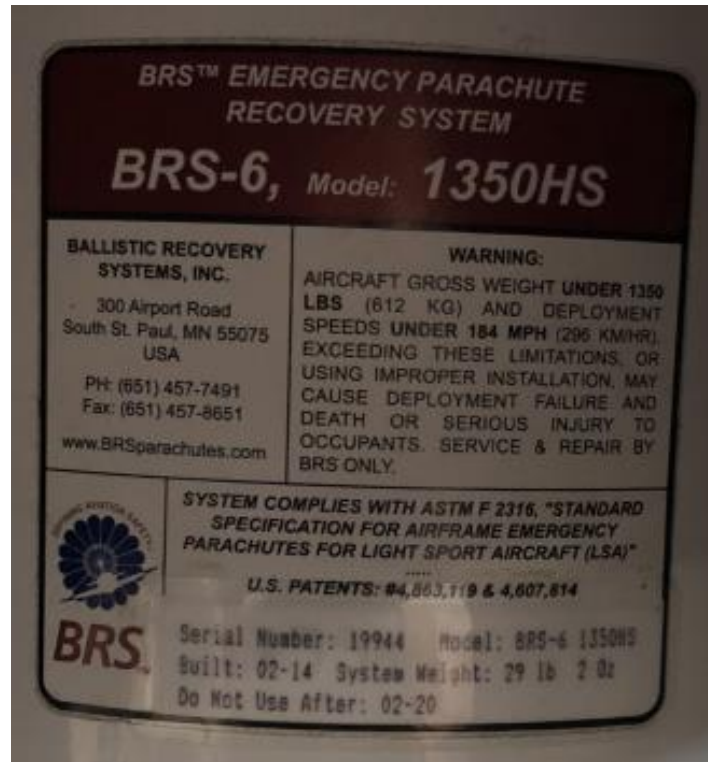
# K. Parachute Canister Markings

Markings on the parachute canister indicated Serial Number 19944 and the repack date of 02-14. The markings are consistent with the serial number and repack date on file with BRS.
