# NATIONAL TRANSPORTATION SAFETY BOARD

## MATERIALS LABORATORY FACTUAL REPORT

Report No. 19-077

Place : Newport News, Virginia  
Date : May 9, 2019  
Vehicle : Hawker Siddeley Hunter MK58; N343AX  
NTSB No. : ERA19LA169  
Investigator : Eric Alleyne, AS-ERA

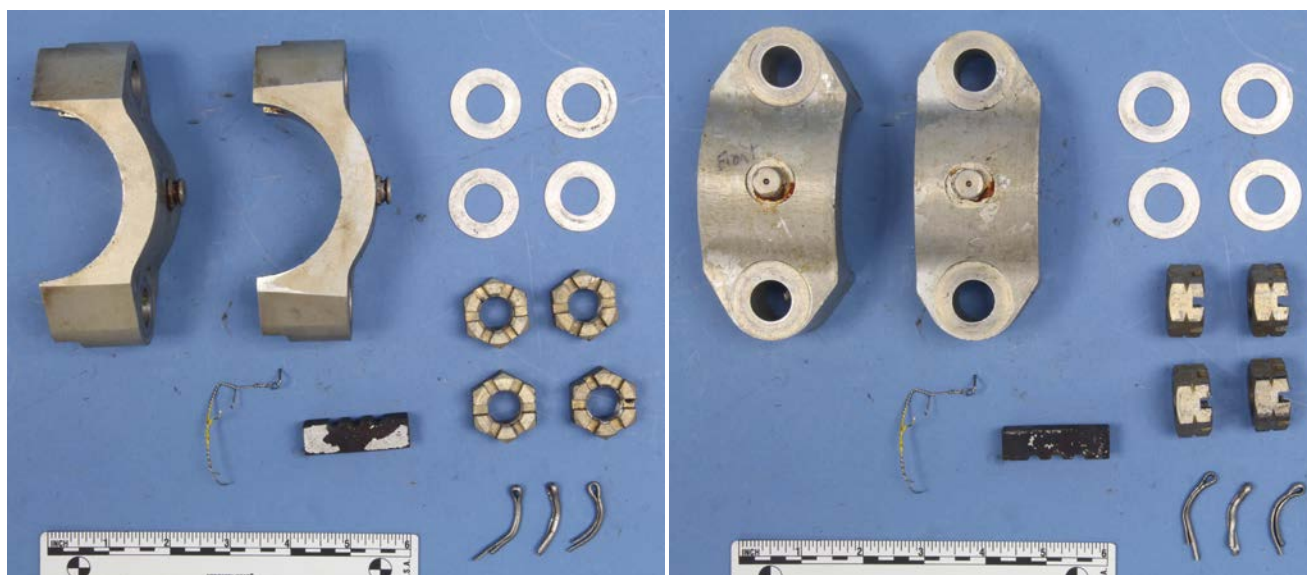
Figure 3 shows additional hardware that was submitted and not identified to a right- or left-hand component.

Figure 3a: Additional hardware received was not identified or clearly assignable to a particular landing gear component. The view on the right shows the same components as the view on the left with rotated or flipped orientation. These components were not documented further than this photograph.

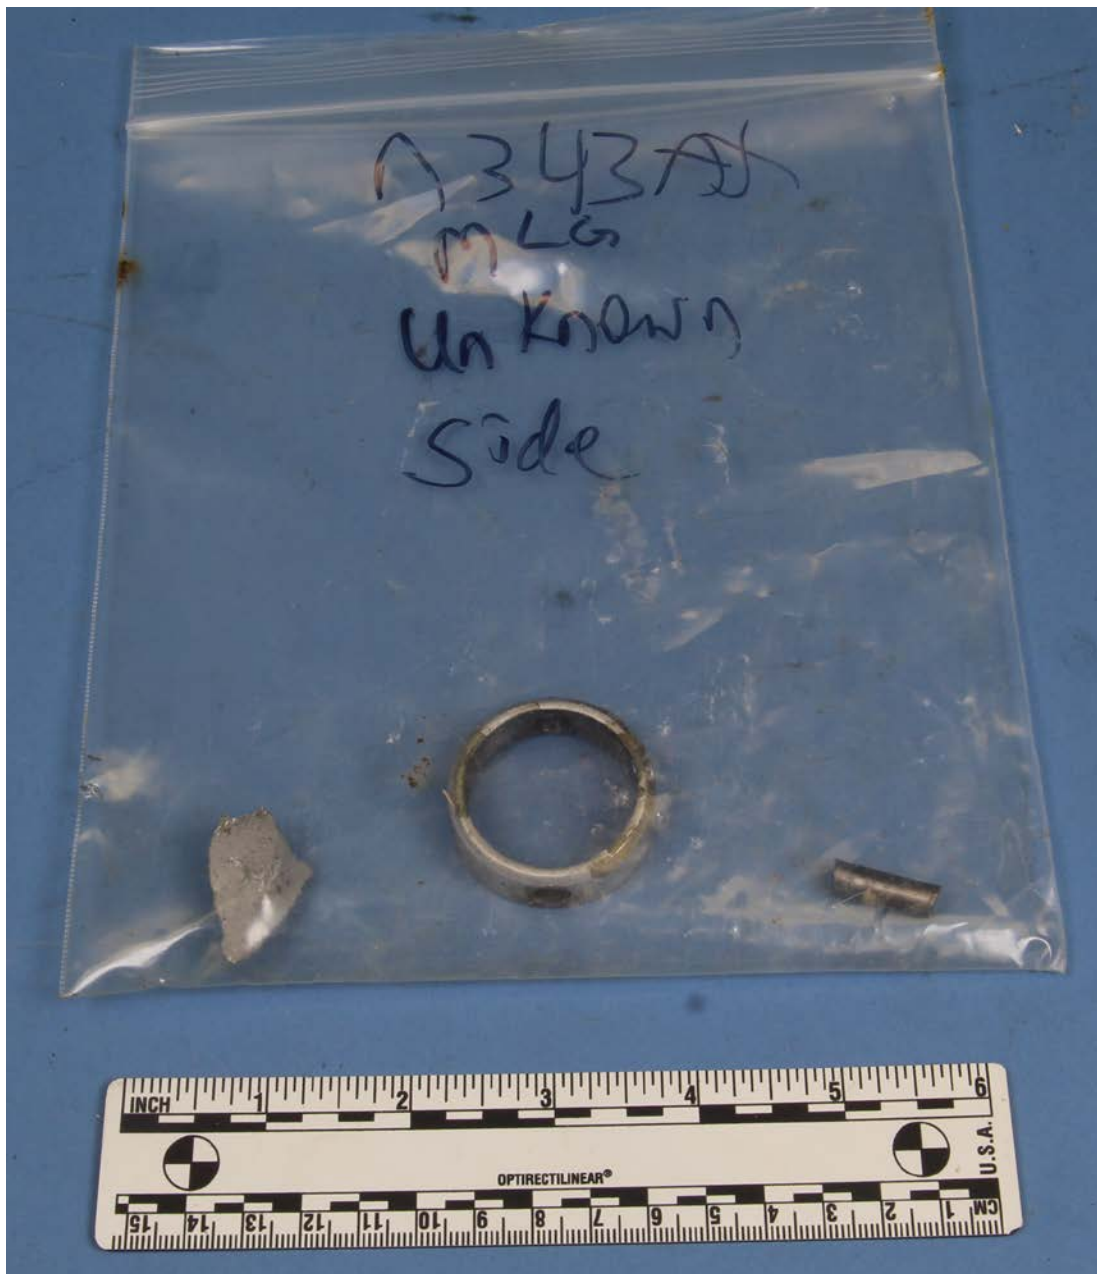
Figure 3b: Additional hardware received was not identified or clearly assignable to a particular landing gear component and was not documented any further.
