# Continental Motors

## ENGINE RUN REPORT

| ENGINE MODEL | TSIO-550-C (1B) |
| FILE NUMBER | 19-050 |

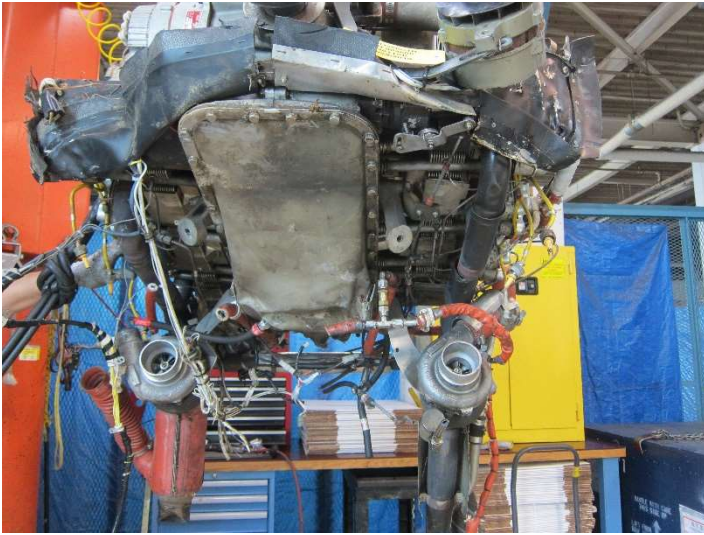
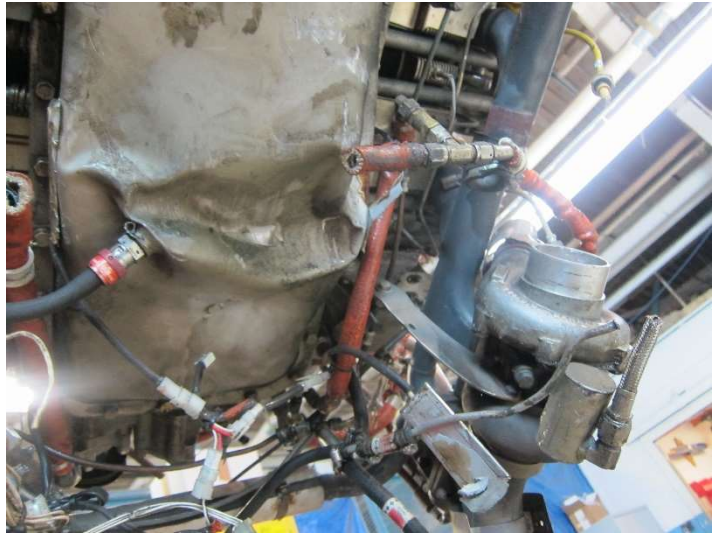
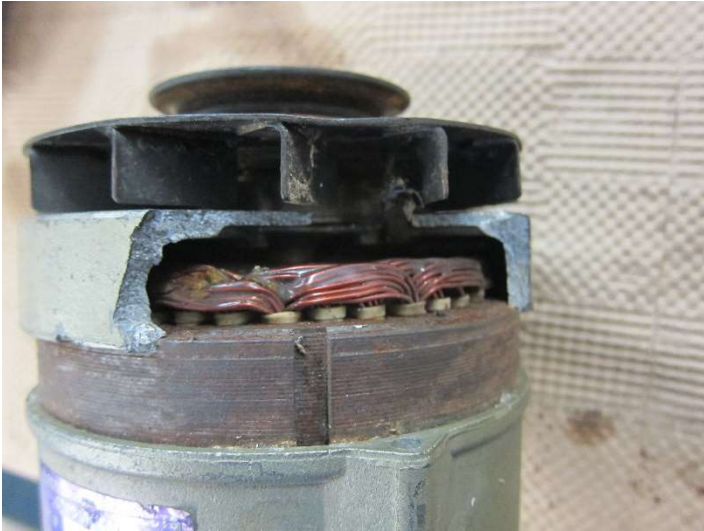
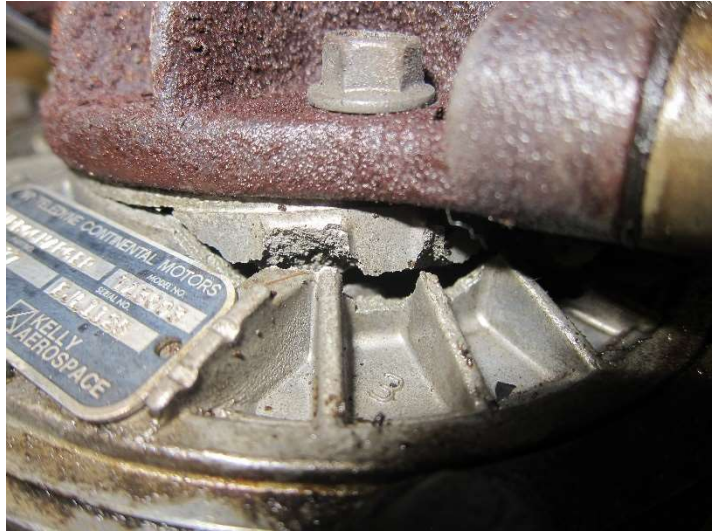
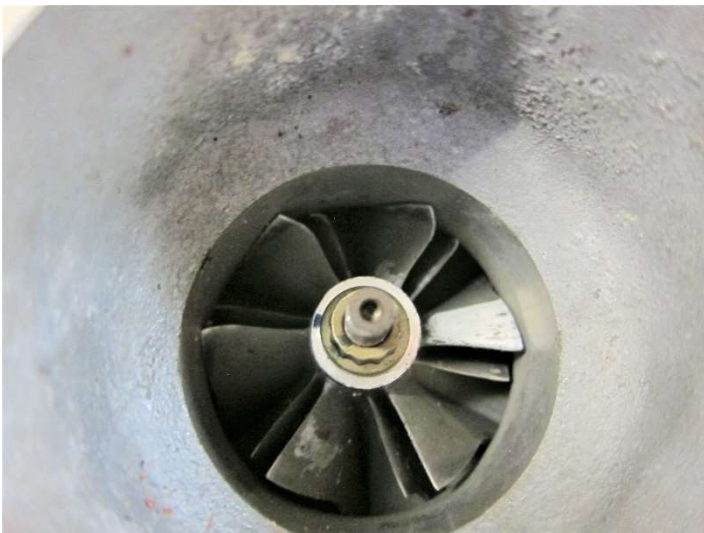
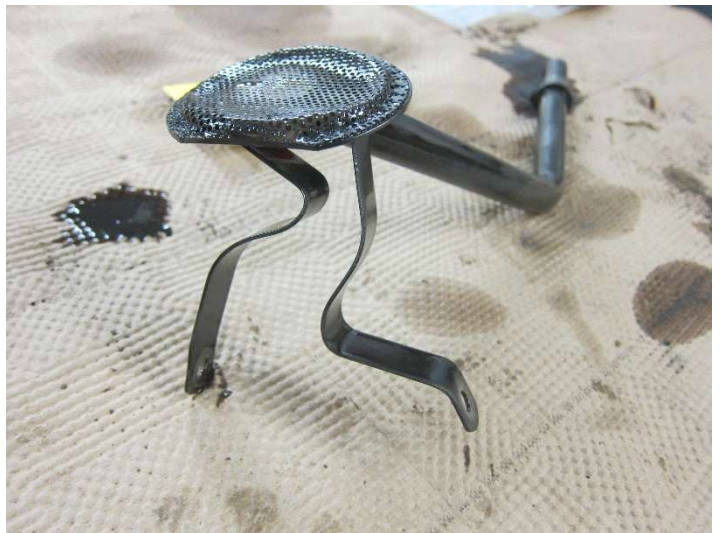
The engine was removed from the shipping crate in the presence of the NTSB Investigator and a visual inspection indicated that the engine exhibited impact damage to induction components, turbochargers, oil sump and starter adapter. The rocker cover for cylinder 6 exhaust rocker arm was impact damaged as was the rocker cover for cylinder # 5, Intake rocker arm.

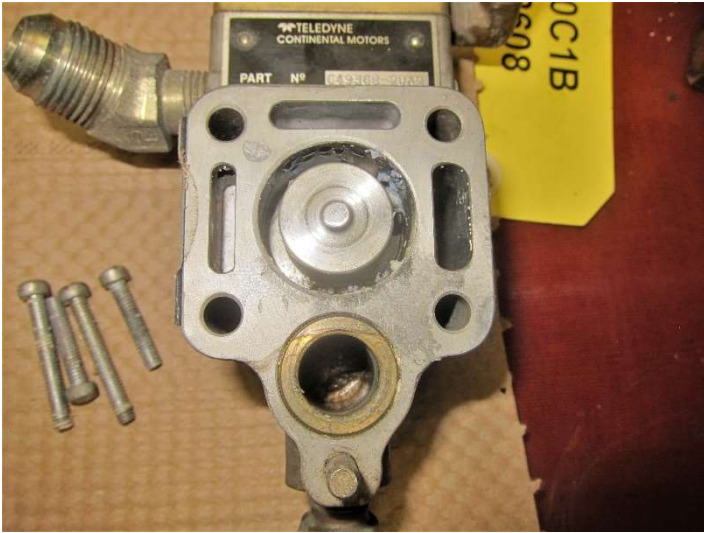
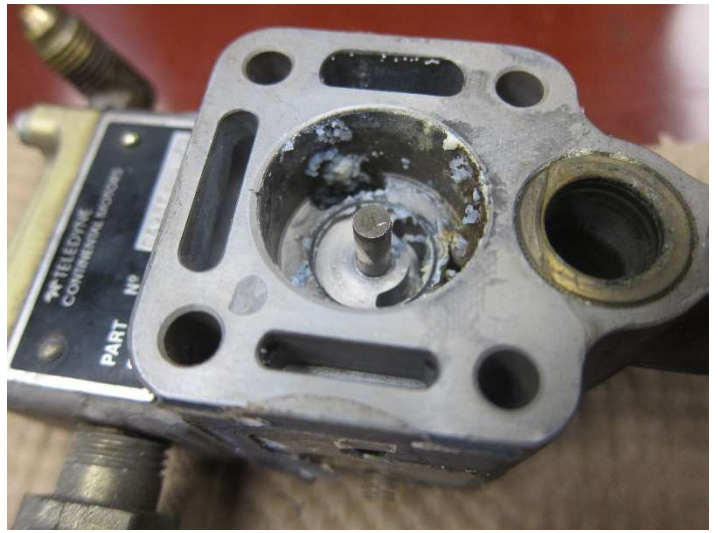
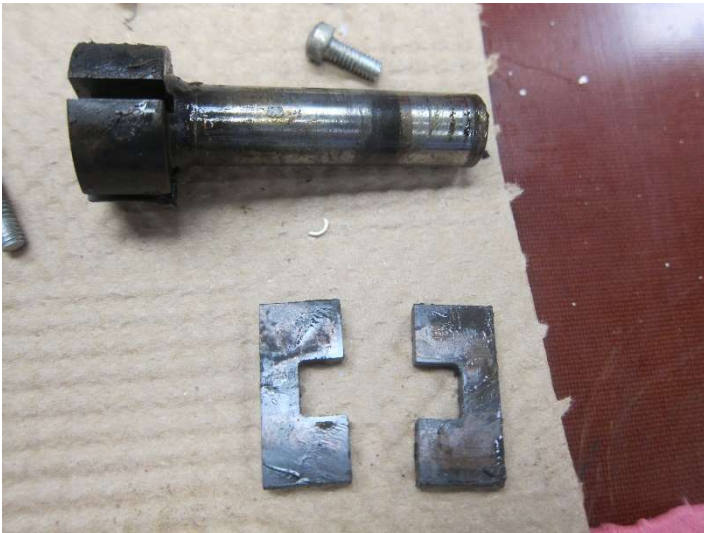
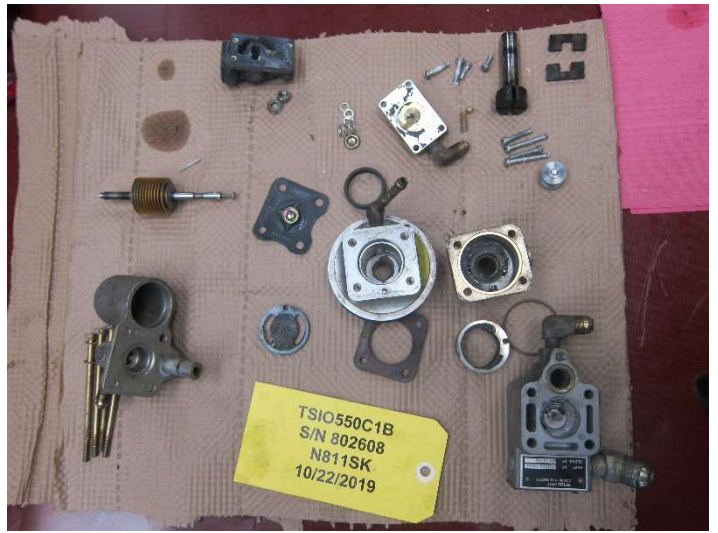
Further examination of the engine-driven fuel pump identified corrosion and contamination throughout the interior of the fuel pump, preventing the pump from rotating. The corrosion is consistent with moisture collecting in the fuel system during post-accident storage while exposed to the environment. The corrosion prevented the pump from rotating damaging the drive coupling. All interior pump components were intact.
