----- SYSTEMS GROUP CHAIRMAN'S FACTUAL REPORT -----

Location: Poughkeepsie, New York  
Date: July 19, 2019  
Time: About 1440 eastern daylight savings time (EDT)  
Aircraft: Piper PA46-310P  
Serial Number: PA46-8508046  
Registration: N811SK

## 3 SUMMARY:

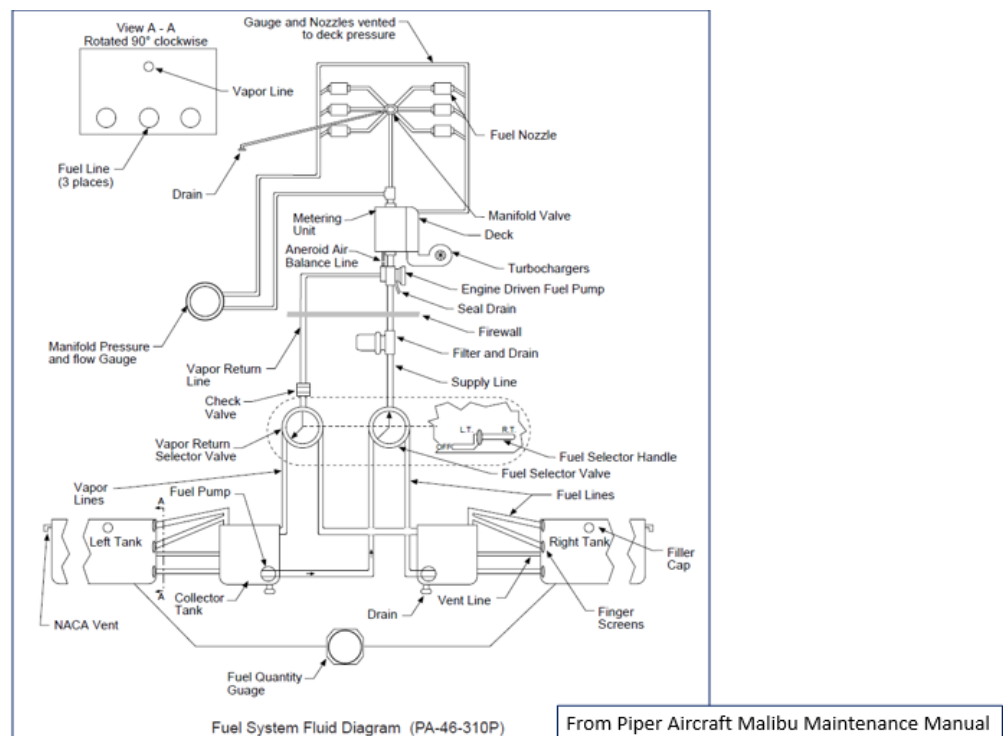
**Figure 1 - Fuel system schematic from aircraft maintenance manual**

The aircraft fuel system main components consist of two main integral wing tanks, two collector/sump tanks, two fuel pumps, a fuel selector valve, a fuel filter and tubing connecting to the engine driven fuel pump. On the powerplant the fuel system consists of an engine driven fuel pump, fuel metering unit, manifold valve and six fuel injector nozzles. Refer to Figure 1 which contains a schematic representation of the fuel system.
