**ERA19LA232**

**Ocean City, Maryland**

**Vans RV-7A N849GS**

**NTSB ENGINE EXAMINATION REPORT**

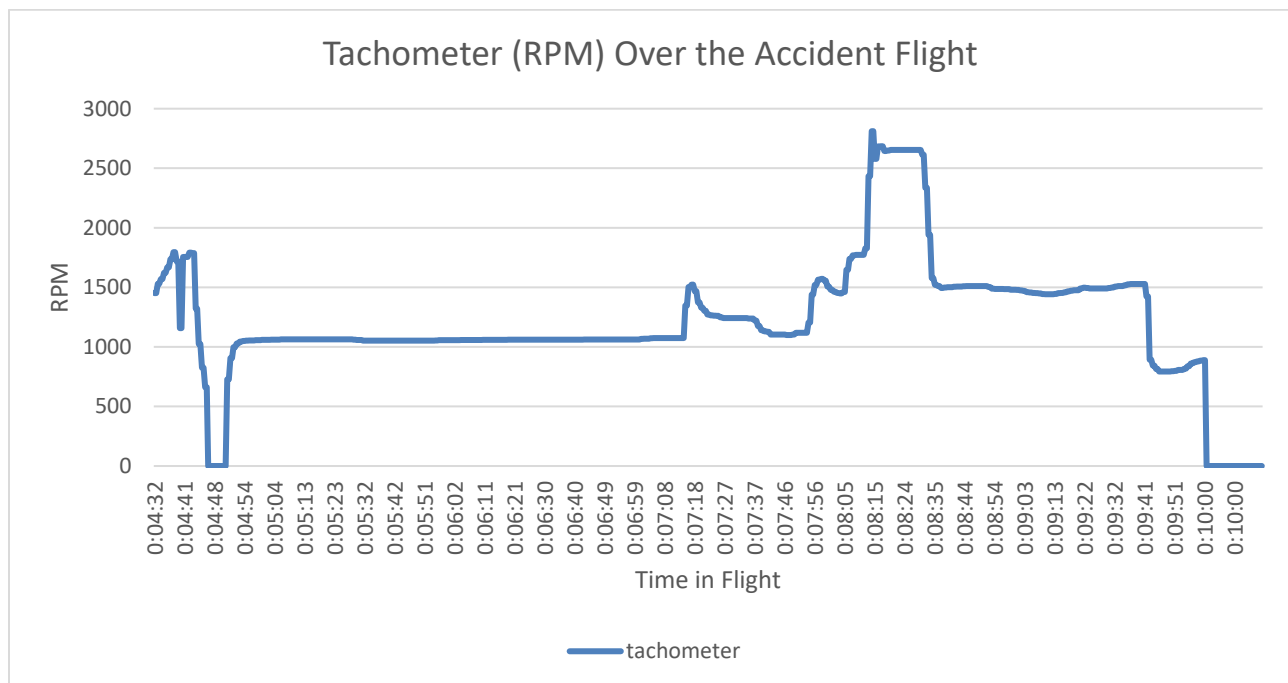
- After the engine was shutdown, the governor control arm had vibrated/turned and was observed in a high pitch, low RPM setting.
- There was a Grand Rapid Technologies Model 4000 Engine Information System installed in the instrument panel. It was downloaded and the data was examined. The most recent flight data indicated that the RPM increased to about 2,600 RPM about 8 minutes and 15 seconds into the recording. Then about 450 ft in the air, and 8 minutes and 30 seconds into the flight, the tachometer decreased to about 1,500 RPM and maintained that RPM over the next one minute and 12 seconds until the engine power reduced to about 800 RPM for about 20 seconds and finally to 0 RPM. Data Recording information can be found in the docket for this accident.
