## ENGINE EXAMINATION REPORT

| ENGINE MODEL | IO-550-N |
| AIRCRAFT MAKE & MODEL | Velocity XL-RG-5 |
| AIRCRAFT REGISTRATION | N735D |

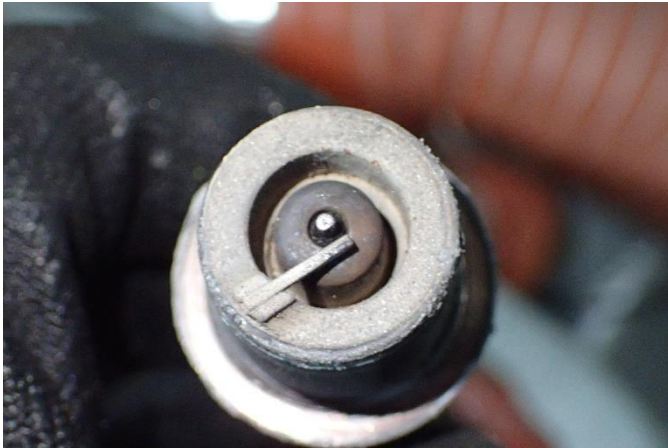
#5 Top Spark Plug

The spark plugs remained installed in their cylinders and were undamaged. The top spark plugs were removed for examination and the bottom spark plug electrodes were examined using a lighted borescope. The electrodes displayed normal operating and wear signatures.

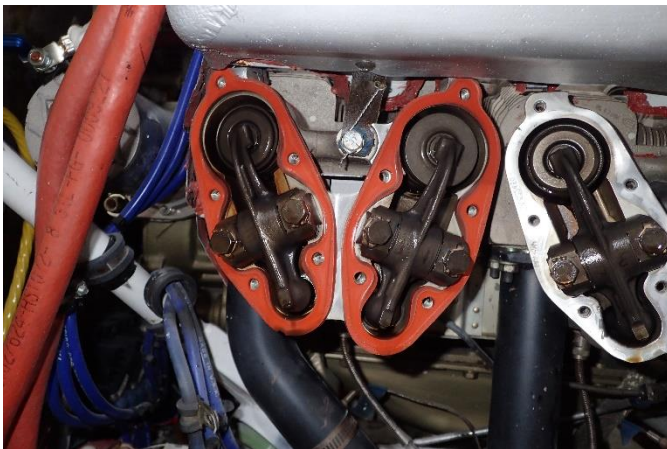
#1 Cylinder Overhead

All six cylinders remained attached to their cylinder bays and the #3 and the #4 cylinders displayed impact damage to the rocker arm box covers; the rest of the cylinders were undamaged. The cylinders were inspected using a lighted borescope; the cylinder bores and valve heads displayed normal operating and combustion signatures. The #3 piston face was noted to have a semicircular impression consistent with a valve strike; it was noted that the #3 cylinder intake rocker arm box cover had impact damage and was pushing against the rocker arm. The rest of the piston faces displayed normal operating and combustion signatures. During crankshaft rotation the cylinders displayed good thumb compression and suction and after removing the rocker arm box covers, all of the rocker arms and valves operated normally.

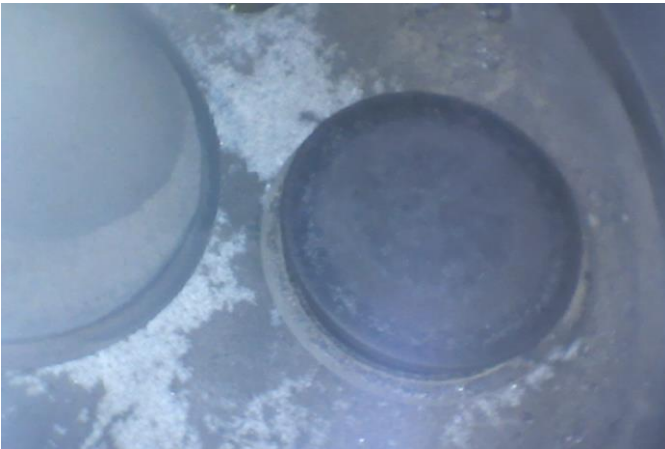
#1 Exhaust Valve

The valve heads were inspected using a lighted borescope; the valve heads displayed normal operating and combustion signatures. During crankshaft rotation all of the valves operated normally.

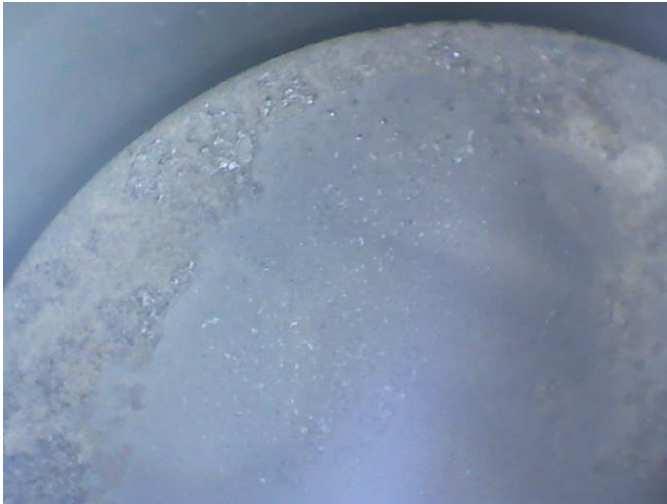
#1 Piston

The piston faces were inspected using a lighted borescope. The #3 cylinder was observed to have a small semicircular impression consistent with a valve strike; it was noted that the intake rocker box cover was impact damaged and pressing against the rocker arm. The rest of the cylinders displayed normal operating and combustion signatures and all of the pistons operated normally during crankshaft rotation.
