# ENGINE EXAMINATION REPORT

| ENGINE MODEL | IO-550-B |
| AIRCRAFT REGISTRATION | N80WH |
| FILE NUMBER | 19-072 |

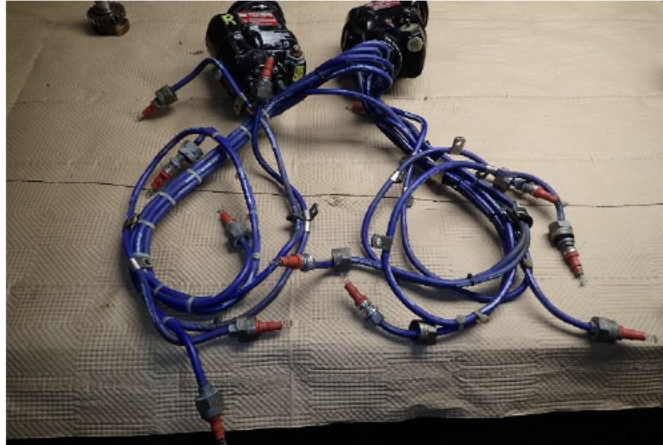
Condition: The top ignition leads had been removed from their spark plugs during the initial examination; the bottom spark plug ignition leads remained secured to their spark plugs. The ignition harness was used during the magneto testing and each ignition lead was capable of conducting a spark from the magneto to the ignition lead end.

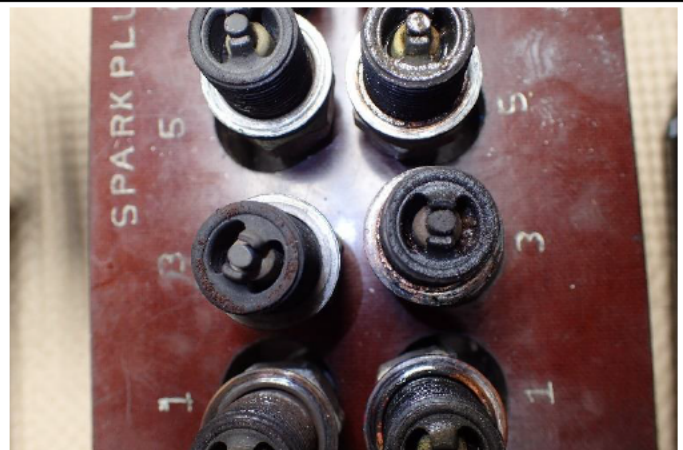
#3 Spark Plugs

Condition: The spark plugs remained installed in their cylinders and were undamaged. The spark plugs were removed, and the electrodes were visually inspected. All of the electrodes were in a worn-out condition and several of the electrodes were extremely worn out.

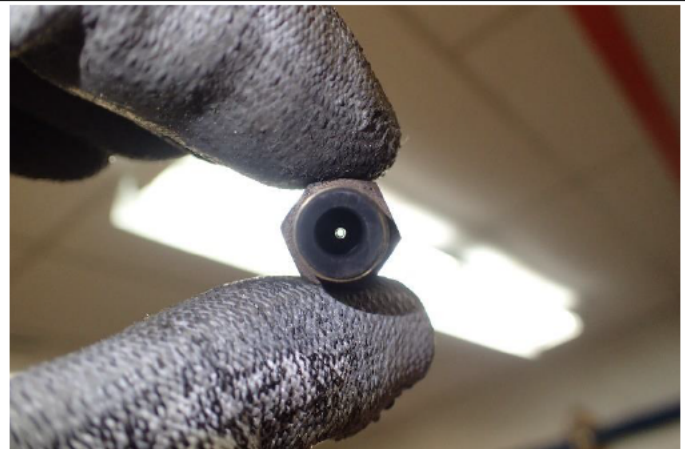
#3 Nozzle

Condition: The nozzles remained installed in their cylinders and were undamaged. The nozzles were removed and checked for obstructions. All of the nozzles were noted to be clear of any obstructions.

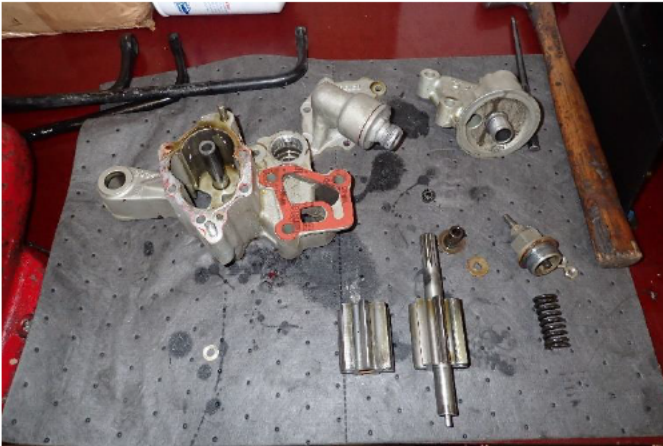
The oil pump remained attached to its installation point and was undamaged. The oil pump was removed and disassembled. The oil pump housing displayed scoring consistent with hard particle passage. The oil pump gears and pressure relief valve displayed normal operating signatures.

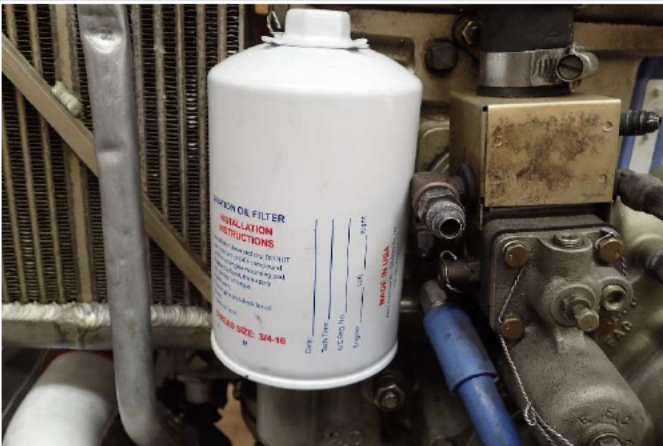
The oil filter was removed and the filter housing was cut open. The filter pleats were visually inspected and it was observed that there was a significant amount of metallic material within the filter pleats.

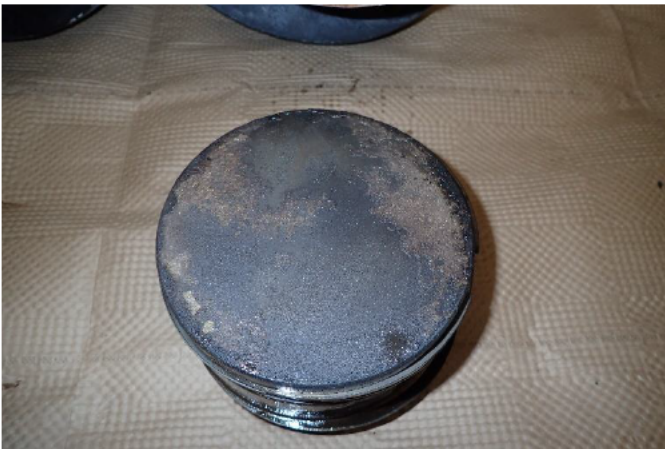
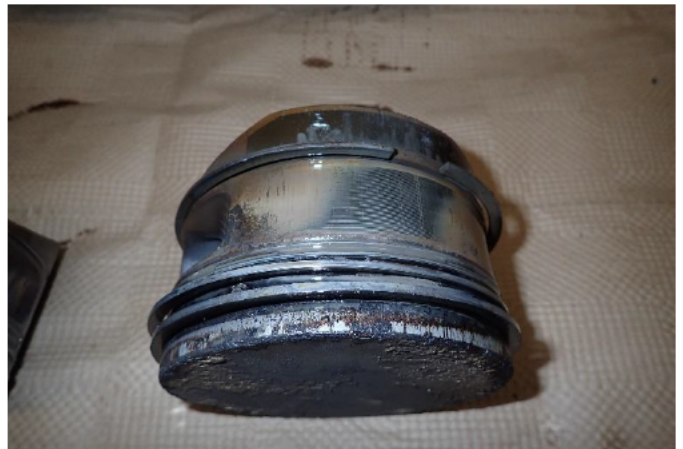
#6 Piston

Condition: All six pistons remained attached to their connecting rods. The #1 and the #2 pistons displayed mechanical damage and had broken piston rings. The #4 piston face displayed a semicircular impression consistent with a valve strike. The rest of the pistons displayed normal operating and combustion signatures. There were no signs of detonation or preignition observed.

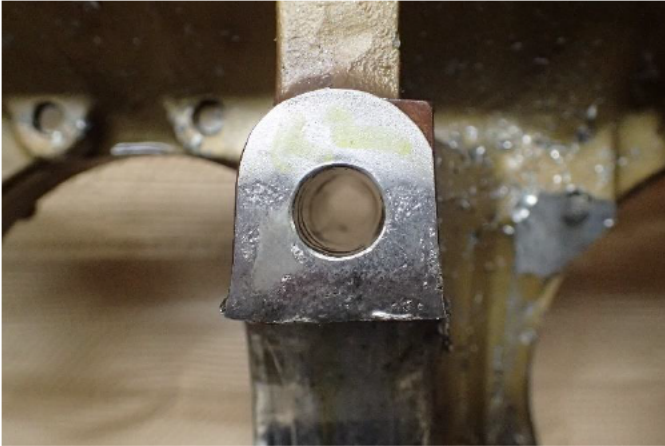
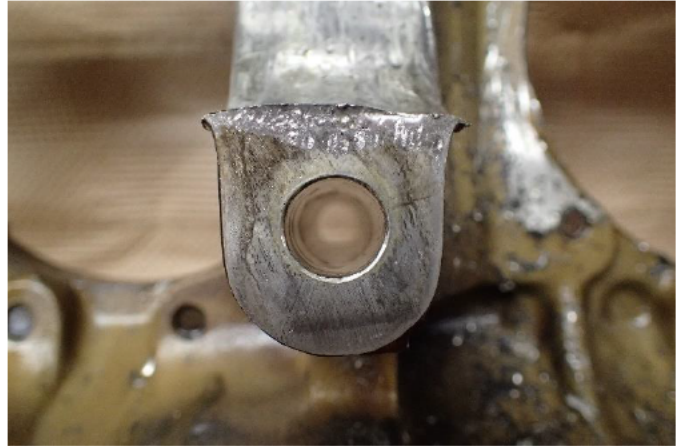
Right Side #2 Bearing Support Mating Surfaces

The crankcase remained mostly intact; there was a large crack observed on both crankcase halves on the top rear portion of the crankcase. The crankcase halves were split and the internal portions of the crankcase were examined. The #1 and the #2 bearings displayed bearing shift signatures with the #2 bearing displaying the most movement; the #2 bearing had been extruded from the bearing support. The bearing support mating surfaces for the #1, #2, #3, and the #4 displayed varying amounts of fretting with the #1 and the #2 mating surfaces displaying the most fretting. It was also observed that along the outer mating surfaces of the crankcase was material that was not consistent with approved sealant and there were no signs of a silk thread along the outer mating surfaces.

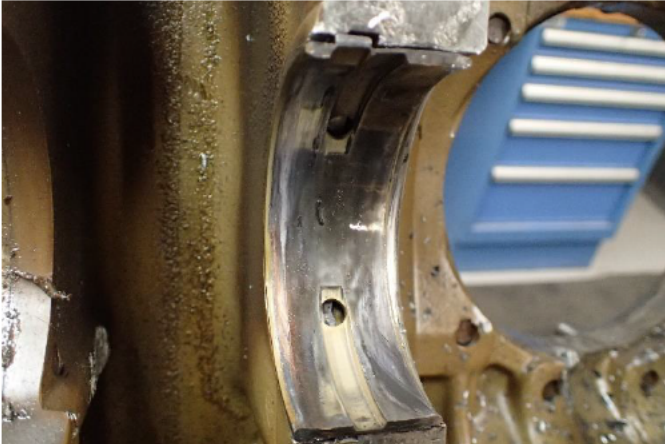
The bearing support mating surfaces displayed significant fretting. The bearing support displayed minor lock tab elongation and the bearing had slightly shifted. There were no signs of lubrication distress.

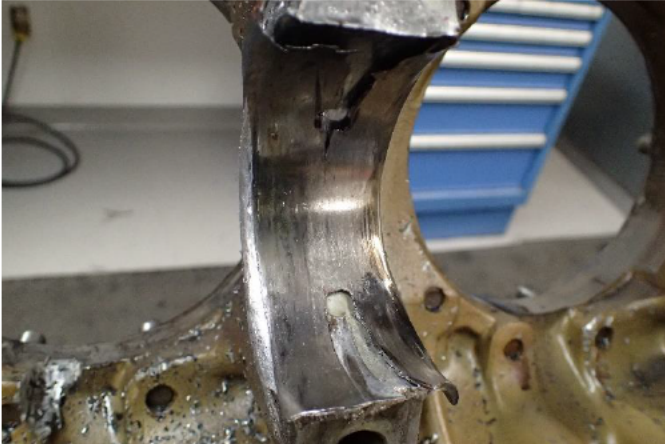
## #2 MAIN BEARINGS

The bearing displayed significant bearing shift signatures and a large portion of the bearing had extruded from the bearing support. The bearing support mating surfaces displayed fretting and the lock tab had completely worn away.

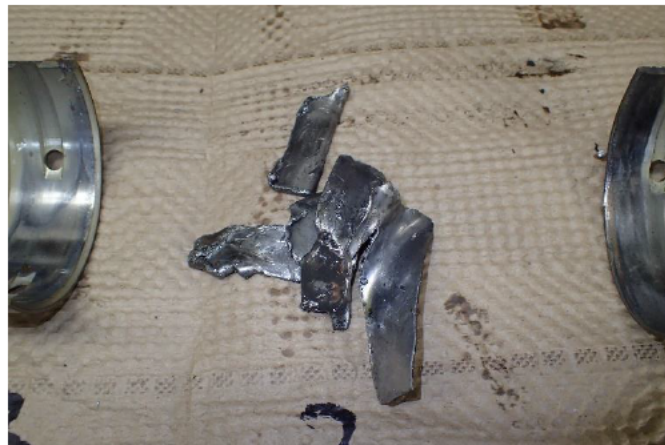
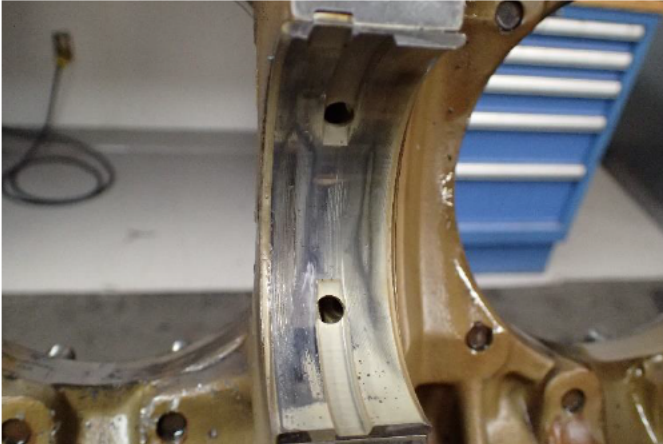
The bearing remained within the bearing support and displayed normal operating and lubrication signatures. The bearing support mating surfaces displayed minor fretting at the bottom mating surfaces.

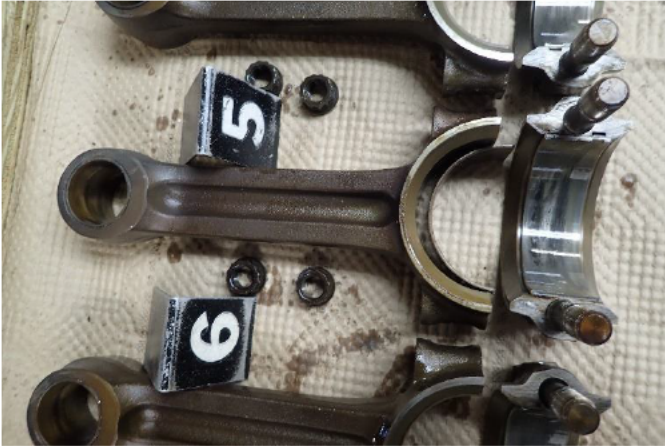
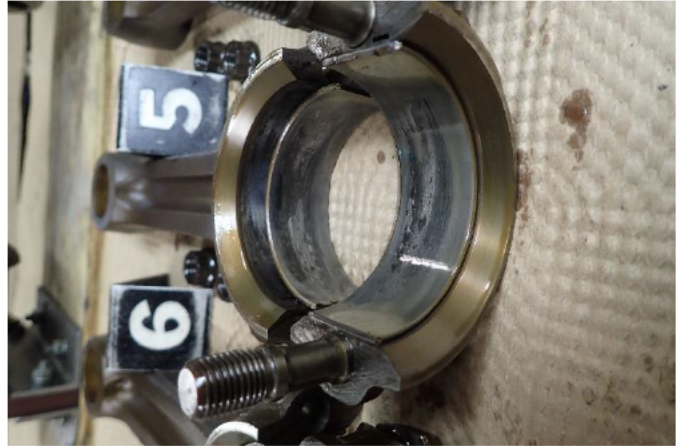
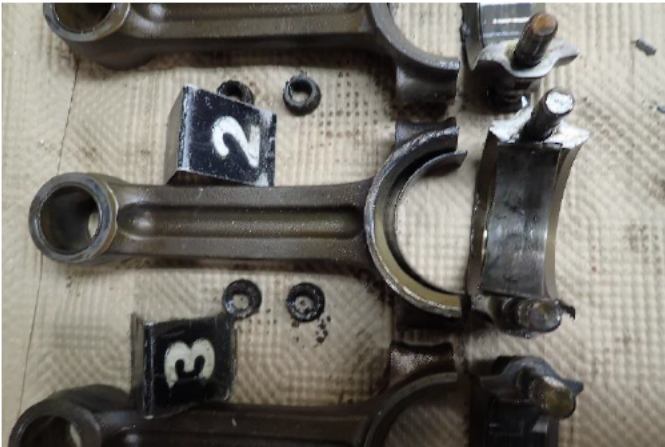
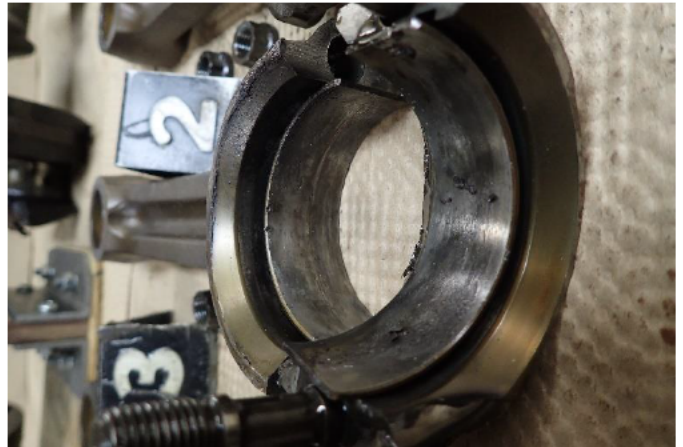
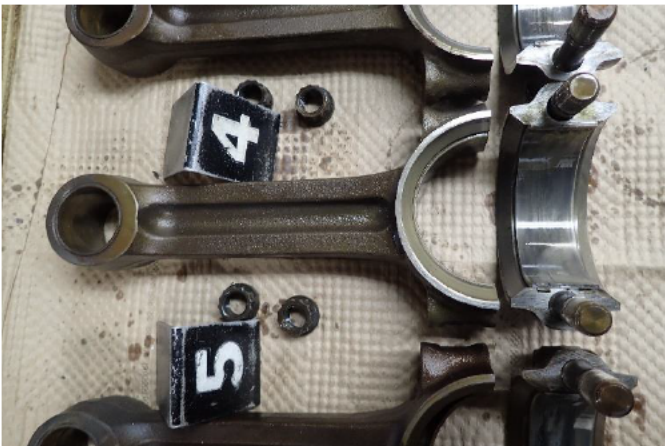
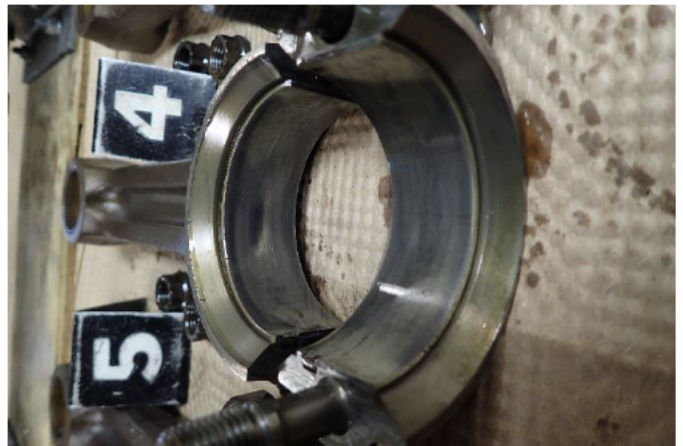
Condition: All of the connecting rods remained attached to their journals and remained intact. The #2 connecting rod journal displayed thermal discoloration consistent with lubrication distress of the bearing. The rest of the connecting rods were undamaged.

Condition: The #2 connecting rod bearing displayed smearing and damage consistent with lubrication distress and the #3 connecting rod bearing displayed minor lubrication distress signatures. The rest of the connecting rod bearing displayed normal operating and lubrication signatures.

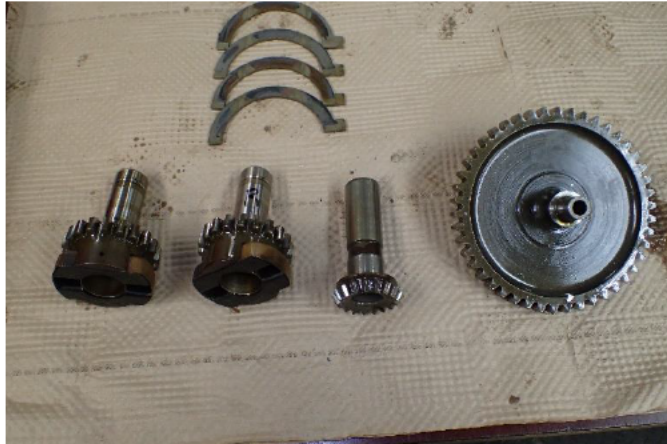
## ACCESSORY GEARS

Condition: The magneto drive gears, governor drive gear, and the idler gear displayed normal operating signatures.

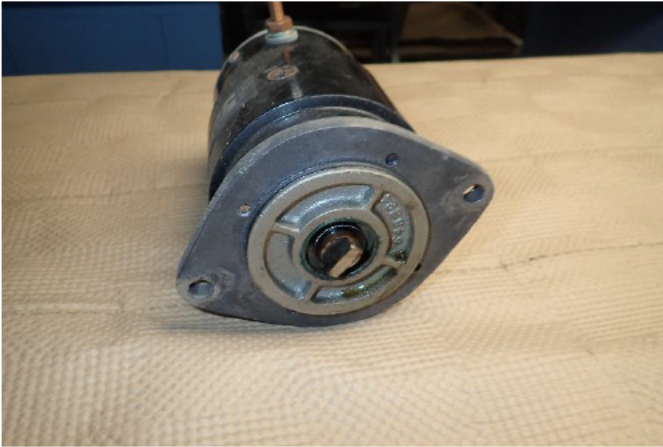
The starter remained intact and was undamaged. The starter was removed, and the driveshaft was noted to be capable of rotation.

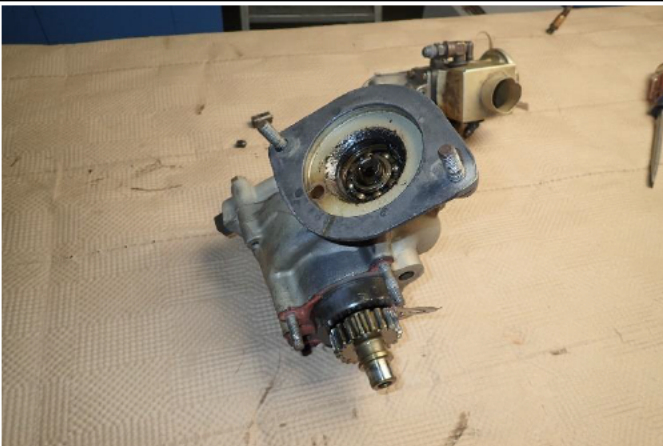
**STARTER ADAPTER**

The starter adapter remained attached to its installation point and was undamaged. The adapter was removed and the adapter driveshafts were capable of normal movement.

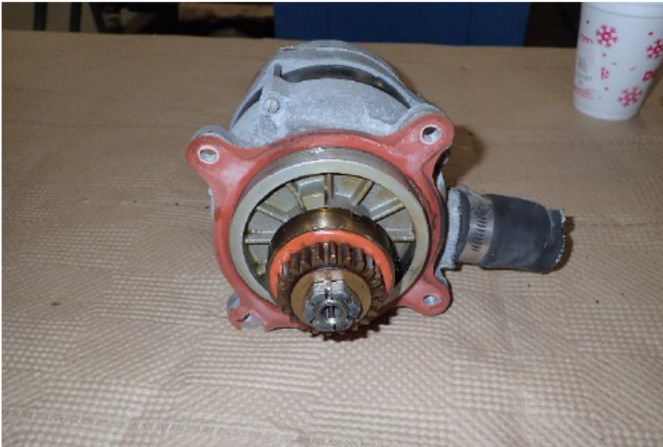
The alternator remained attached to its installation point and was undamaged. The alternator was removed, and the drive coupling was observed to remain intact and was capable of normal movement.
