**NATIONAL TRANSPORTATION SAFETY BOARD**

**AIRFRAME AND ENGINE EXAMINATION**

**ERA19LA264**

**ENGINE TEAR-DOWN EXAMINATION**

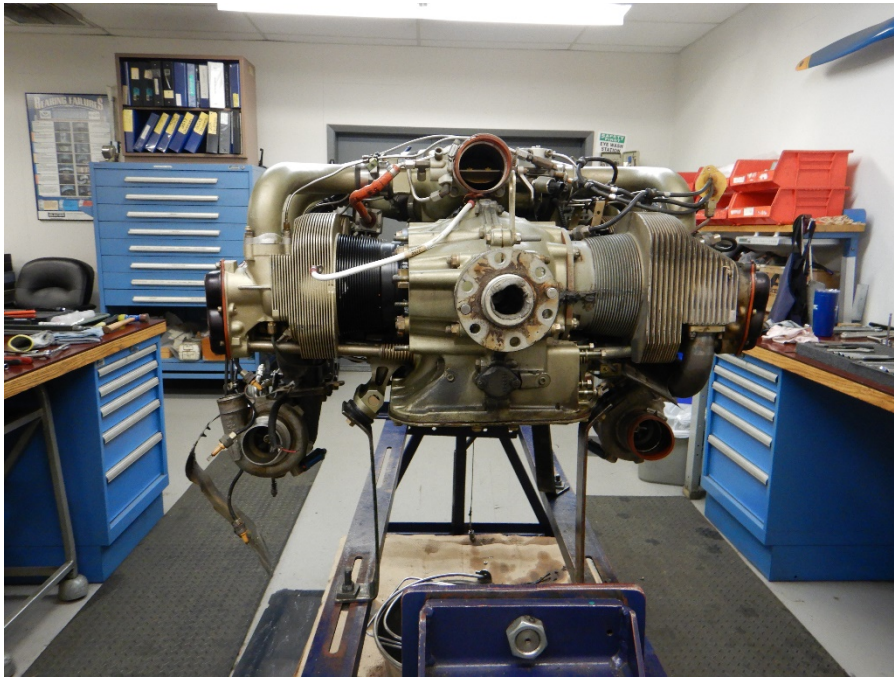
Engine accessories and baffling were removed. Fuel nozzles for all cylinders were found loose in the cylinders. Torque check of through-bolt, deck studs and 7<sup>th</sup> studs torque check revealed no anomalies. The cylinders and pistons were removed. Testing of the left and right magnetos revealed no anomalies. Several gear teeth were observed in the oil pan. Examination of the fuel injectors revealed no anomalies. Examination of the camshaft drive gear revealed the absence of 10 teeth and damage to one tooth.

*Figure 2: Engine with baffling and accessories removed*
