**SERVICE BULLETIN**

**SB97-6B****FAA APPROVED**Supersedes M87-11 REV. 2,  
SB97-6, 6A**SUBJECT:** MANDATORY REPLACEMENT PARTS**PURPOSE:** TO IDENTIFY ITEMS TO BE REPLACED DURING MAINTENANCE,  
PREVENTATIVE MAINTENANCE AND OVERHAUL**COMPLIANCE:** DURING MAINTENANCE, PREVENTATIVE MAINTENANCE AND  
OVERHAUL**MODELS AFFECTED:** ALL MODELS

**SB05-8****Technical Portions  
FAA Approved****SUBJECT: IMPROVED CAMSHAFT GEAR P/N 656818****PURPOSE:** To announce the production of an improved camshaft gear P/N 656818 which will supersede the current gear P/N 656031**COMPLIANCE:** At next engine overhaul or at camshaft gear replacement.**MODELS****AFFECTED:** IO-470-U,V; IO-520-Series; TSIO-520-Series; IO-550-Series; IOF-550-Series; TSIO-550-Series; TSIOL-550-Series**GENERAL**

**PURPOSE:** To eliminate the possibility of camshaft gear tooth fracture, resulting in power loss or in-flight shutdown, and to inspect and remove from service P/Ns 631845, 655430, 655516, or 656031 and replace with camshaft gear, P/N 656818. This Service Document initially announced the release of improved camshaft gear P/N 656818 in 2005. It now clarifies part number superseding action and amplifies camshaft gear re

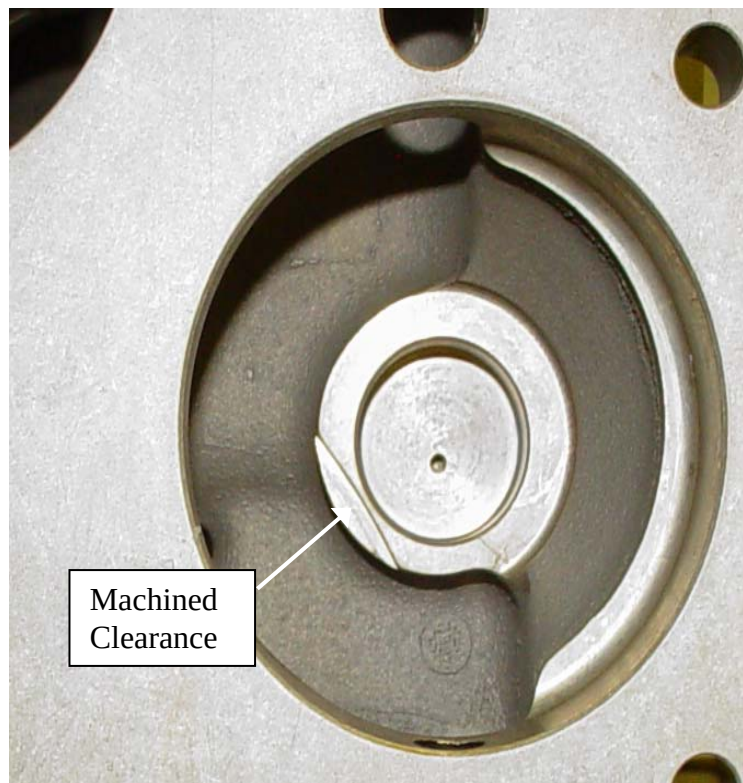
FIGURE 2  
MODIFIED PERMOLD CRANKCASE

The Permold style of crankcase must be modified to allow use of the new, thicker camshaft gear. A clearance cut is made in the starter drive bearing boss in accordance with the dimensions shown in Figure 3. TCM recommends that a properly certified repair station machine the required clearance.

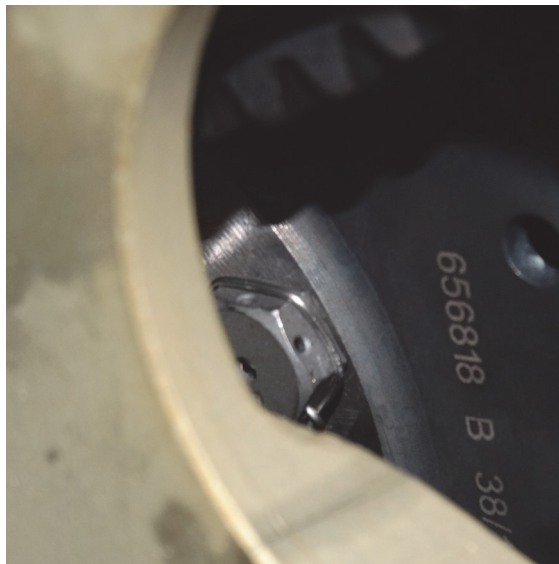
**Figure 2. Camshaft Gear Part Number Location, typical**  
*(P/N is visible through the starter adapter mounting pad opening)*

1. Disassemble the engine according to the instructions in the primary ICA.
2. During engine disassembly, inspect the camshaft gear to determine the part number.
  - a. Identify the camshaft gear part number. The camshaft gear part number is visible through the starter adapter mounting pad opening (reference Figure 2):
    - 1) Remove the starter adapter according to instructions in the primary ICA.
    - 2) Manually rotate the crankshaft until the camshaft gear part number becomes visible.
    - 3) Create a logbook entry identifying the camshaft gear part number.
  - b. If the camshaft gear is 631845, 655430, 655516, or 656031, discard the camshaft gear, regardless of condition, and reassemble the camshaft assembly with camshaft gear P/N 656818.

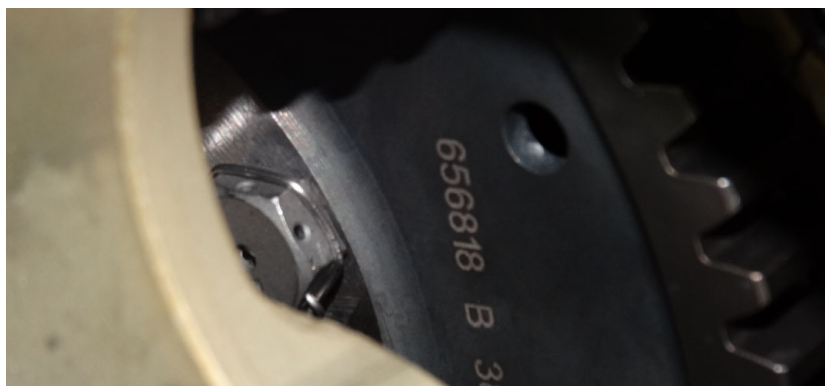
Figure 1. Camshaft Gear Part Number Location, typical  
(P/N is visible through the starter adapter mounting pad opening)

identified. The camshaft gear part number is visible through the starter adapter mounting pad opening (reference Figure 1).

3. If the camshaft gear part number cannot be determined, measure the gear face width at the circumference. Camshaft gear part number 656818 will measure 0.500". All previous part numbers, measure the gear face width as 0.440" at the circumference. The new camshaft gear face is 0.060" wider at the circumference.
4. If the camshaft gear part number is identified as P/N 656818, document compliance with CSB05-8C (list the latest revision) in the engine log book.

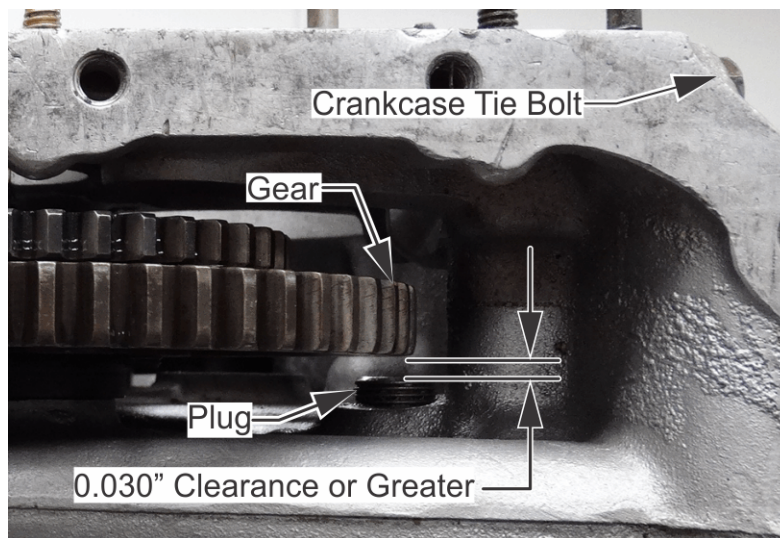
Figure 20. Lower Rear Oil Gallery (Control) Plug, Sandcast 1-3-5 Crankcase Half

*CAUTION: Camshaft gear (P/N 656818) is 0.060" wider at the circumference than the replaced camshaft gears (P/Ns 631845, 655430, 655516, or 656031). For engines with a Sandcast crankcase, the assembler must inspect and sustain a minimum clearance (0.030" or greater) between the camshaft gear (P/N 656818) and the oil gallery plug at the rear crankcase below the starter adapter (see step k. and Figure 20)).*

- k. Measure the clearance between the oil gallery plug and the camshaft gear using a feeler gauge (see Figure 20). Ensure the minimum clearance is 0.030" or greater. If the clearance is less than 0.030":

- 4) Install the oil gallery plug (according to the instructions in the primary ICA) to the maximum allowable torque specified in M-0, "Standard Practice Maintenance Manual, Appendix B" and verify required minimum clearance (0.030" or greater) is met.

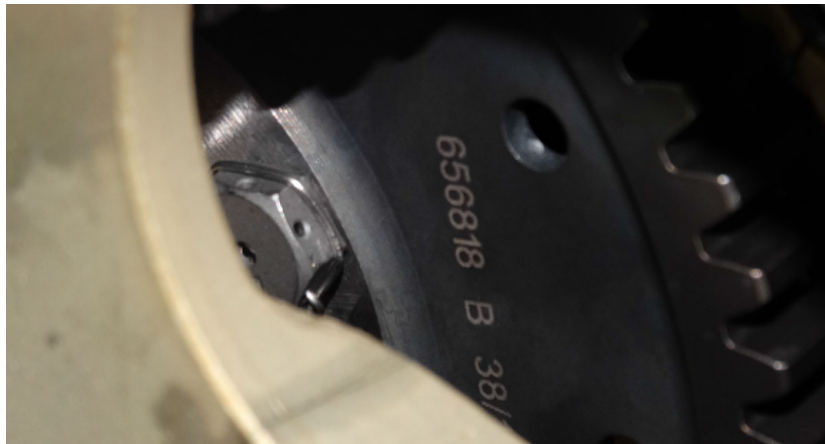
**Figure 1. Camshaft Gear Part Number Location, typical**  
(part number is visible through the starter adapter mounting pad opening)

1. Remove the starter adapter according to instructions in the primary ICA to gain visual access to identify the camshaft gear.
2. Determine the camshaft gear part number. Manually rotate the crankshaft until the camshaft gear part number becomes clearly visible and the part number can be identified. The camshaft gear part number is visible through the starter adapter mounting pad opening (reference Figure 1).
3. If the camshaft gear part number cannot be determined, measure the gear face width at the circumference. Camshaft gear part number 656818 will measure 0.500". All previous part numbers, measure the gear face width as 0.440" at the circumference. The new camshaft gear face is 0.060" wider at the circumference.
4. If the camshaft gear part number is identified as P/N 656818, record compliance with Service Document CSB05-8D in the engine log book.

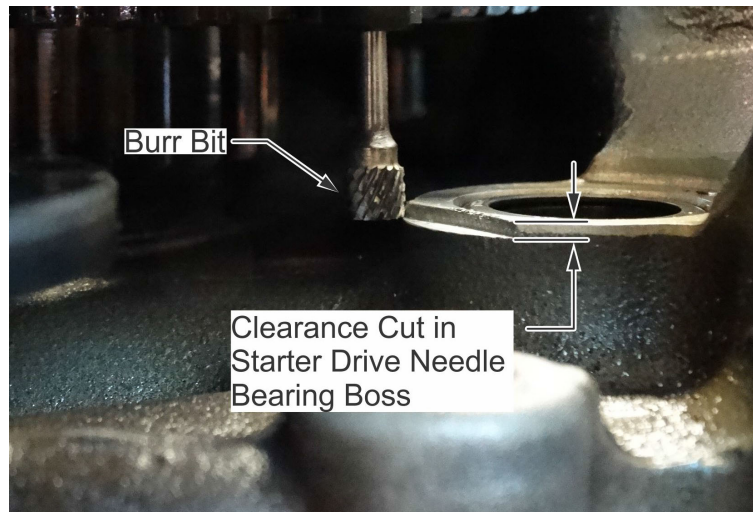
**Figure 14. Clearance Cut, Setup**

*CAUTION: Inspect and ensure there is a minimum 0.030" clearance between the camshaft gear and the starter drive needle bearing boss*

- i. Inspect the clearance cut surface and remove all nicks, burrs or sharp edges using a de-burring tool and Scotch-Brite® ultra fine scuff pad.
- j. Vacuum and thoroughly clean all debris or metal shavings from the crankcase gear work area.
- k. Remove cap plug and verify needle bearing has no debris, damage, or contamination.
- l. Transfer the markings from the old camshaft gear to the new camshaft gear to aid in the camshaft gear bolt hole alignment.
- m. Carefully insert camshaft gear P/N 656818 and seat into position over the camshaft.
- n. Ensure camshaft and crankshaft gear timing marks are correctly aligned.

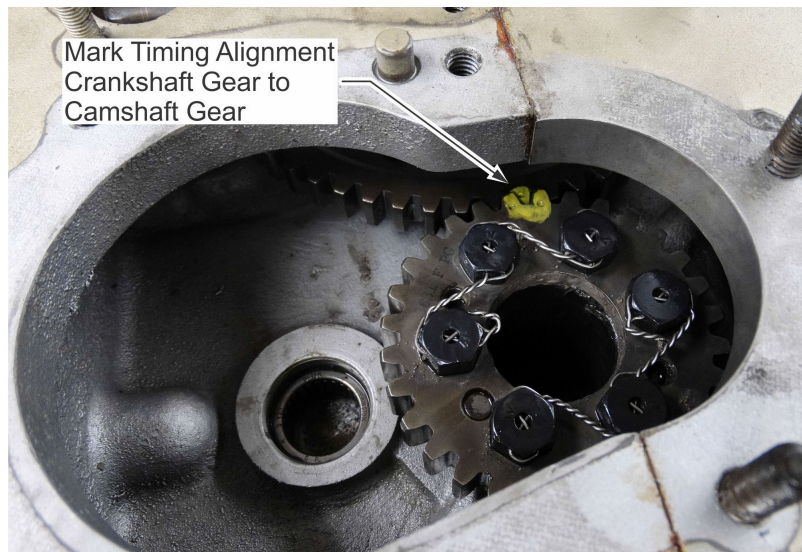
**Figure 15. Camshaft Gear Timing Alignment Marked, Sandcast Crankcase**

*CAUTION: Camshaft gear (P/N 656818) is 0.060" wider at the circumference than the replaced camshaft gears (P/Ns 631845, 655430, 655516, or 656031). For engines with a Sandcast crankcase, the assembler must inspect and sustain a minimum clearance (0.030" or greater) between the camshaft gear (P/N 656818) and the oil gallery plug at the rear crankcase below the starter adapter (see step k. and Figure 20)).*

1. Replace camshaft gears 631845, 655430, 655516, or 656031, and reassemble the camshaft assembly with camshaft gear P/N 656818 according to the following procedure (typical for cluster gear configuration):
  - a. Rotate the crankshaft until the timing marks on the crankshaft gear and camshaft gear align.
  - b. With the crankshaft gear and camshaft gear (and cluster gear where applicable) in the timed position, mark the crankshaft gear and camshaft gear alignment (see Figure 15) and mark the bolt closest to the starter adapter mount opening to ensure correct alignment of the replacement camshaft gear.
