# AIRFRAME AND ENGINE EXAMINATION REPORT

**NTSB ACCIDENT NUMBER: ERA20FA020**

AIRCRAFT REGISTRATION: N959MJ

ACCIDENT LOCATION: Colonia, New Jersey

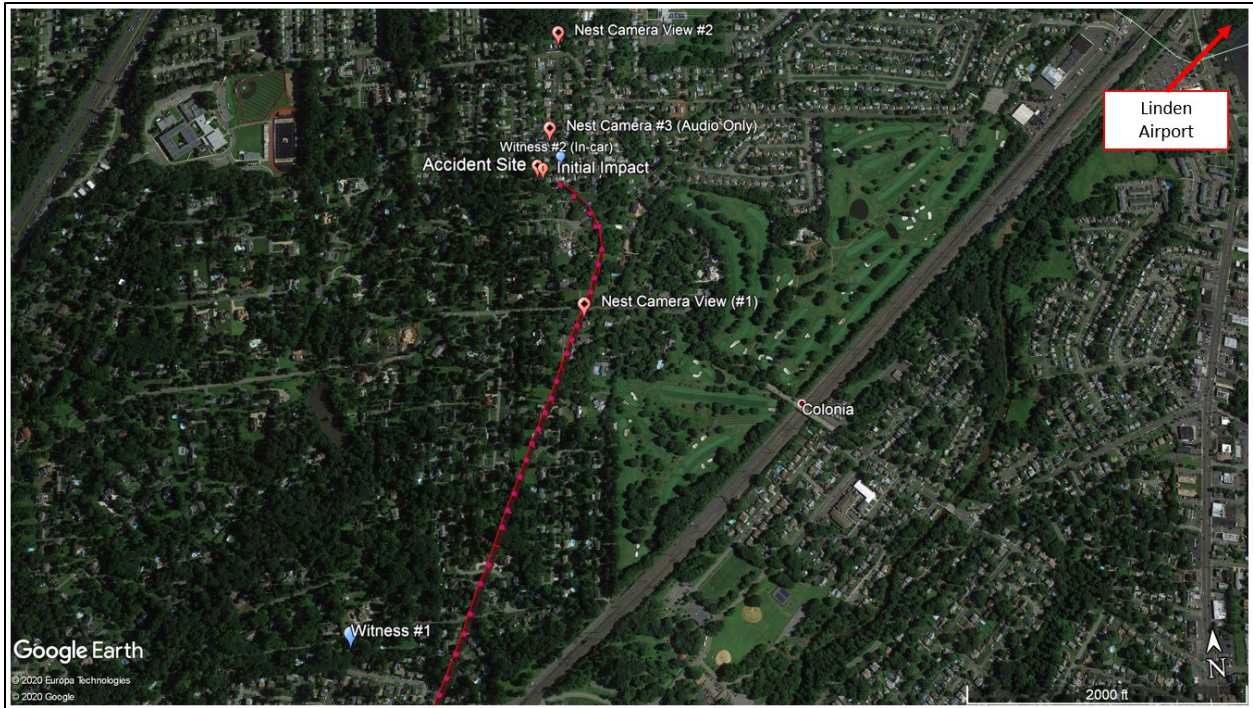
Figure 1: Overview of the flight track, witness locations, and nest cameras.

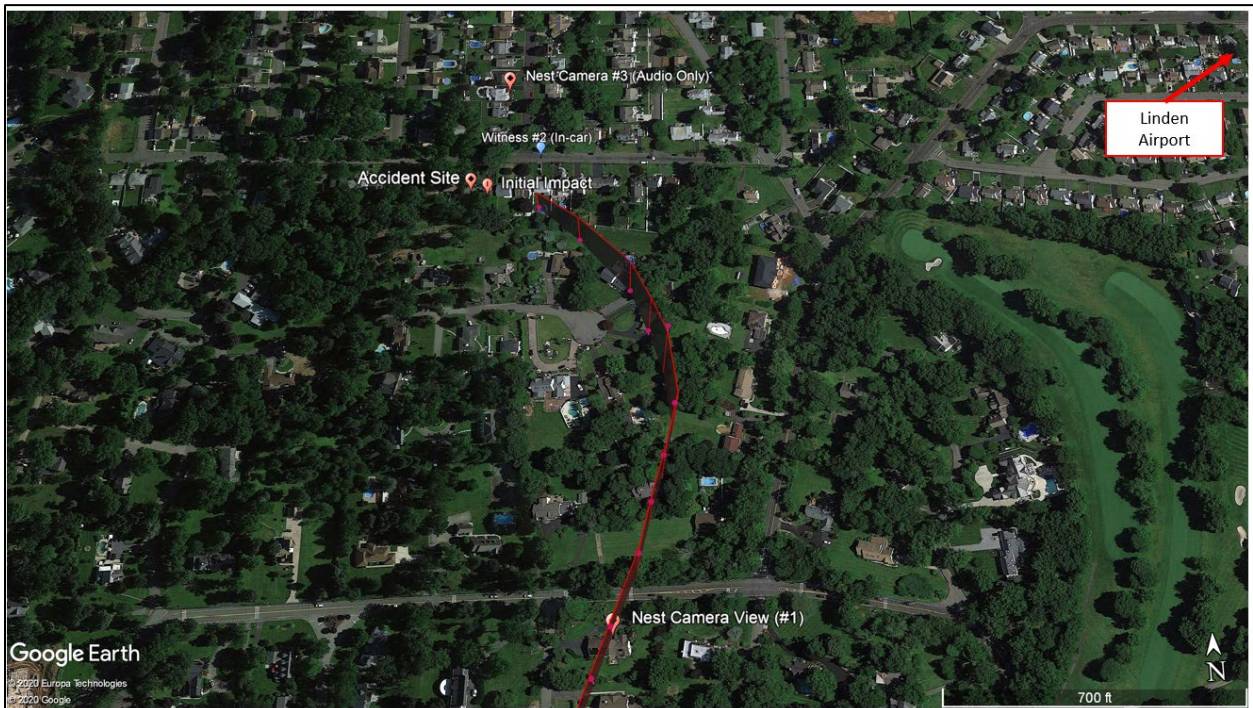
The initial impact point was observed to coincide with large broken tree branches about 40 ft from the main wreckage; the wreckage path was oriented on a true heading of 278°. Multiple trees branches located below and near the initial impact exhibited clean cut surface areas.

Figure 2: Closer view of the flight track, initial impact, and accident site.
