# Continental Motors

## ENGINE RUN REPORT

| ENGINE MODEL | TSIO-550-C (1B) |

| EXAMINATION | | ACCIDENT DATA | |
|---|---|---|---|
| DATE | 3-12-2020 | NTSB ACCIDENT # | ERA20LA011 |

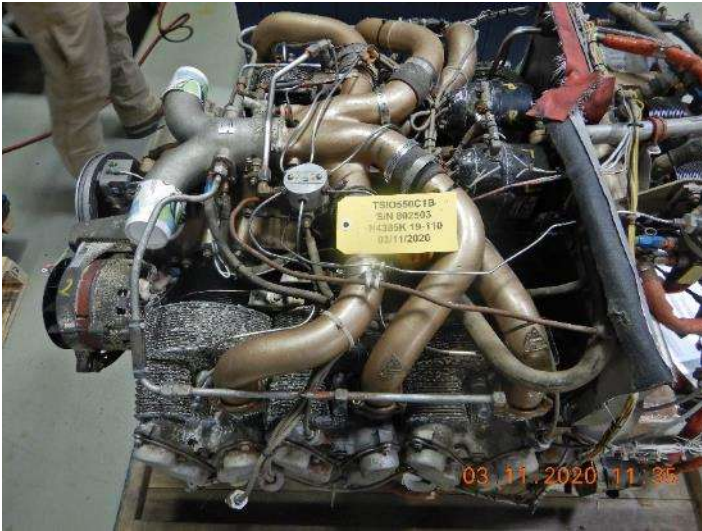
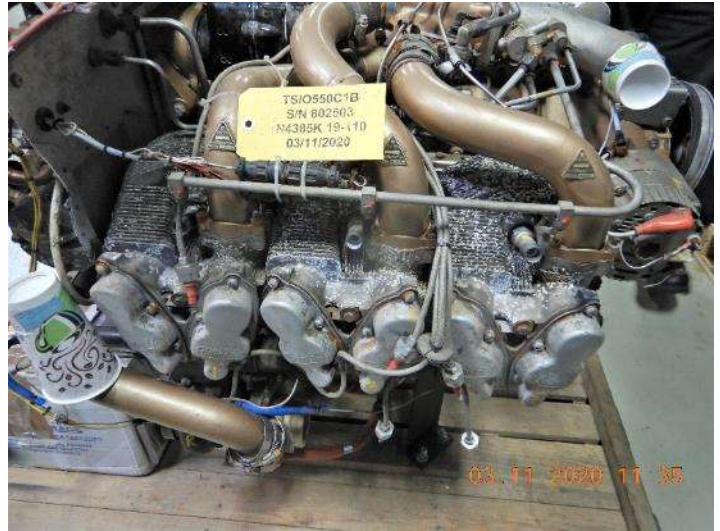
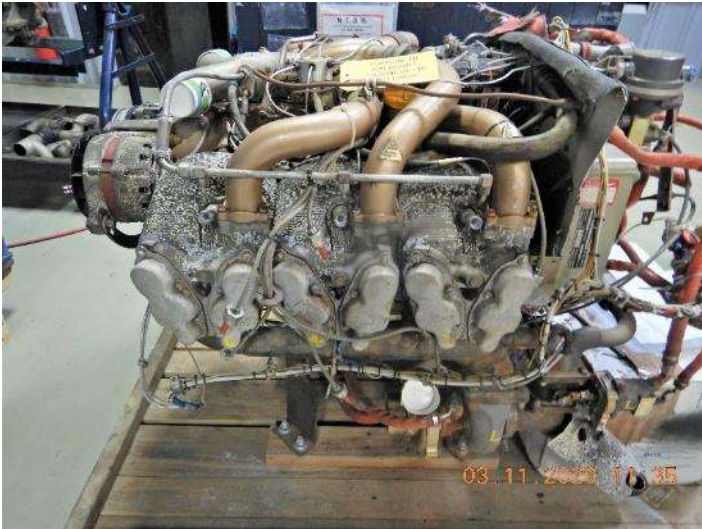
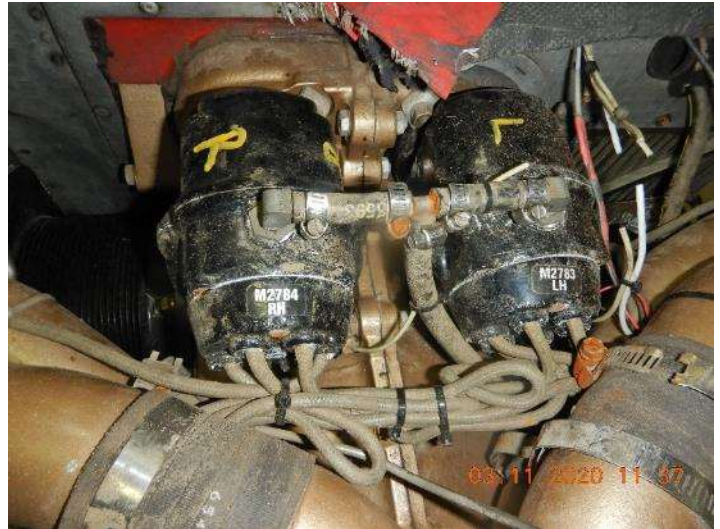
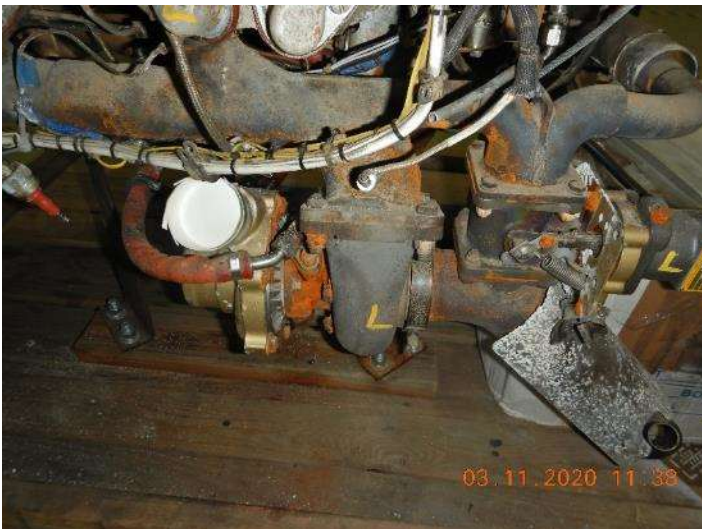
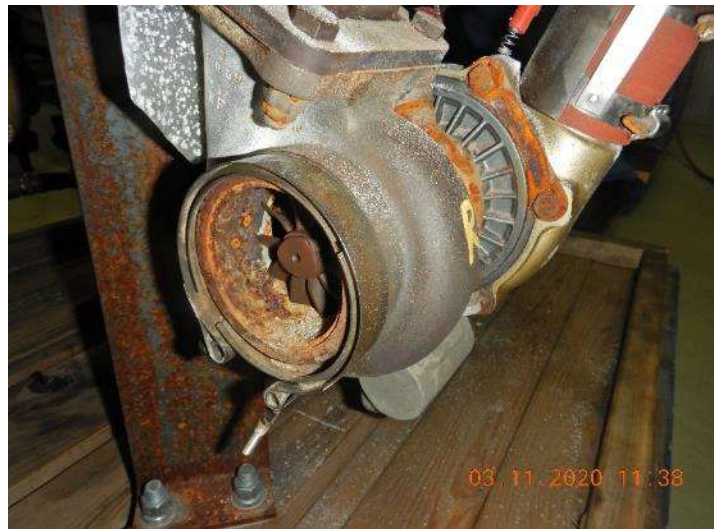
The engine was removed from the shipping crate in the presence of the NTSB Investigator and a visual inspection indicated that the engine exhibited surface corrosion on all cylinder cooling fins, both alternators and the left and right turbo chargers. A cardboard box was shipped with the engine which contained induction tubes, over boost valve, muffler and inner coolers.

This engine had been submerged in the Susquehanna River near Harrisburg, PA for 13 days before being recovered. The recovery crew drained the crankcase of oil and water and filled all cylinders and crankcase with diesel fuel to preserve the engine. No impact damage was noted.

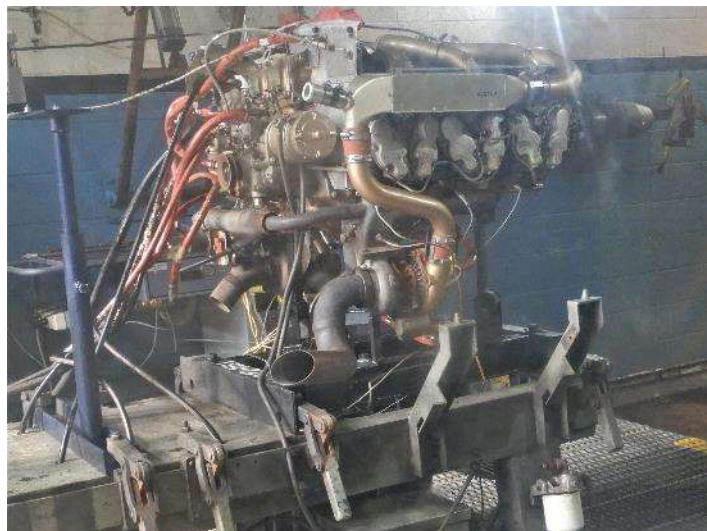
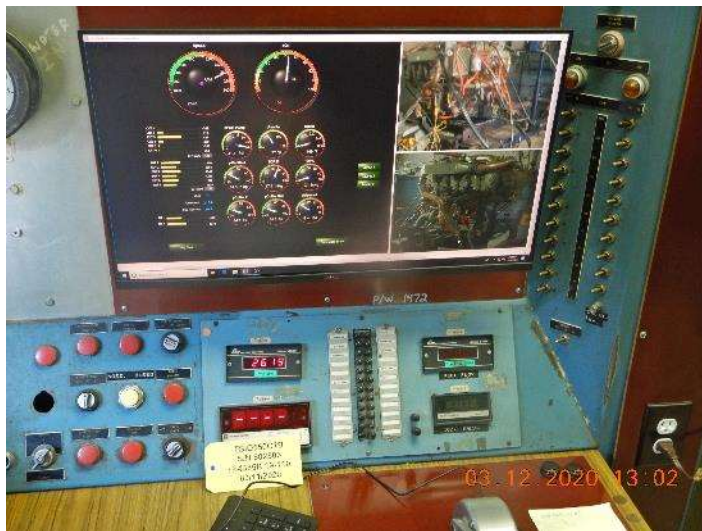
A cylinder leakage test was performed after the test run in accordance with the latest revision of CMI Service Bulletin SB03-3 with the engine hot with the following results (master orifice reading – 43 PSI):

Cylinder #1 - 74/80 PSI (rings)
