**ERA20LA039**

**West Liberty, Kentucky**

**Rans S7 – N831RS**

**NTSB ENGINE EXAMINATION REPORT**

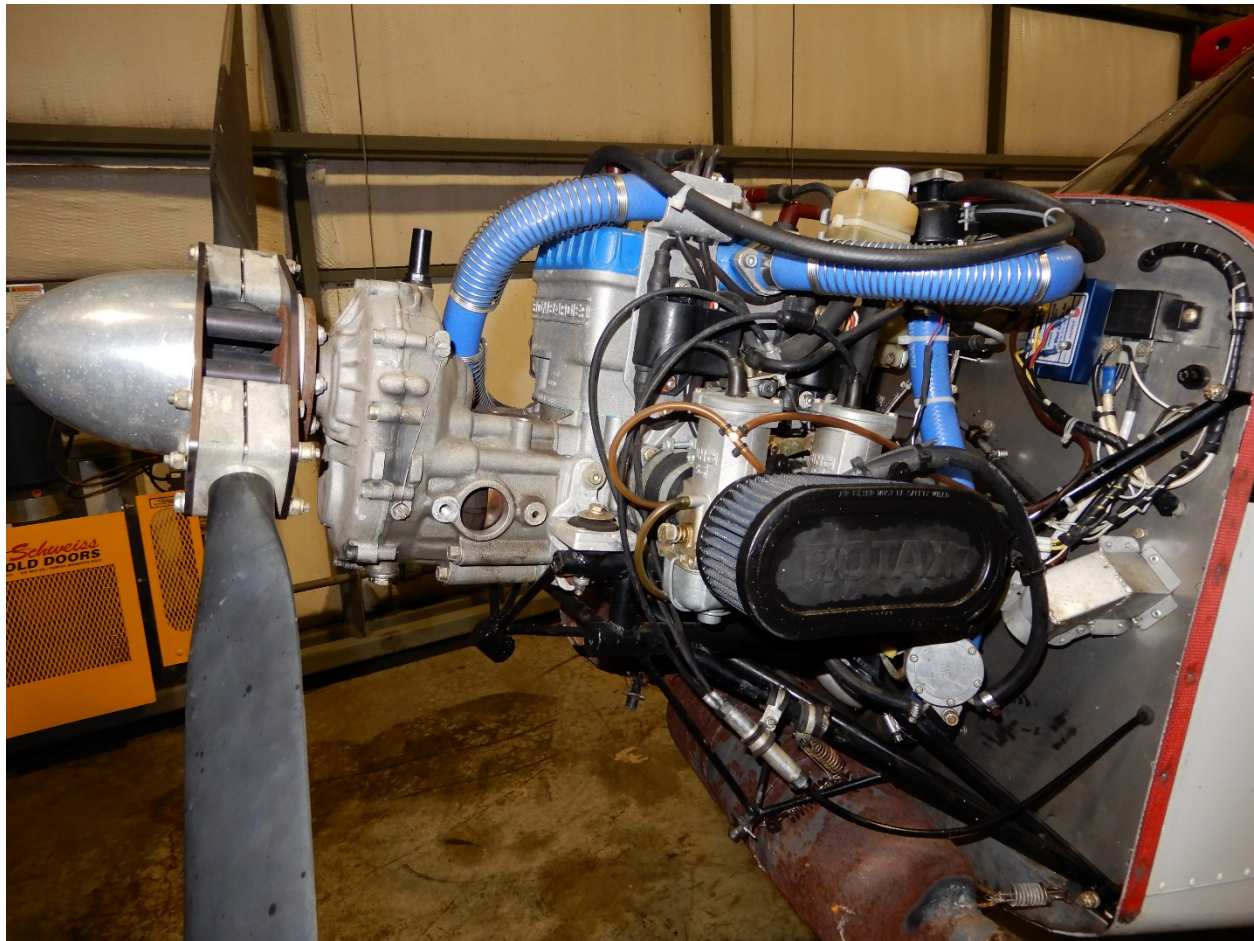
The engine remained mounted to the airplane and the following was noted:

- The engine remained attached to the airframe through all engine mounts.
- The crankcase remained intact.
- The cylinders remained attached to the crankcase.
- There was no oil in the oil injection tank.
- The propeller remained attached to the engine and the blades were not damaged.
- The propeller could be rotated through 360° of motion by hand.
