## **Engine Investigation Report**

**Rolls-Royce Corporation  
Model 250-C20B  
Engine CAE-836941**

**US Dept. of Agriculture – OH-6A  
Weston, Georgia**

**Accident date: 8 January 2020  
Wreckage exam date: 16 January 2020  
Engine exam date: 4-5 January 2020  
Report date: 13 March 2020  
NTSB Case: ERA20LA071**

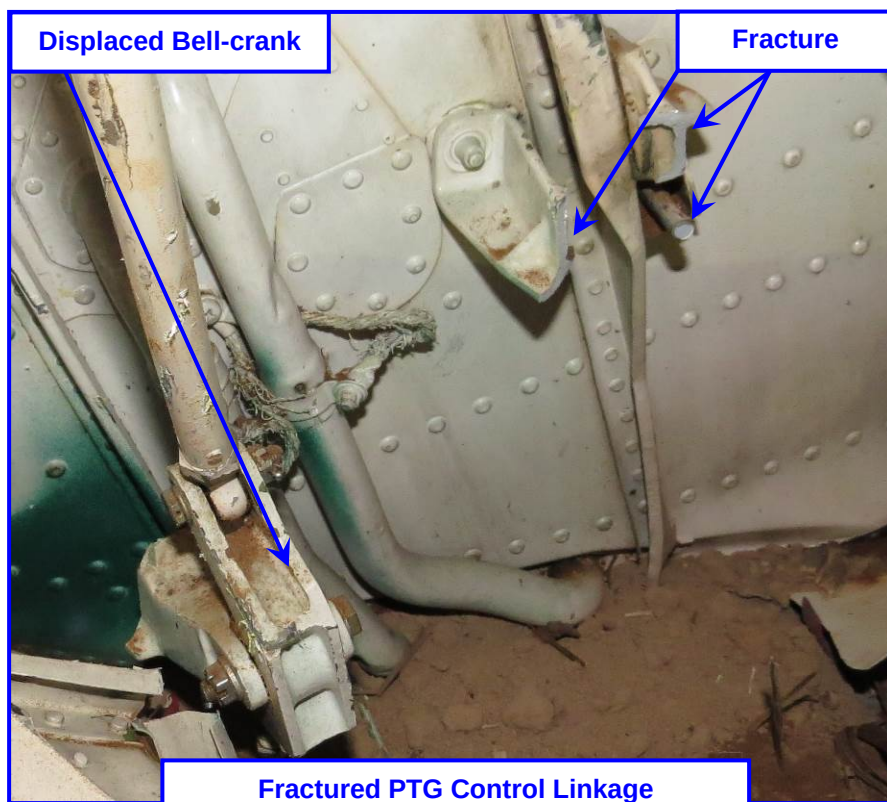
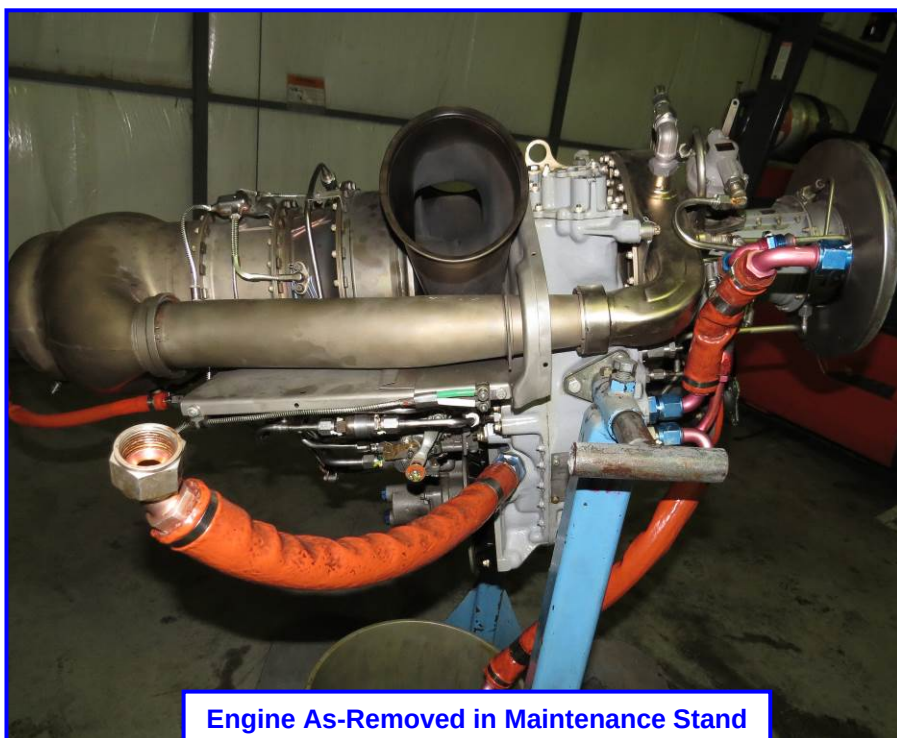
Both N1 and N2 rotors could be rotated freely by hand and were smooth and quiet. Continuity from the power turbine 4<sup>th</sup>-stage wheel to the power output shaft forward of the freewheeling unit was established. Continuity was also confirmed throughout the N1 rotor system from the impeller to the starter-generator cooling fan.
