# N230BW Accident Report

On 12/24/2019 an F1 Rocket with a MK I empennage, manned by a crew of 2, sustained a structural failure to the horizontal stabilizer while maneuvering. The failure resulted in the majority of the starboard stabilizer departing the aircraft. The starboard elevator remained attached to heavily damaged rear spar and to the port elevator through the hinge points and the control horns. The starboard HS that departed the aircraft has not been recovered.

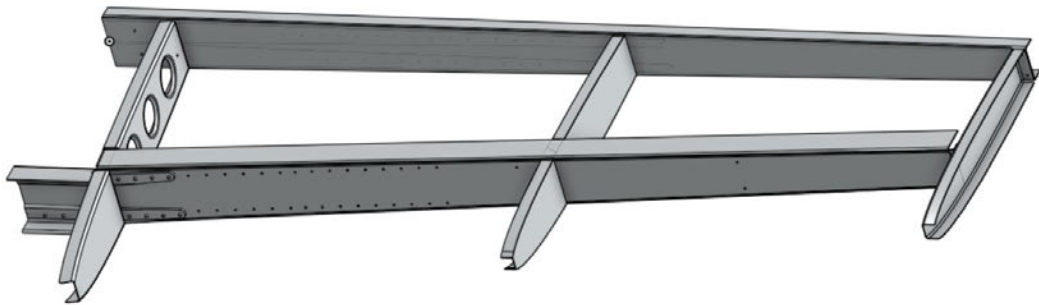
Figure 7

The MK I horizontal stabilizer is structurally indistinguishable from the Van's Aircraft stabilizer on the RV-7. The MK I has three main ribs which connect the front and rear spars (Figures 7 & 8).

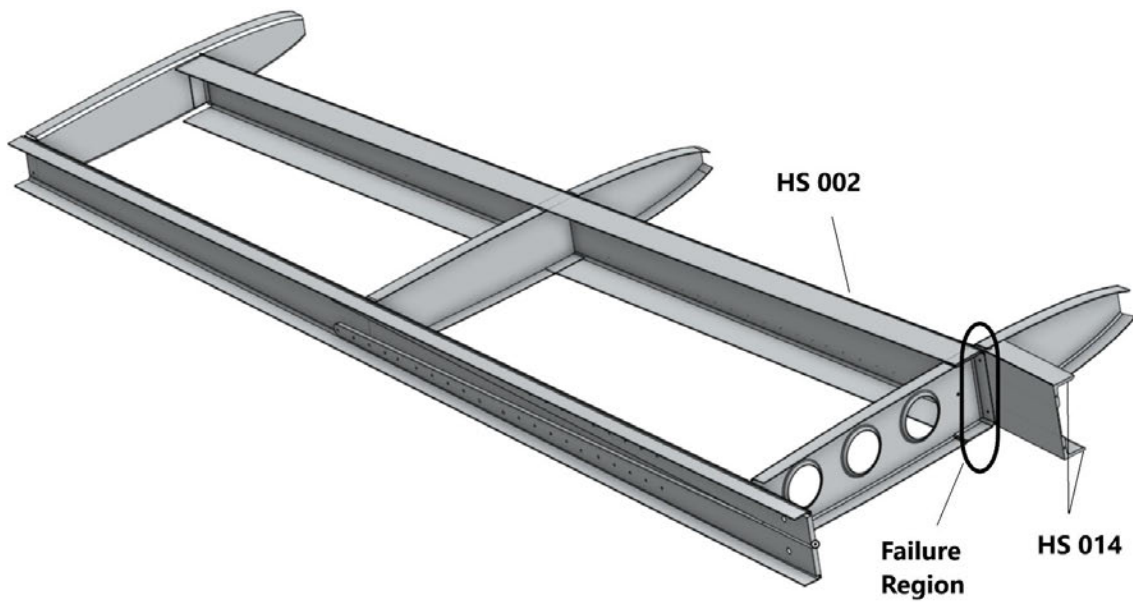
Figure 8

The failure region on the accident aircraft is at the bend in the HS 002 where the root rib, HS 002 and the HS 014s intersect.

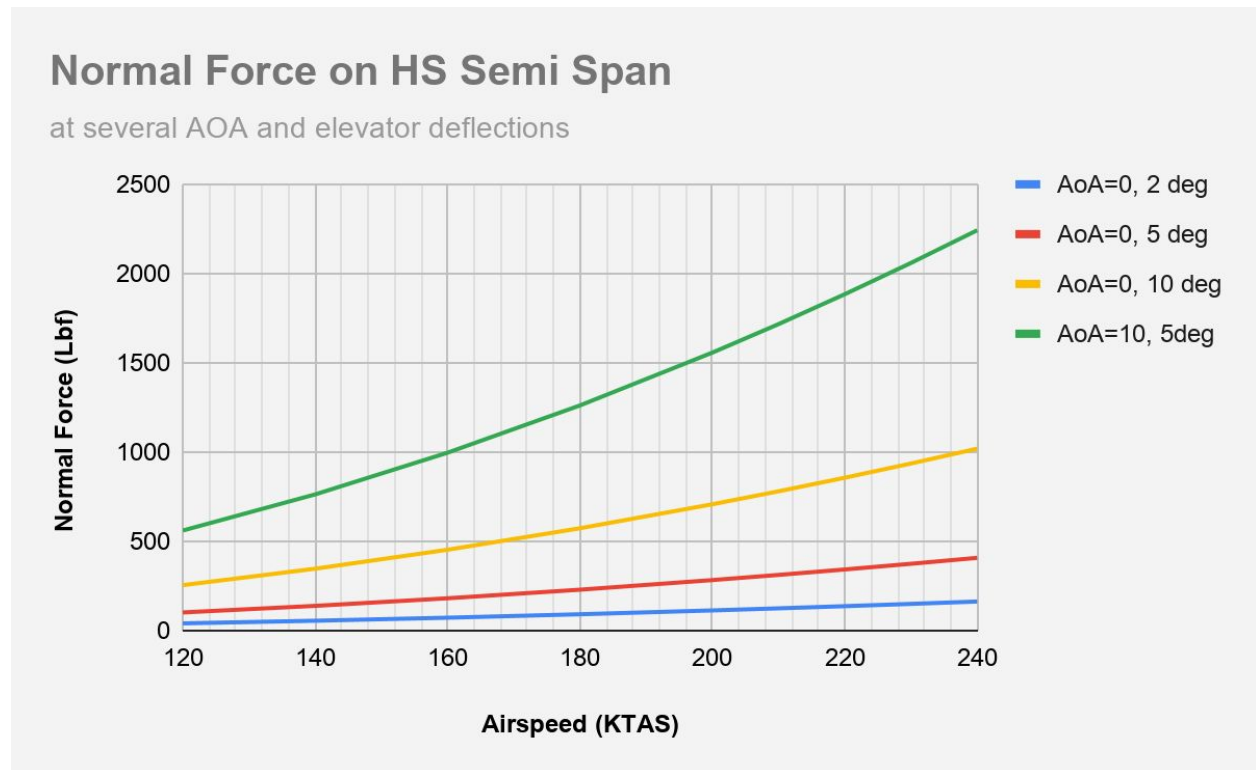
Figure 10

The MK I is a symmetric NACA 0009 airfoil, and experimental data from NACA Report 759 “Pressure Distribution Investigation of a N.A.C.A 0009 Airfoil with a 30 Percent Chord Plain Flap and Three Tabs” was used to generate the Normal Force and Moment Curves for a number of possible angle of attacks and elevator deflections. The results of the analysis are summarized in Figures 10 and 11.

The MK I stabilizer is capable of generating considerable force and pitching moment, as can be seen from Figures 10 and 11. The increased stabilizer area from the original RV-4 stabilizer on the HR II design allows for better performance at low speeds but is problematic at higher speeds. Since both the tail arm on the F1 and the stabilizer area are both significantly greater than on the RV-4, the MK I design if flown aggressively at speed will generate high stress levels not only in the empennage but also in the rear fuselage.
