## ENGINE EXAMINATION REPORT

| ENGINE MODEL | IO-520-BA |
| AIRCRAFT MAKE & MODEL | Beechcraft F33A |
| FILE NUMBER | 19-199 |

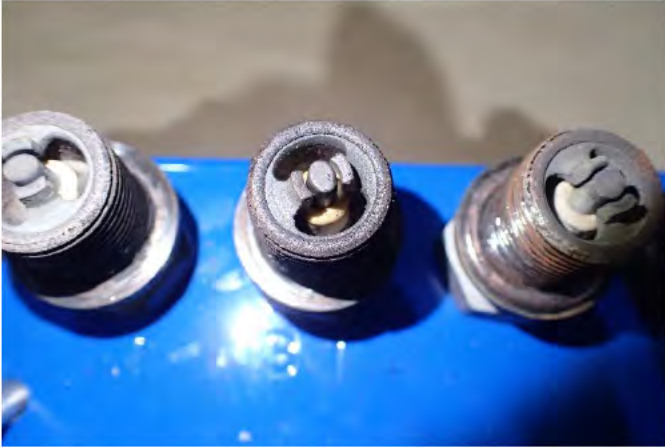
#3 Top Spark Plug

The spark plugs remained installed in their cylinders and displayed varying amounts of thermal damage signatures. The top spark plugs were removed for examination and the bottom spark plug electrodes were examined using a lighted borescope. Several of the bottom spark plug electrodes were partially submerged in oil which was consistent with post-accident accumulation. The observed electrodes displayed normal operating and wear signatures, several of the spark plugs were in a normal worn-out condition when compared with Champion Aviation Service Manual AV6-R

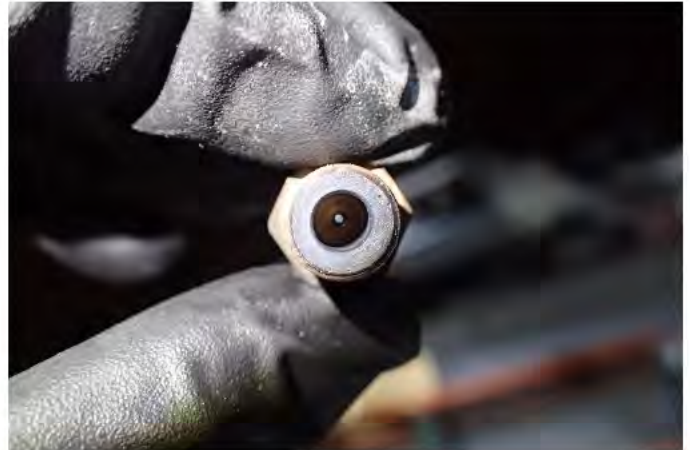
#3 Nozzle

The fuel pump remained attached to its installation point and displayed thermal damage signatures. The throttle and metering assembly displayed significant thermal damage and remained attached to its installation point. The fuel manifold valve displayed minor thermal discoloration and remained secured to its installation point. The fuel nozzles remained secured in their cylinders and were undamaged.

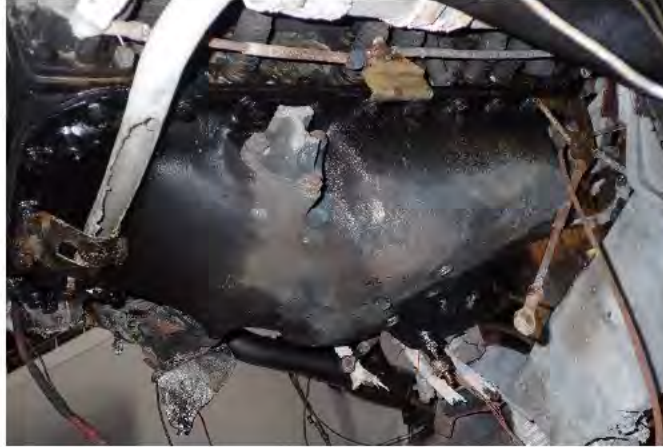
The oil sump remained attached to its installation point and displayed minor thermal discoloration.

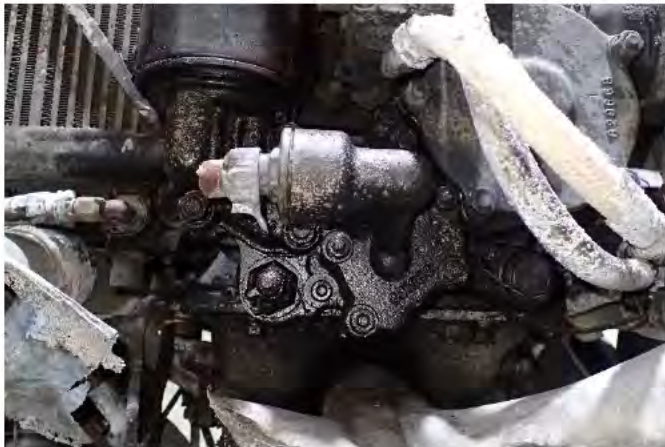
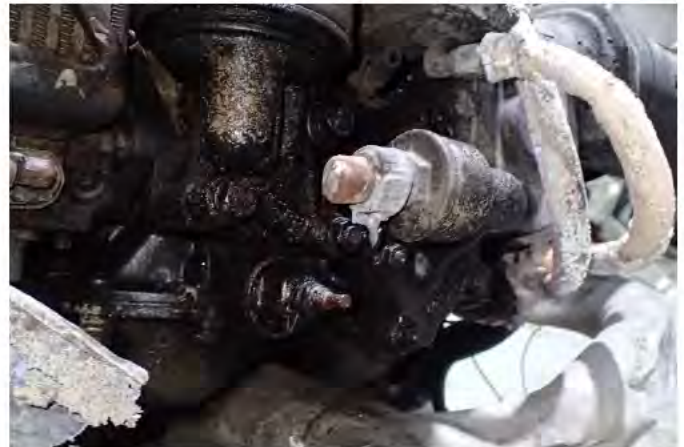
The oil pump remained attached to its installation point and displayed thermal damage signatures. There were no signs of lubrication distress to any observed components.

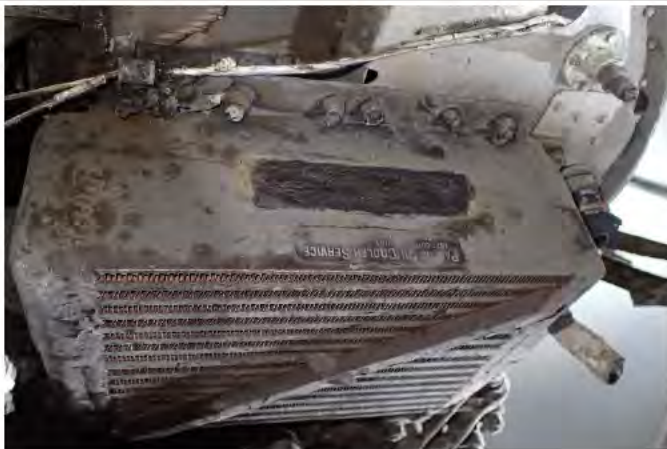
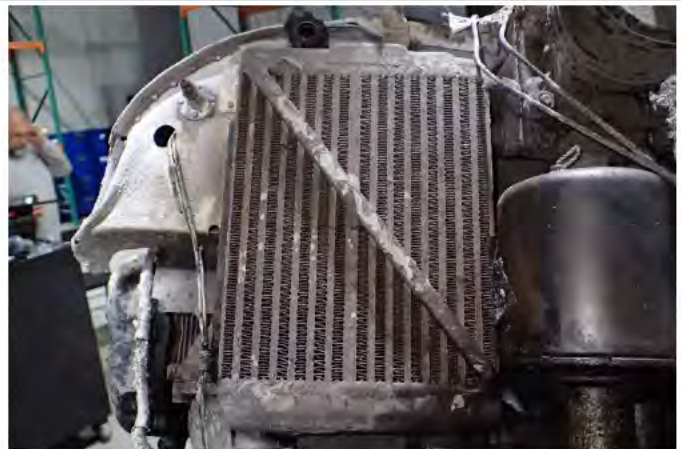
The oil cooler remained attached to its installation point and displayed thermal damage signatures. There were no anomalies observed.

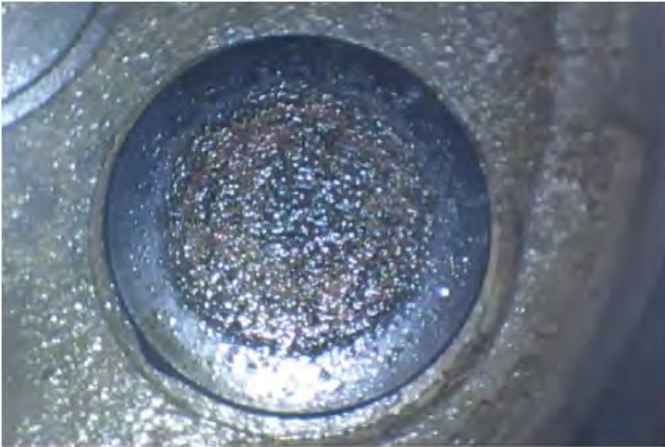
#1 Exhaust Valve

The valve heads were inspected using a lighted borescope. The valve heads displayed normal operating and combustion signatures. During crankshaft rotation, all of the valves operated normally.

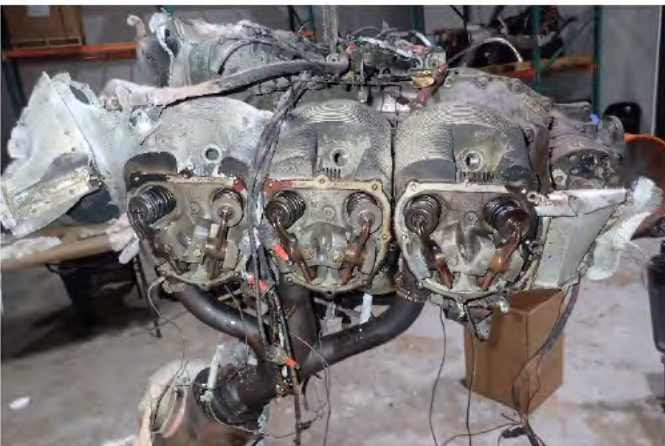
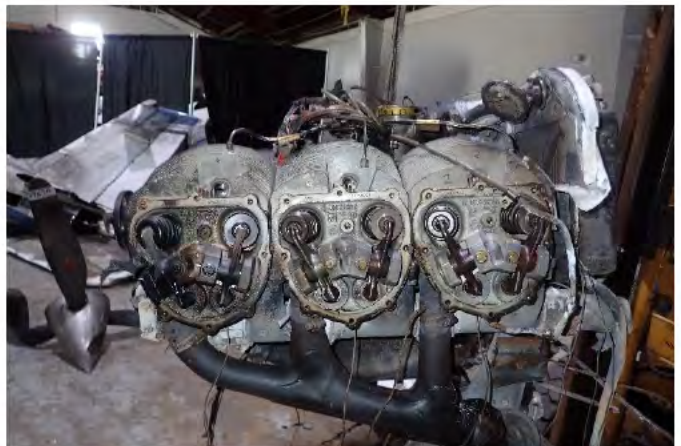
## ROCKER ARMS AND SHAFTS

The rocker arms displayed normal operating and lubrication signatures. During crankshaft rotation, the rocker arms operated normally.

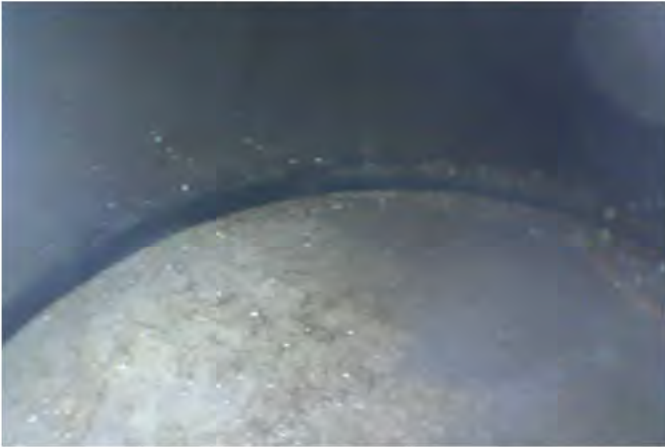
#1 Piston

The piston faces were inspected using a lighted borescope. The piston faces displayed normal operating and combustion signatures. During crankshaft rotation, it was observed that all of the pistons operated normally.

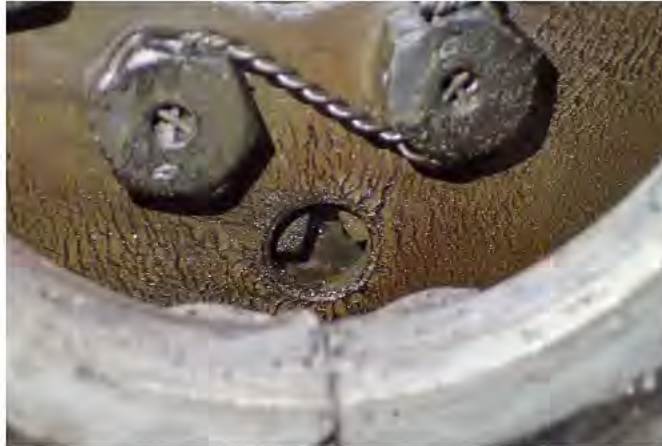
The crankshaft to camshaft timing was verified by lining up the crankshaft gear and camshaft gear timing marks.

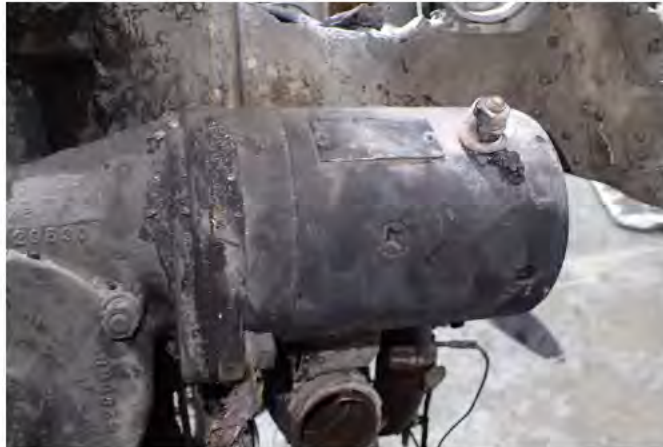
The starter remained attached to the starter adapter and displayed thermal damage signatures.

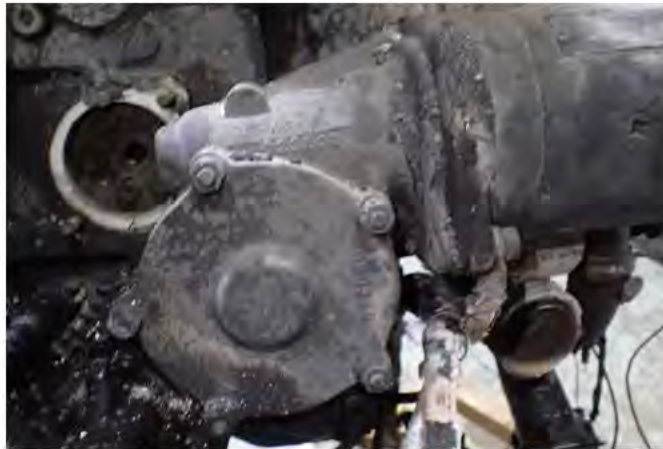
STARTER  
ADAPTER

The starter adapter remained attached to the engine and displayed thermal damage signatures. There were no anomalies observed.

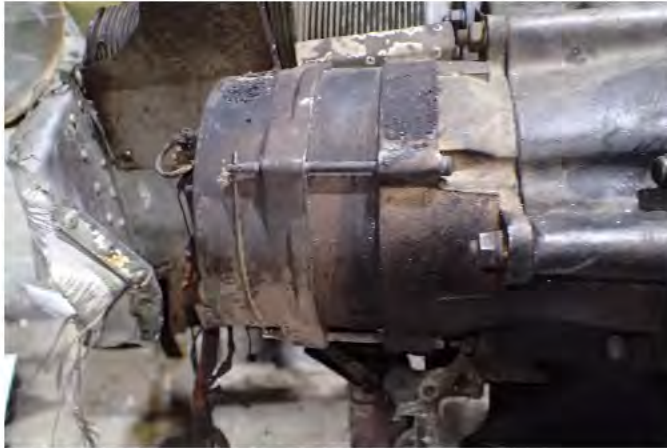
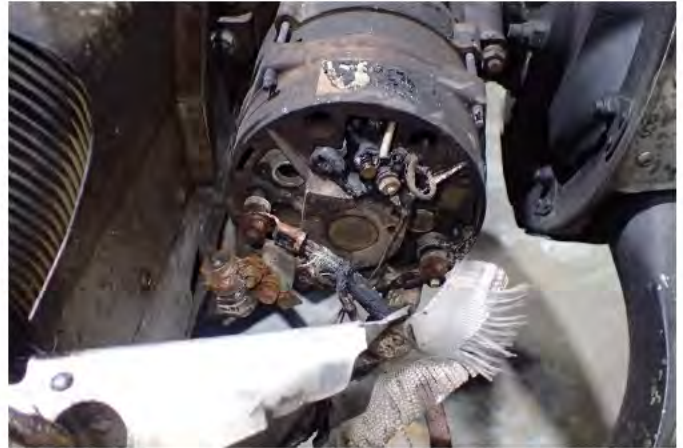
The alternator remained attached to its installation point and displayed thermal damage signatures. There were no anomalies observed.

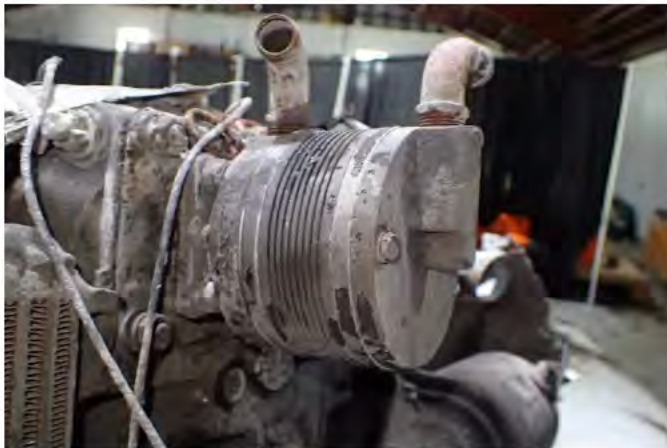
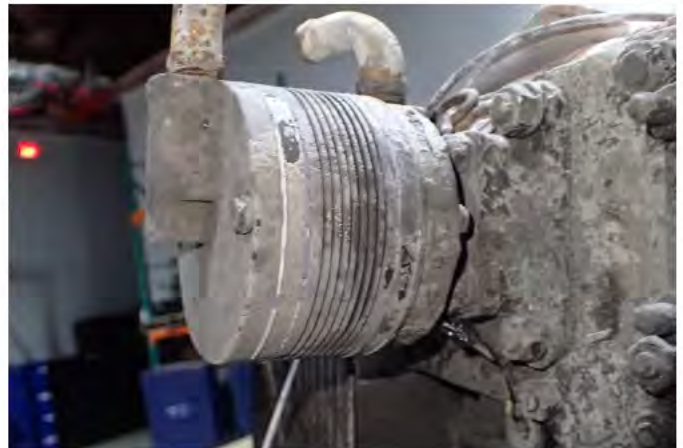
VACUUM  
PUMP

The vacuum pump remained attached to its installation point and displayed thermal damage signatures.

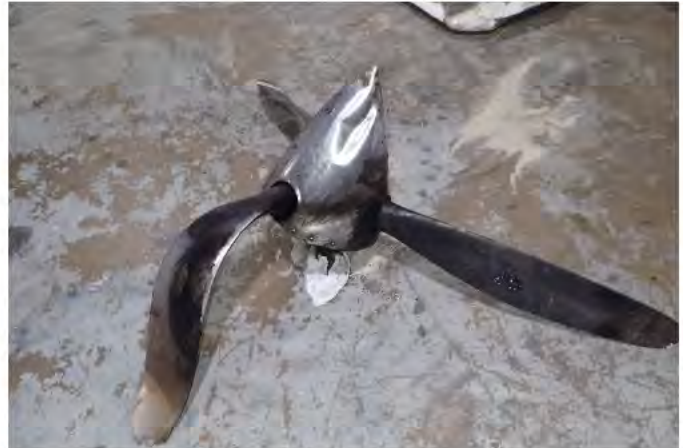
Propeller after removal

The three-blade, constant speed propeller remained attached to the crankshaft and all three propeller blades remained within the hub. The blades displayed varying amounts of impact and thermal damage signatures. The propeller blade marked "A" displayed significant thermal damage to the blade tip, minor S-bending deformation, and significant aft bending deformation. The propeller blade marked "B" displayed minor S-bending deformation. The propeller blade marked "C" displayed thermal damage signatures and minor aft bending deformation.
