**National Transportation Safety Board**  
Office of Research and Engineering  
Washington, D.C. 20594

## Airplane Performance Study

**Location:** Eatonton, Georgia  
**Date:** June 5, 2020  
**Time:** 1920 GMT (1520 EDT)  
**Airplane:** Piper PA-31T, N135VE  
**NTSB Number:** ERA20LA206

**ERA20LA206, N135VE, Piper PA-31T Cheyenne, June 5, 2020**

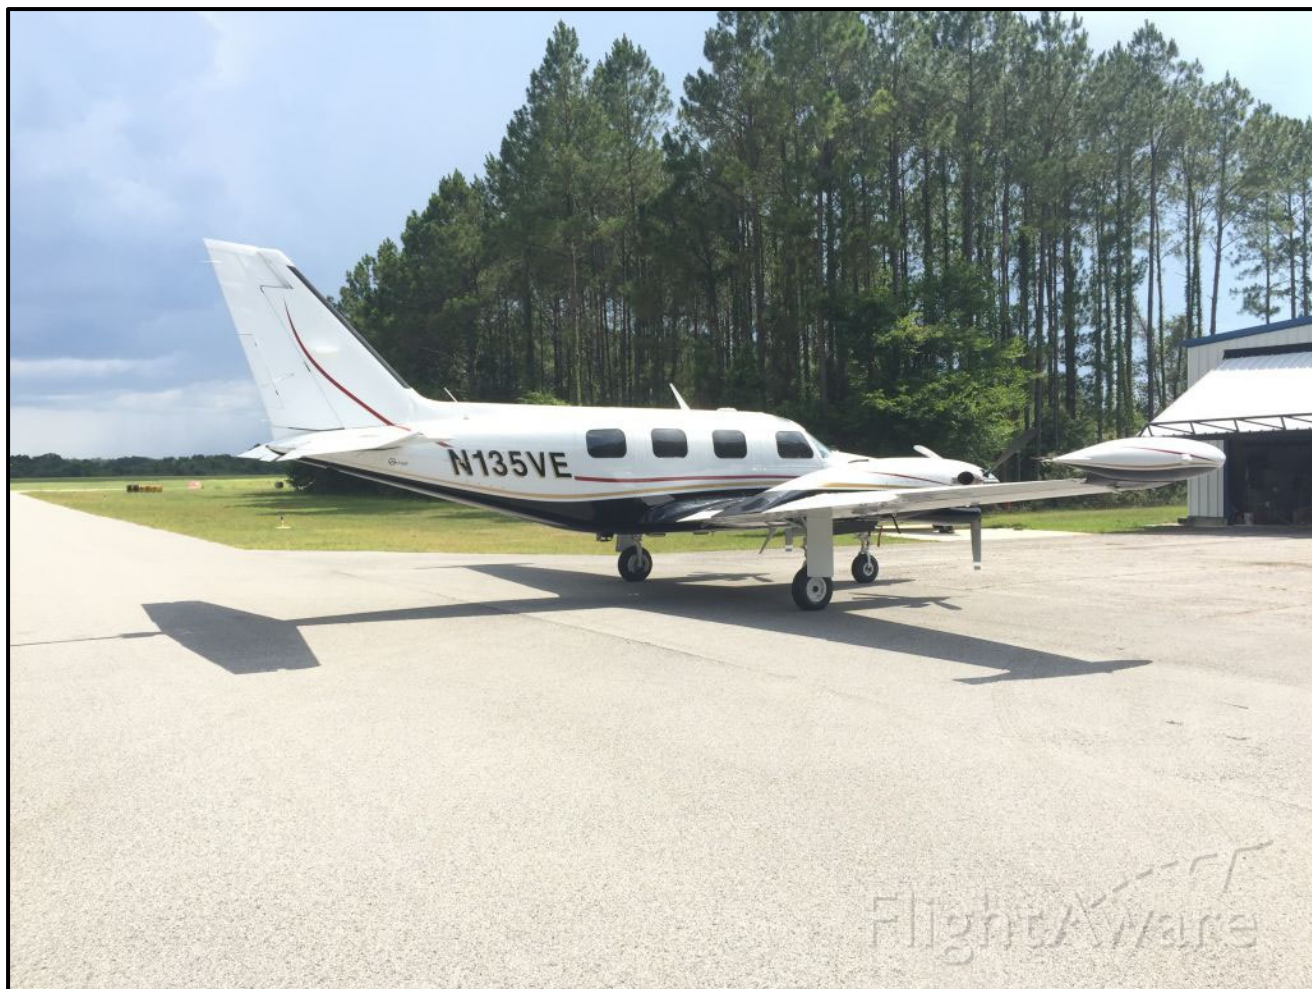
**Figure 2: Accident Airplane, N135VE, a Piper PA-31T Cheyenne**

A picture of the accident airplane, N135VE, a Piper PA-31T Cheyenne, is shown in Figure 2. The airplane was manufactured by Piper in 1975 and registered to the accident pilot.
