**NATIONAL TRANSPORTATION SAFETY BOARD**  
Office of Aviation Safety

**AIRWORTHINESS GROUP CHAIRMAN'S FACTUAL REPORT**

**ERA20LA237**

Operator: Private  
Location: Titusville, Florida  
Date: July 3, 2020  
Time: 1157 Eastern Daylight Time (EDT)  
Aircraft: Piper PA-46-600TP (M600), SN 4698109  
Registration: N89MA

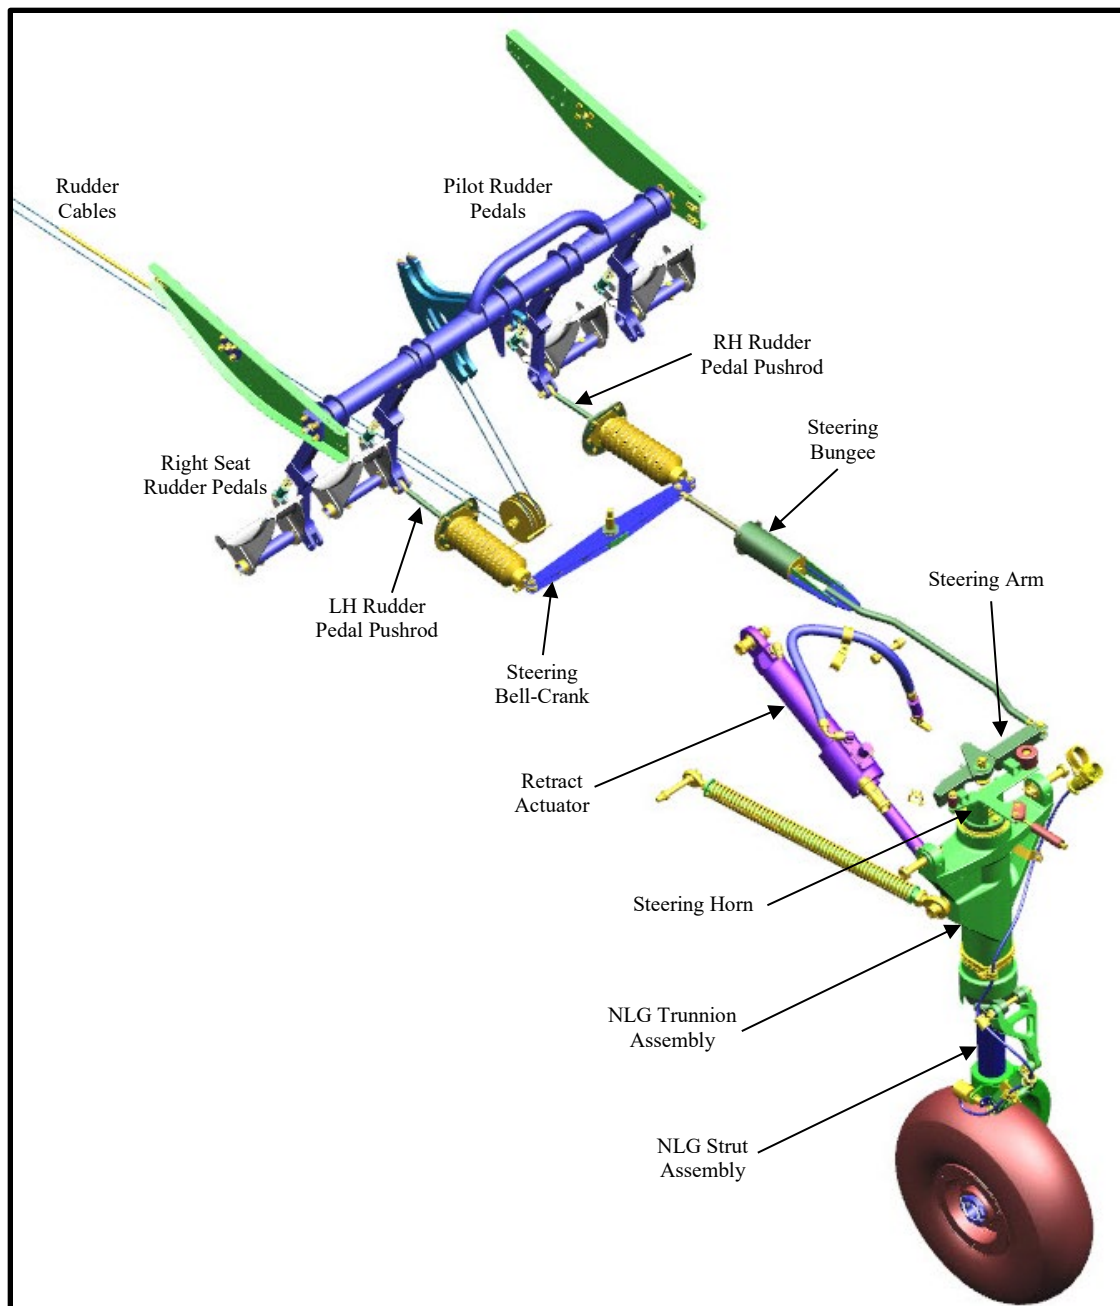
The retractable nose landing gear (NLG) is attached to the engine mount at the upper end of the trunnion assembly by two trunnion bolts. The NLG strut assembly is installed inside the trunnion assembly where it can rotate for nose wheel steering. The retract actuator is attached to the NLG trunnion assembly and engine mount to allow the NLG to retract aft into the wheel well. A down spring is also attached to the trunnion assembly and engine mount to assist with NLG extension if there is a hydraulic failure. During retraction, the NLG strut and tire rotate 90° left through a mechanism that stows the NLG tire in a horizontal position. The NLG is steerable through a 50° arc by use of the rudder pedals, 20° left and 30° right, Figure 2. The pilot and right seat rudder pedals are hung from a torque tube assembly below the instrument panel that connects both right rudder pedals to each other and both left rudder pedals to each other. The rudder is connected by cables to sectors on the rudder pedal torque tubes. The rudder cables run aft through the fuselage to the rudder sector. The pilot right rudder pedal and the right seat left rudder pedal are connected to the steering bell-crank through pushrods that translate the linear motion of the pedals to a rotational motion of the bell-crank. The steering bell crank is attached to a fitting in the aft end of the NLG wheel well. Bellows assemblies are installed around the pushrods where they pass through the pressure bulkhead. The primary rudder mechanical stops are located adjacent to the rudder sector in the empennage to limit the deflection of the rudder and thus the motion of the rudder pedals. Secondary rudder pedal mechanical stops are installed in a machined aluminum fitting aft of the steering bell-crank. The secondary stops allow for a small amount of additional motion of the rudder pedals as the rudder cables stretch before the stops engage the steering bell-crank. The steering bungee is connected to the left side of the steering bell-crank at the aft end and to the left side of the steering arm at the forward end to translate the rotational motion of the bell-crank to a rotational motion of the steering arm. A spring is installed in the bungee to dampen any vibrations from the NLG. The steering arm is attached to a mount plate on the engine mount with a bolt and can be adjusted forward and aft for proper rigging through a locking assembly. The NLG steering horn is attached to the top of the NLG strut with 3 bolts. With the gear in the extended position the right and left forward faces of the steering arm engage the right and left pads and rollers on the steering horn to transmit the rotational motion of the steering arm to a rotational motion of the NLG strut. When the NLG retracts, the strut rotates about the trunnions and the steering horn disengages from the steering arm preventing rudder pedal motion from being translated to NLG steering.

Figure 2-M600 Steering system illustration.

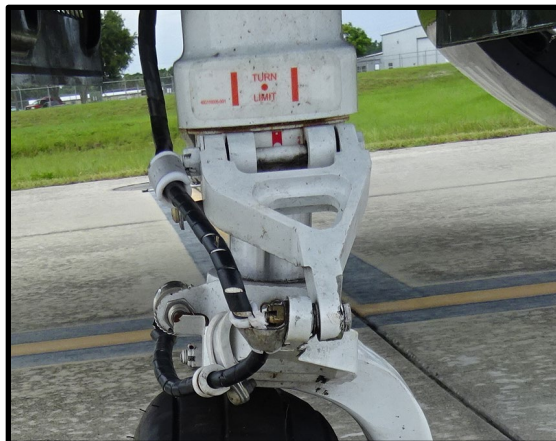
The airplane can be maneuvered on the ground by power equipment using a tow bar attached to the NLG axle. Piper has established turn limits for towing and a placard is installed on the lower end of the NLG trunnion assembly. A corresponding red line on the NLG strut allows the operator to see the relationship between the turn angle of the NLG strut and wheel and the towing limits, Figure 3. The placard towing limits allow for turning about 20° right and left.

Figure 3-M600 NLG turn limits placard.

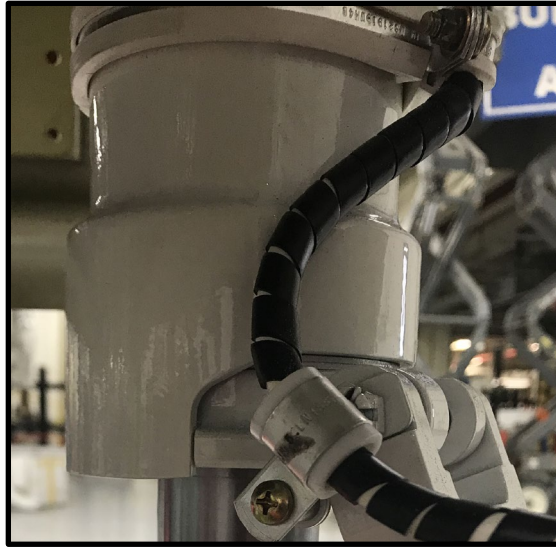
If the NLG is externally turned beyond the left or right placard limits, mechanical stops will engage where portions of the NLG and steering mechanism come into contact. If turned beyond limits to the right, a machined stop on the lower portion of the rotating strut assembly will contact a machined stop on the lower end of the stationary trunnion assembly, Figure 5. The right stops will engage when the NLG tire is turned about 36° right. Further turning to the right may damage the machined stops and will load the strut-trunnion interface but will not affect the steering arm or steering horn. If turned beyond limits to the left, the steering arm left flange aft face will contact the steering arm mount plate on the engine mount, Figure 6. The left stops will engage when the NLG tire is turned about 30.5° left. Further turning to the left may damage the steering arm or mount plate or may apply a torsional load to the steering horn installed on top of the NLG strut. The rudder primary and secondary mechanical stops do not allow the mechanical turn limit stops to engage through pilot input at the rudder pedals. There are machined stops on the left side of the lower strut and trunnion assemblies similar to those on the right. These stops can only engage during NLG retraction as the strut rotates 90° to stow in the wheel well.

*Figure 5-M600 Right turn mechanical stop between trunnion and strut just prior to engagement.*

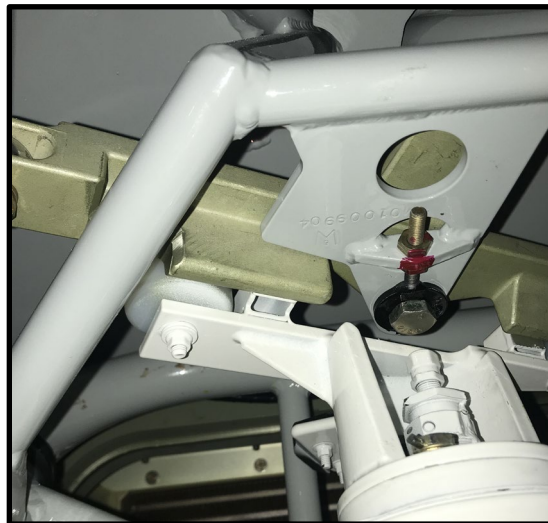
*Figure 6-M600 Left turn mechanical stop between engine mount and steering arm just prior to engagement.*
