**Cessna 177-A**

**N30309**

**NTSB Accident # ERA20LA245**

**FAA Inspector Statement**

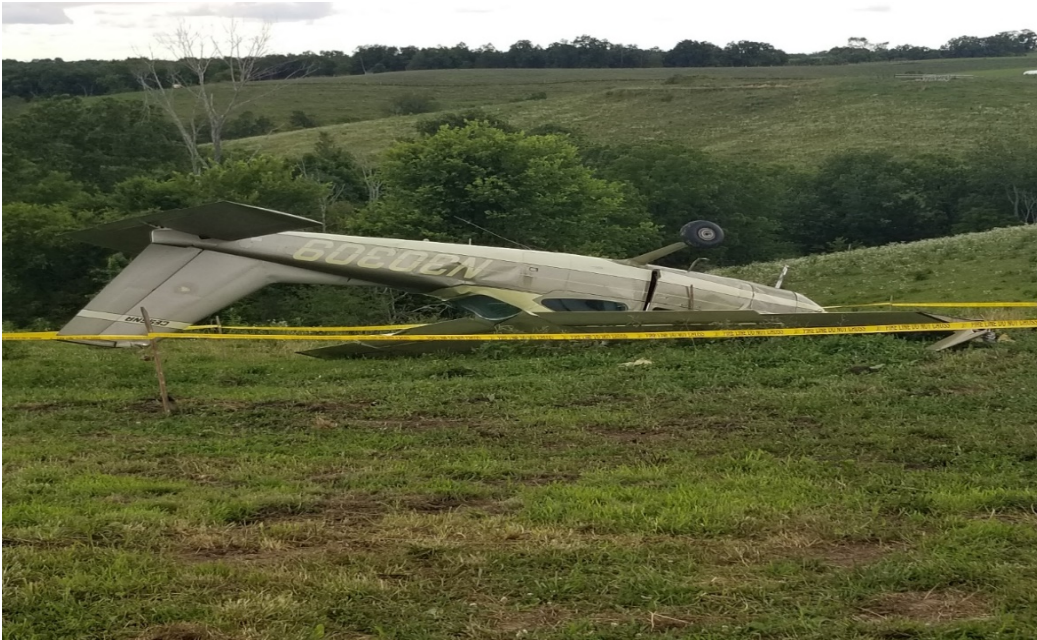
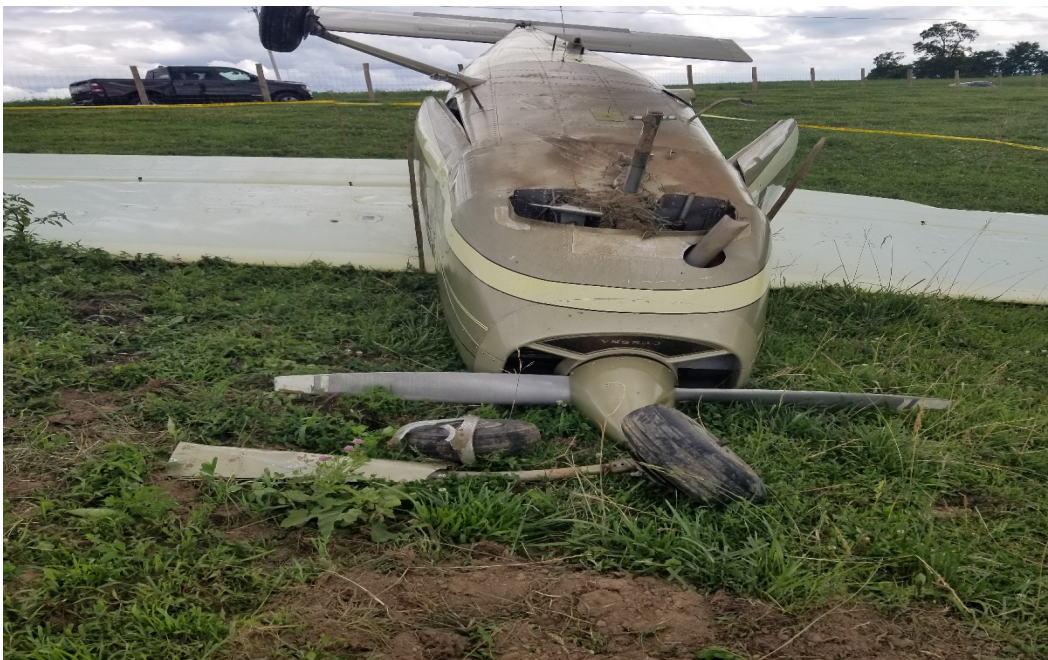
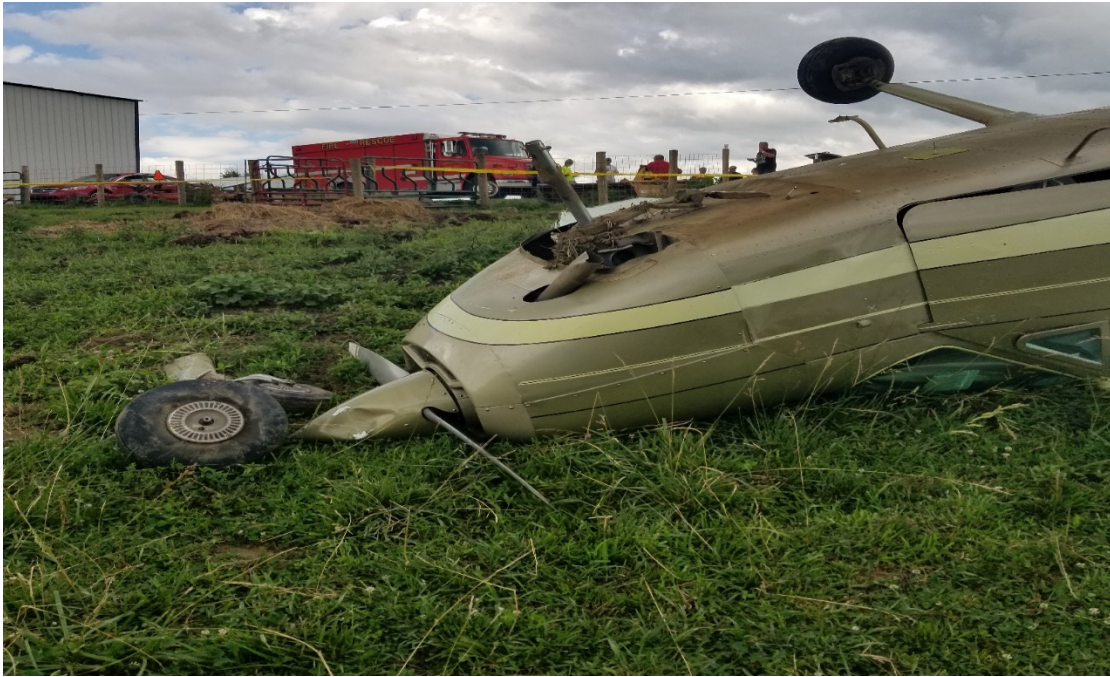
FAA Inspector in Charge (IIC) examined the wreckage on scene on July 12, 2020 and all major components were accounted for at the scene.
