## ENGINE ANALYTICAL INSPECTION REPORT

ENGINE MODEL: IO360B1DA2

ENGINE SERIAL: 03207

REGISTRATION: N800PB

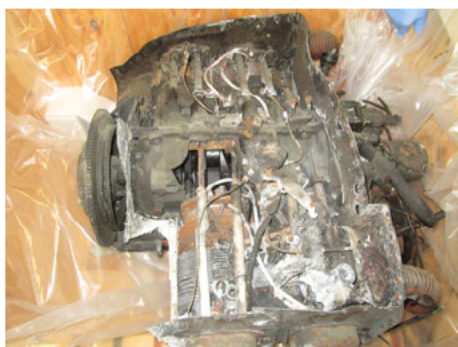
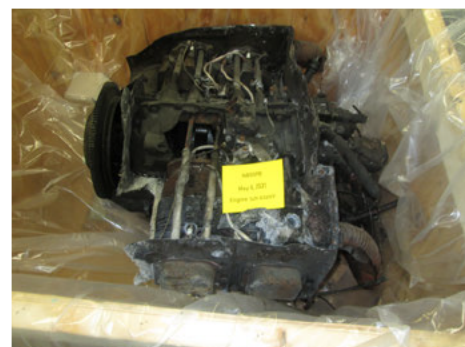
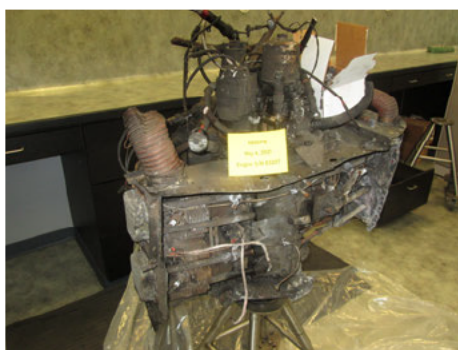
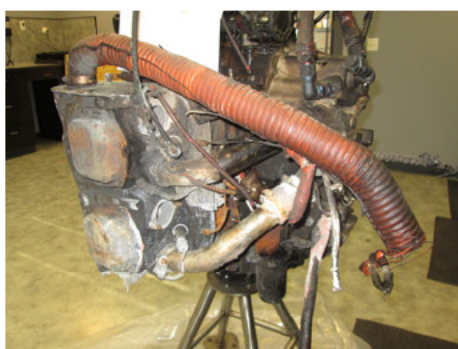
**EXTERNAL INSPECTION OF ENGINE:** The engine was received in a wooden crate and was not NTSB or FAA tagged. The box was undamaged. The engine was wrapped in plastic and secured to the engine crate.
