## **AIRWORTHINESS GROUP FACTUAL REPORT**

**NTSB No. ERA21FA130**

**Rolls-Royce Materials Evaluation Report No. 21FAE-025-PR  
(111 pages)**

| <b>TITLE</b><br><br><b>METALLURGICAL INVESTIGATION OF COMPRESSOR COMPONENTS REMOVED FROM AN M250-C20B, ENGINE S/N CAE833459, OPERATED BY CARIBBEAN BUZZ HELICOPTER</b> | | <b>PREPARED</b><br>Signatures on File | | |

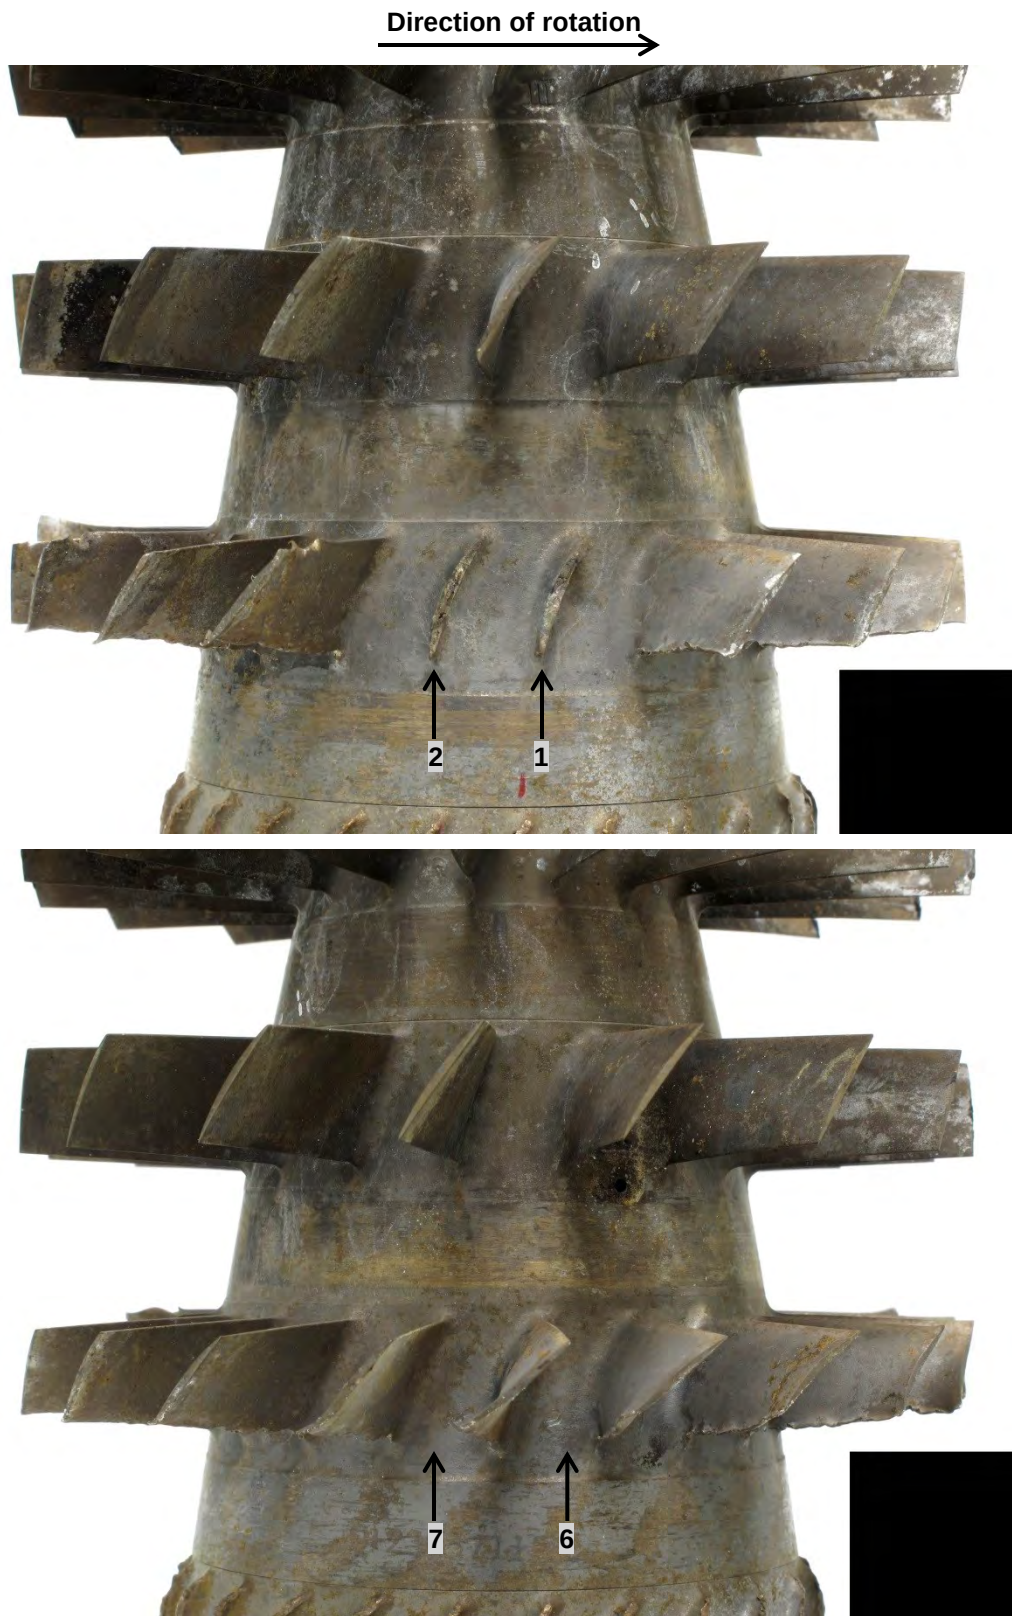
Figures 4 and 5 show the stage 2-3 compressor wheel prior to cutting it from the compressor rotor. Two adjacent stage 3 compressor blades were liberated from the wheel near the root (see Figure 4). For the purposes of this report, these two blades were labeled blades 1 and 2, and the rest of the blades were numbered counter to the direction of rotation. The trailing edge side of every stage 3 compressor blade was impact damaged. Five of the stage 3 blades also exhibited impact damage and deformation at the leading edge tip. The rest of the stage 3 compressor blade leading edges did not exhibit impact damage. None of the stage 2 compressor blades exhibited impact damage.

**Figure 4.** Detailed radial views of the stage 2-3 compressor wheel. Each image shows the wheel rotated approximately 90° from the previous. The black annotations indicate the blade numbering scheme used throughout this report.

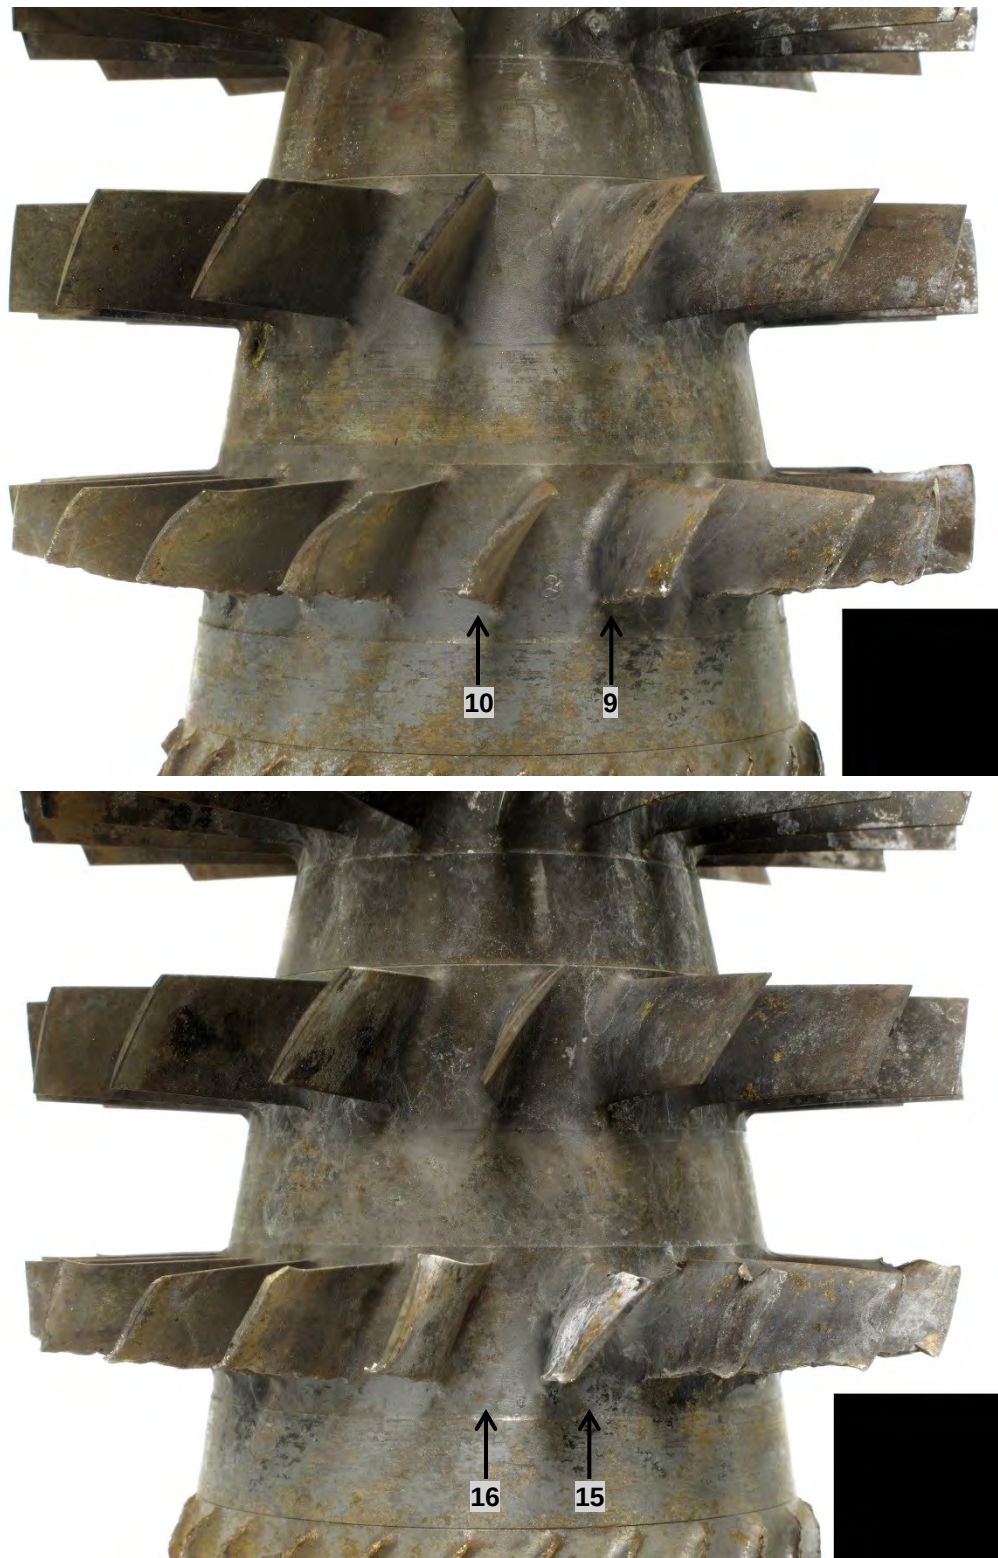
**Figure 5.** Detailed radial views of the stage 2-3 compressor wheel. Each image shows the wheel rotated approximately 90° from the previous. The black annotations indicate the blade numbering scheme used throughout this report.

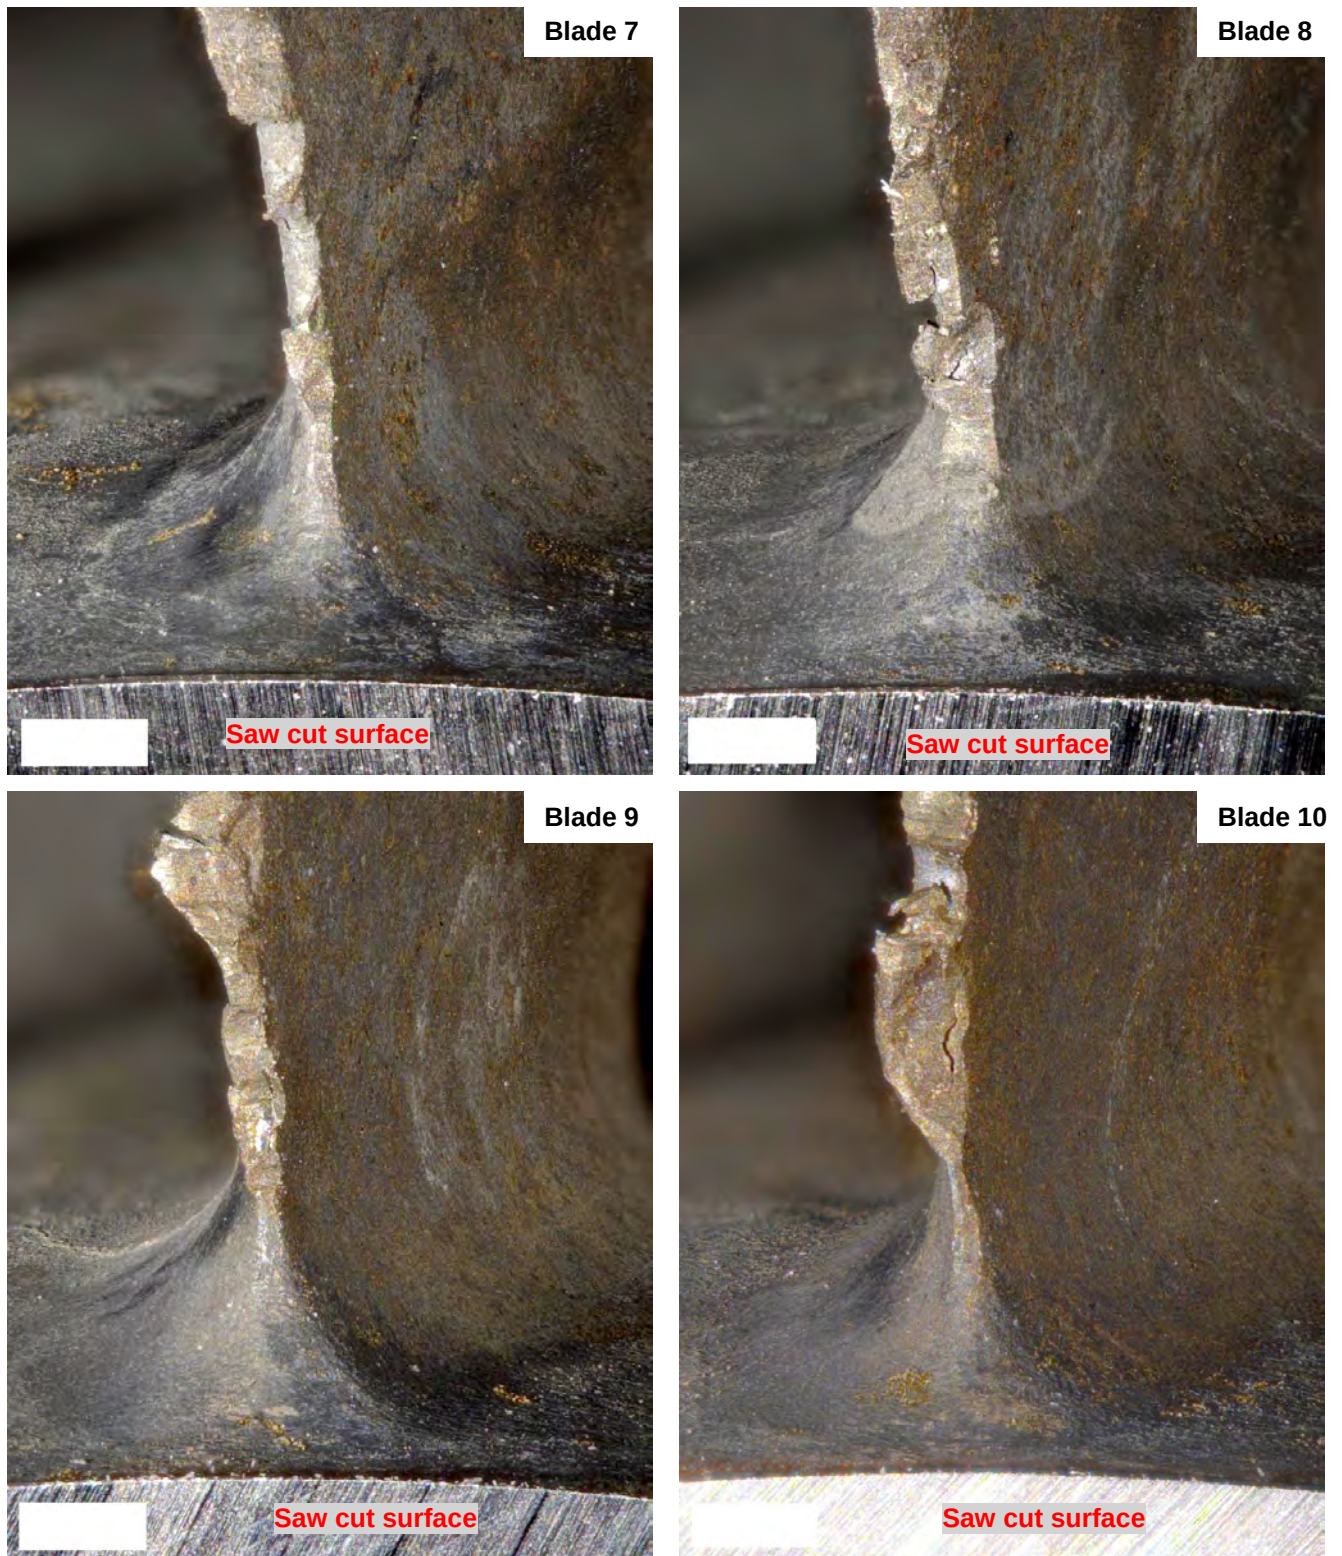
The compressor wheel exhibited generalized corrosion over the entire gas path surface. There were isolated areas on the inner diameter that also exhibited corrosion (see Figure 6). Figures 7 through 11 show detailed views of the trailing edge root areas of all the non-liberated stage 3 compressor blades. No corrosion pitting was noted on any of the blades. There was impact damage on every stage 3 blade trailing edge area, which obfuscated any visually detectable cracking on other blades; however, magnetic particle inspection (MPI) was performed by the Rolls-Royce Test Department to see if any other stage 3 blades exhibited crack-like indications. One blade (blade 16) had an MPI indication on the trailing edge, suction side radius; however, scanning electron microscope (SEM) examination of the area revealed that the indication was in an area of damage from the cutting process (see Figure 12). No other blades exhibited MPI indications.

**Figure 7.** Detailed images of the trailing edge root area of stage 3 compressor blades 3 through 6.

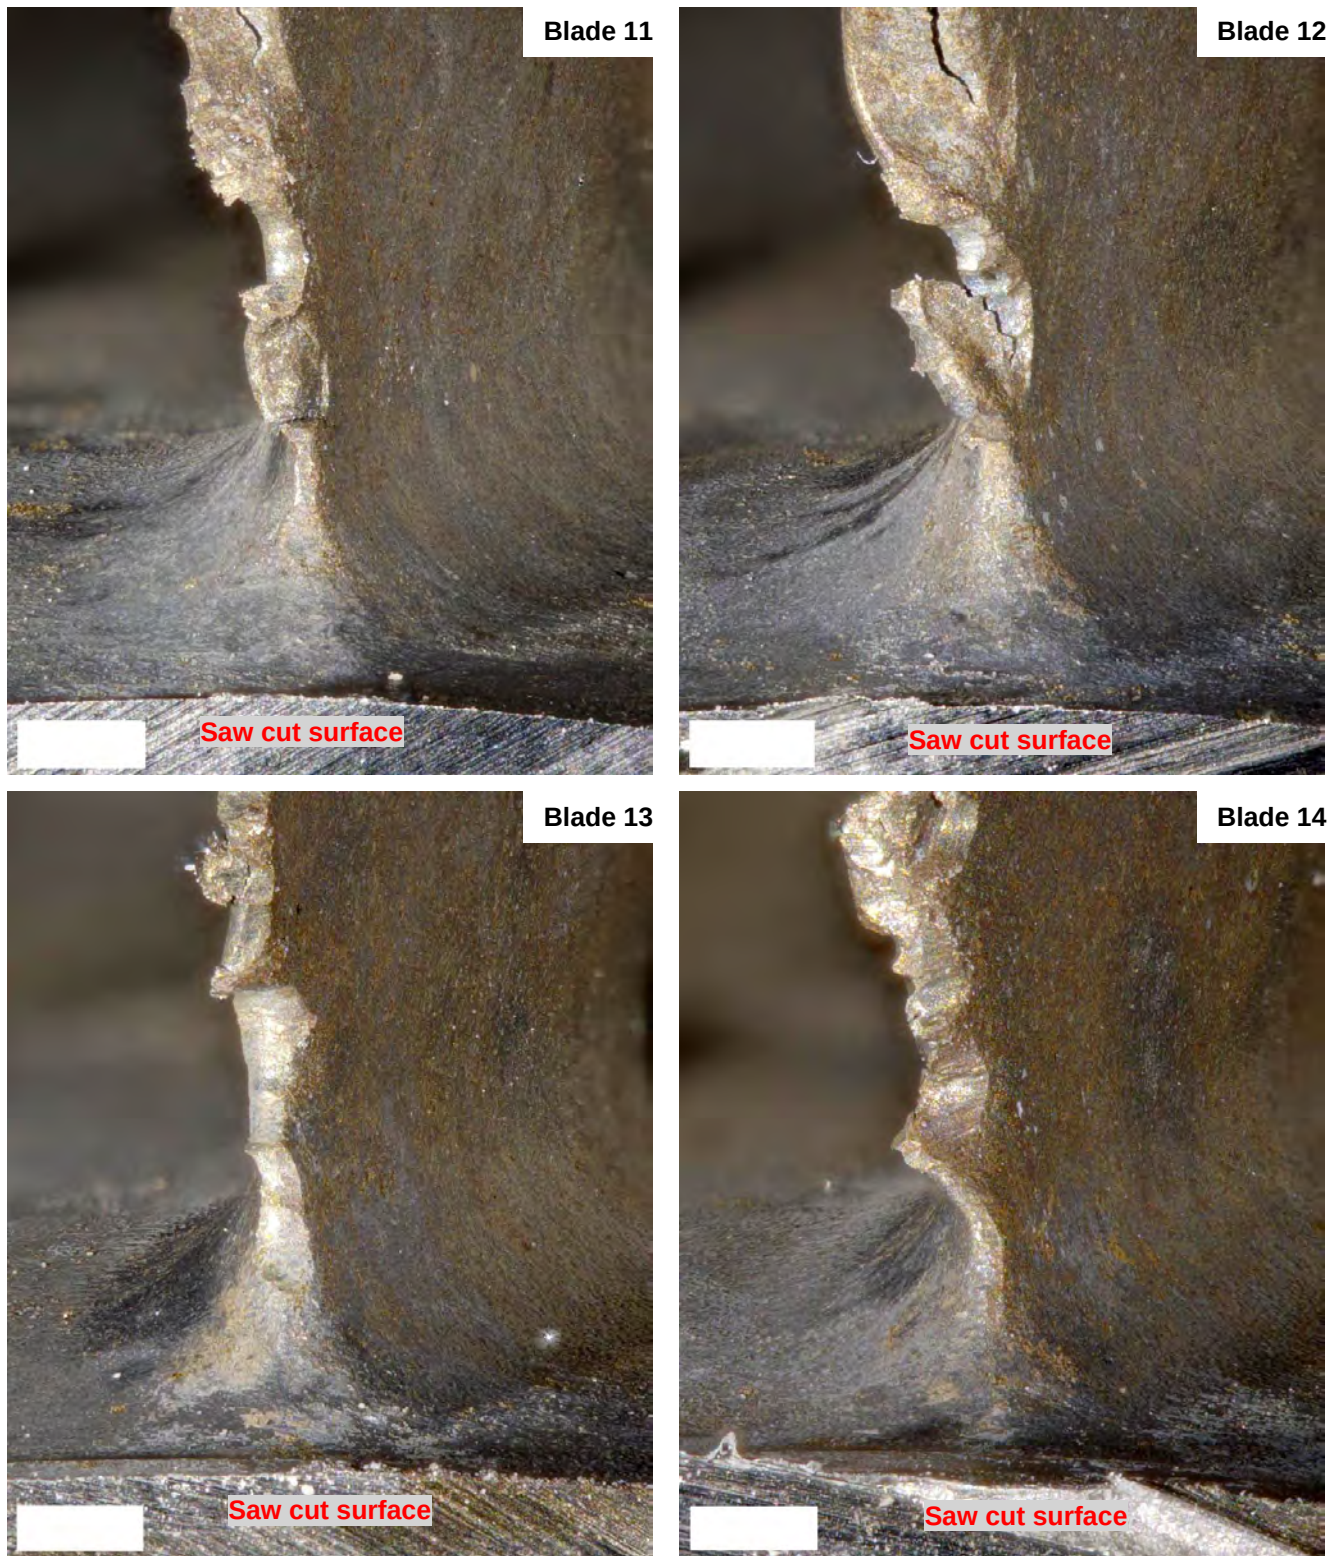
**Figure 8. Detailed images of the trailing edge root area of stage 3 compressor blades 7 through 10.**

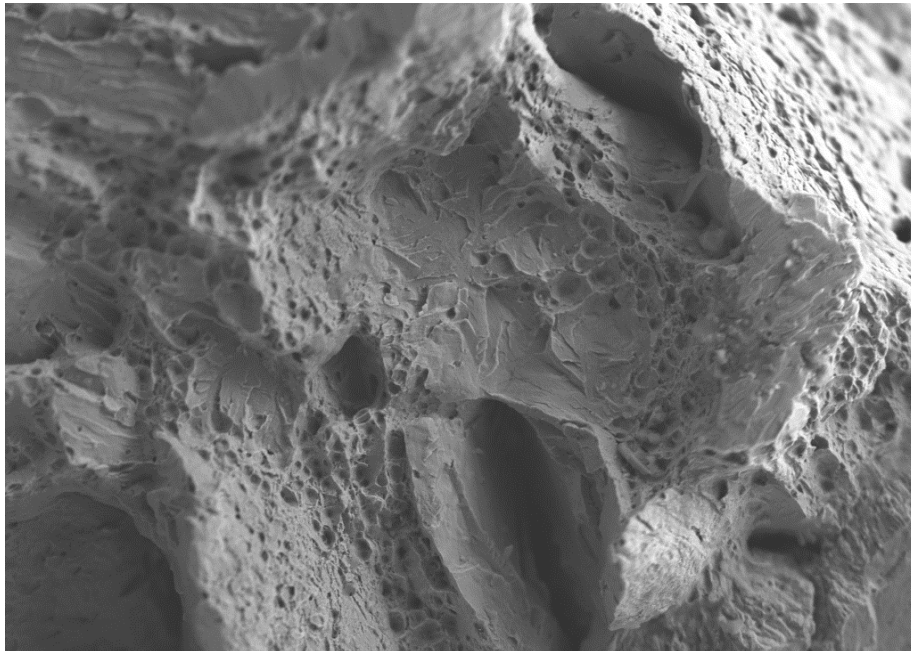
SEM examination of the fracture surface revealed fatigue progression from the impact damaged area on the trailing edge pressure side corner (see Figures 15 and 16). Figure 17 shows representative ductile fracture features from the overload region. Figure 18 shows the trailing edge of blade 1, which did not exhibit any geometric or material anomalies other than the aforementioned impact damage.

**Figure 16. Detailed secondary electron SEM images of fatigue fracture features from blade 1 (see Figure 14).**

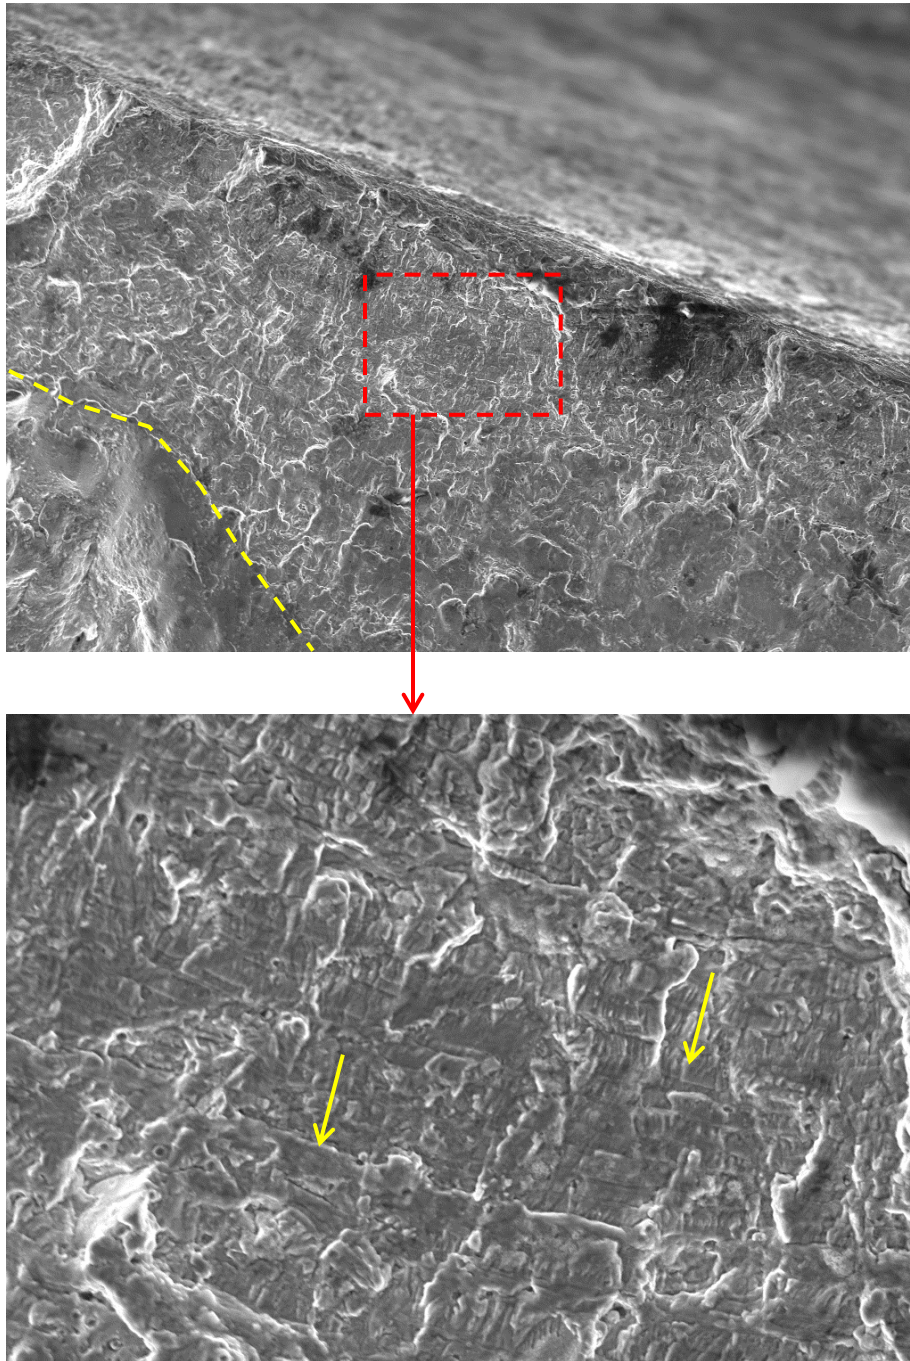
Figure 19 shows SEM images of the trailing edge of blade 2, which revealed two fatigue fractures initiating from multiple origins on the pressure side near the trailing edge. The total length of the fatigue crack was approximately 0.023 inch along the pressure side surface, extending from the trailing edge. Figures 20 and 21 show detailed SEM images of fatigue fracture features from multiple initiations on the pressure side surface of

**Figure 20.** Secondary electron SEM images of area C from Figure 19. The yellow dashed line indicates the approximate boundary of the fatigue region. The yellow arrows indicate the local direction of fatigue progression.

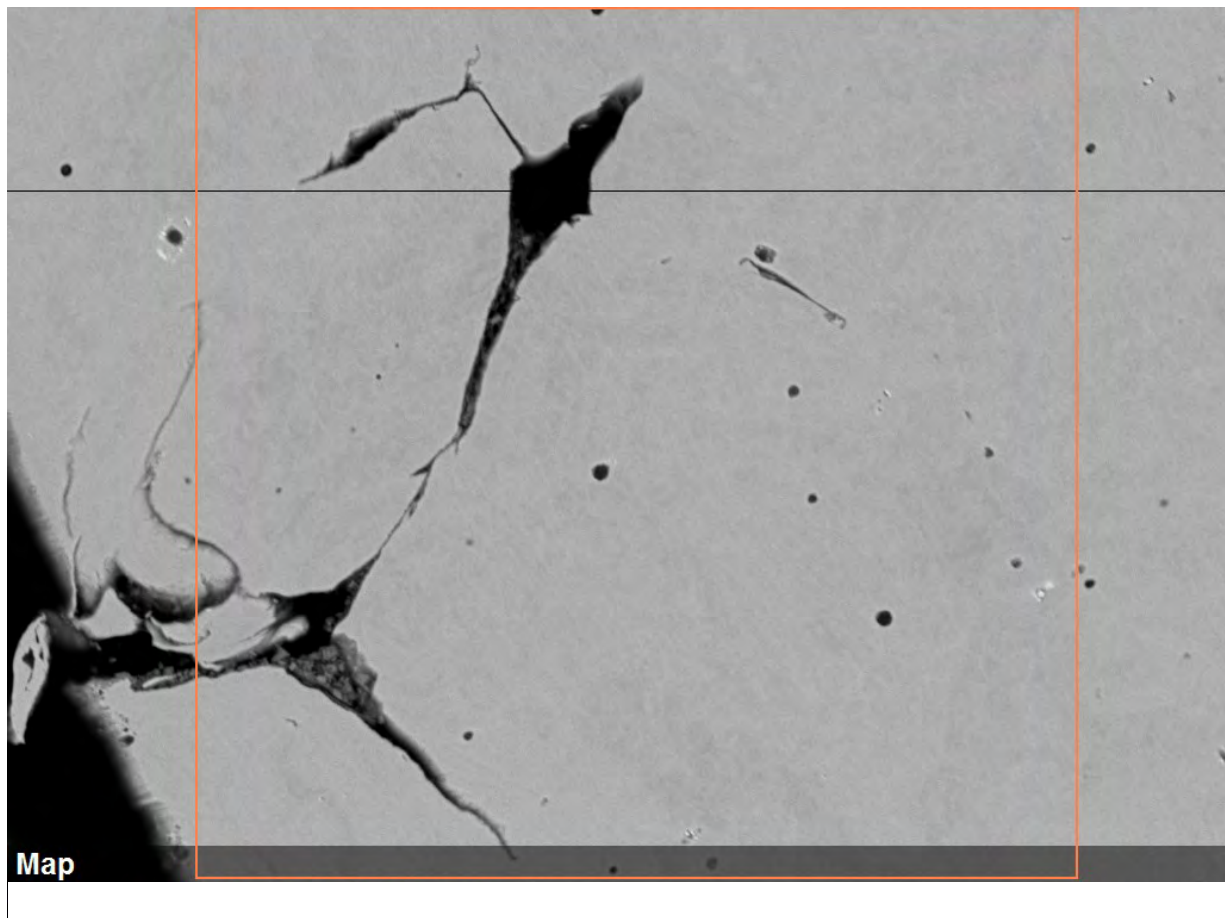
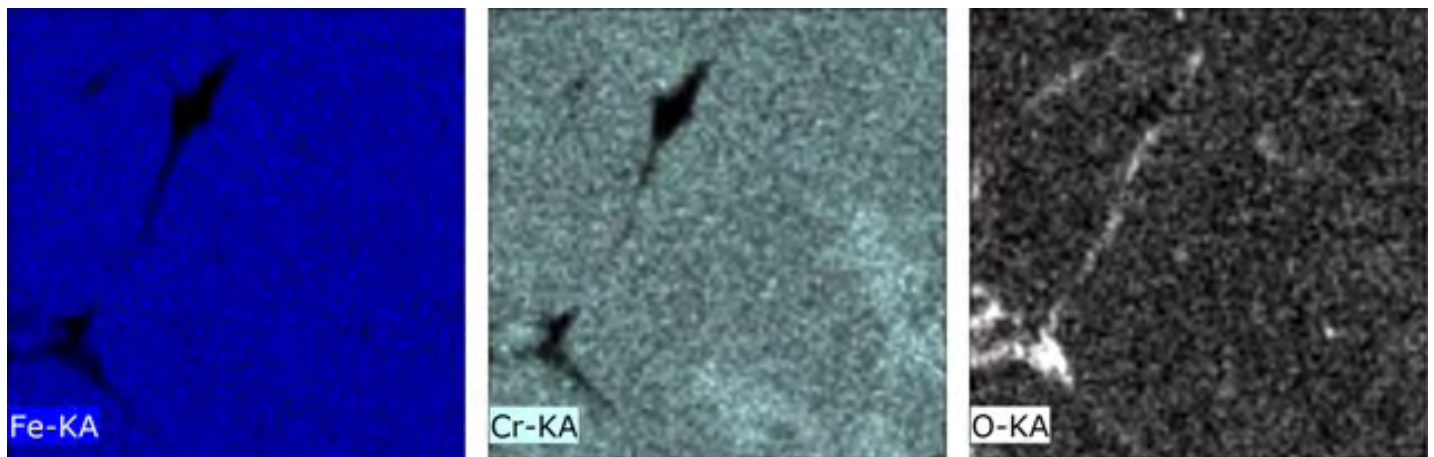
Figure 23 shows the cross section on the first plane of polish. The fracture surface was approximately 0.12 inch above the rim at this plane of cross section. Figure 24 shows the trailing edge origin area at the first plane of cross section and Figure 25 shows the trailing edge origin area at the second plane of cross section. Both planes of cross section exhibited subsurface voids (see Figure 26). The second plane of cross section exhibited one area on the suction side of the blade in the impact damaged area where the voids appeared to have an intergranular morphology. An etched view of this area is shown in Figure 27. Energy dispersive x-ray spectroscopy (EDS) mapping of the area showed that there were elevated levels of oxygen in the area that appeared to have an intergranular morphology (Figure 28).

**Figure 27. Montage of etched metallographic images of the area of the cross section in Figure 25 that exhibited subsurface voids. The area in the red dashed box is shown in Figure 28.**

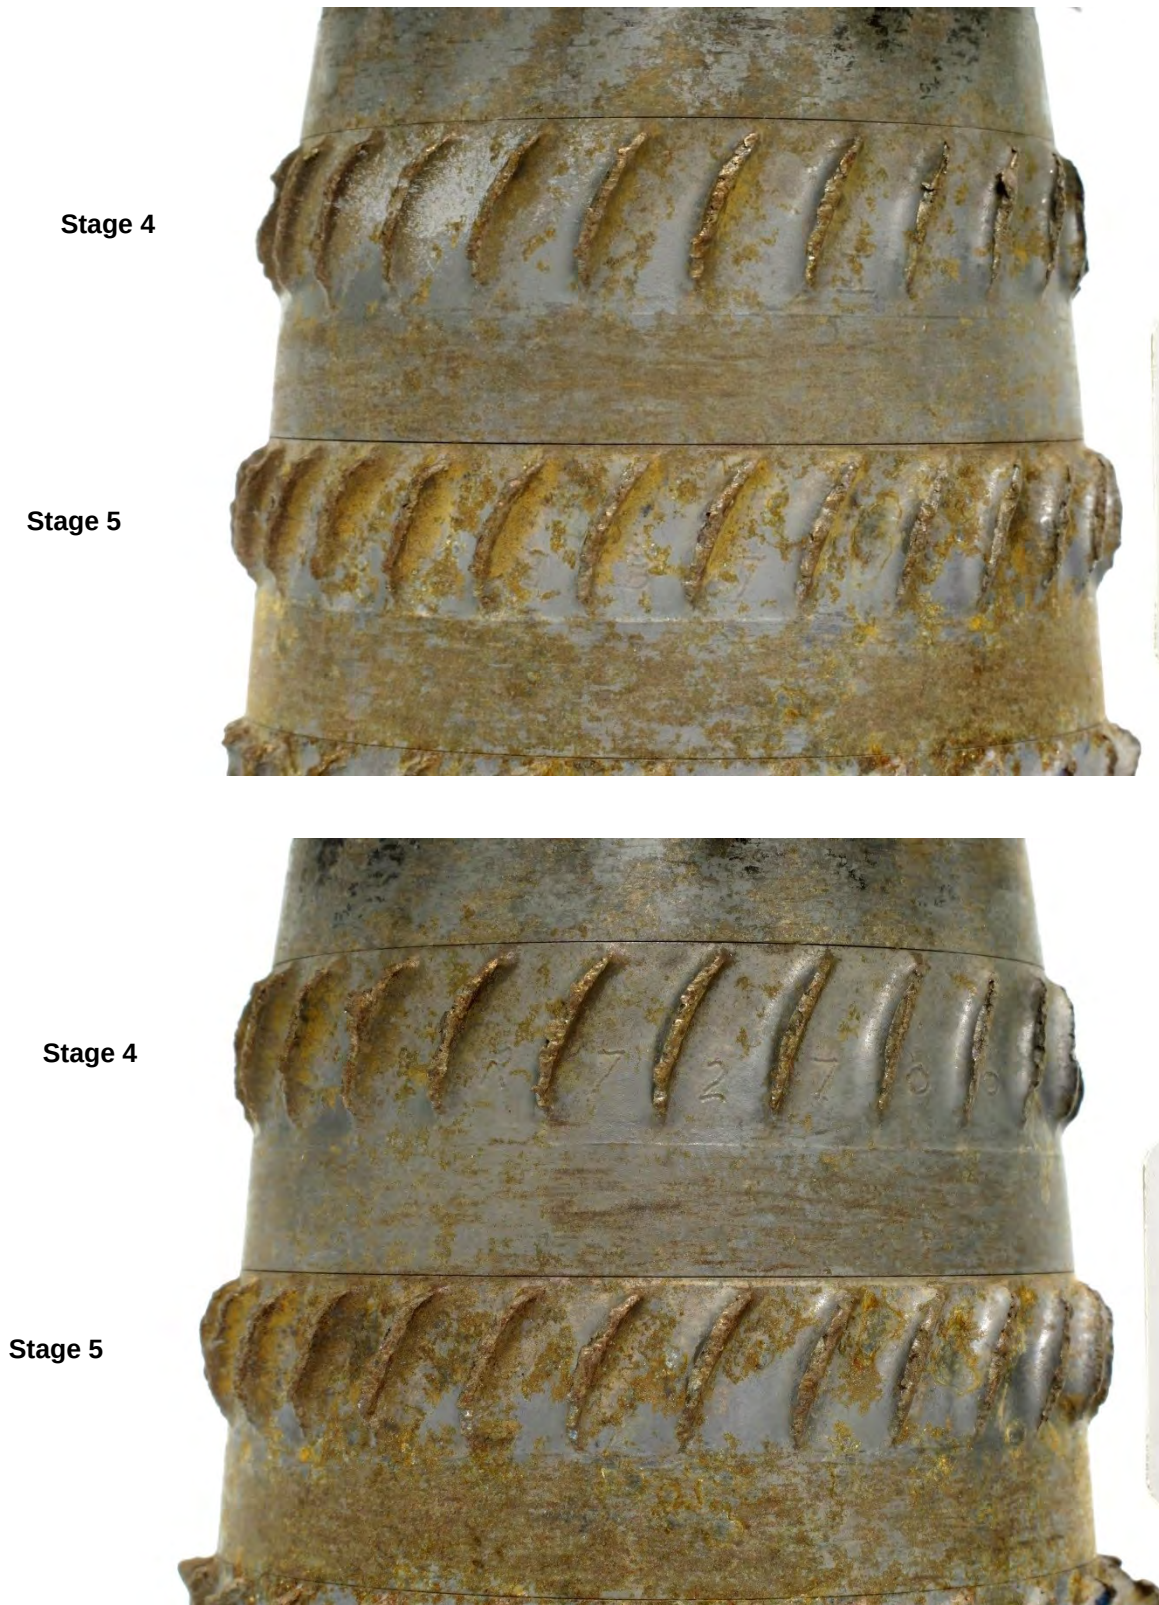
**Figure 31. Detailed radial views of the stage 4 and 5 compressor wheels, while still in the rotor stack. Each image shows the rotor rotated approximately 90° from the previous.**

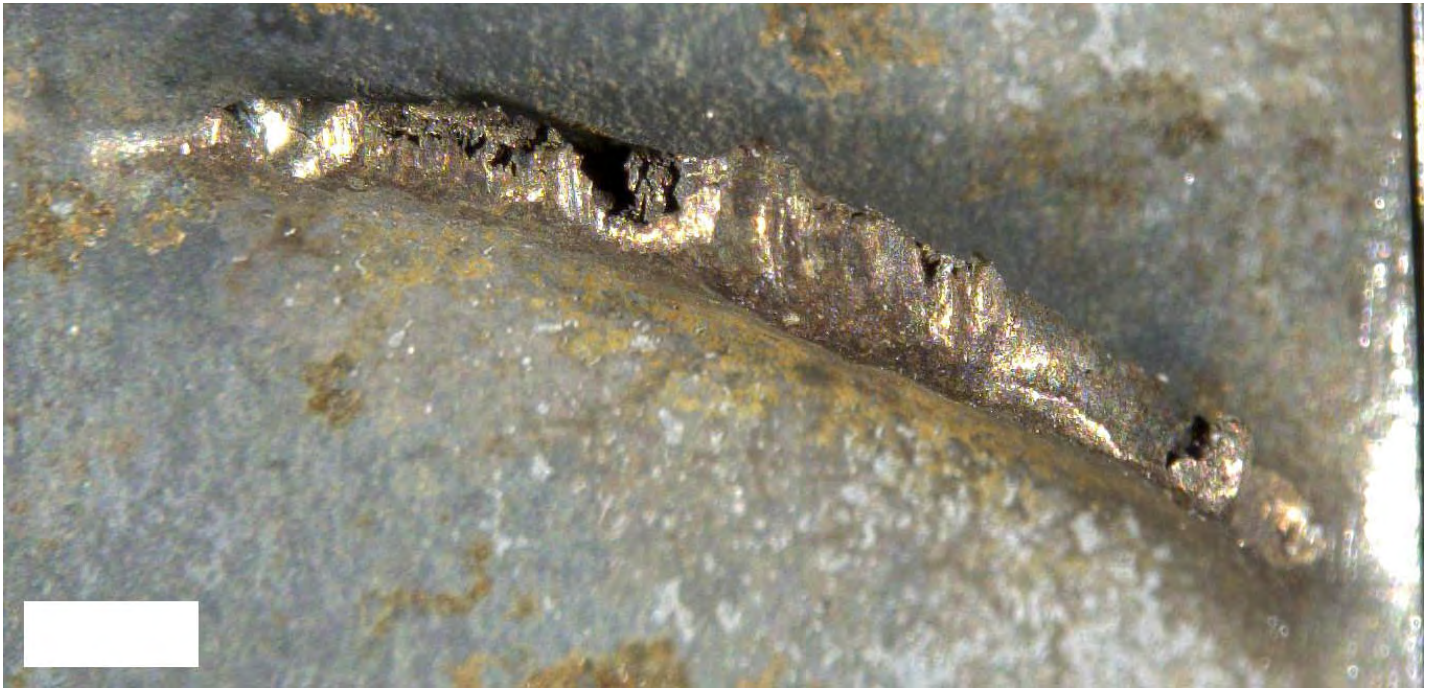
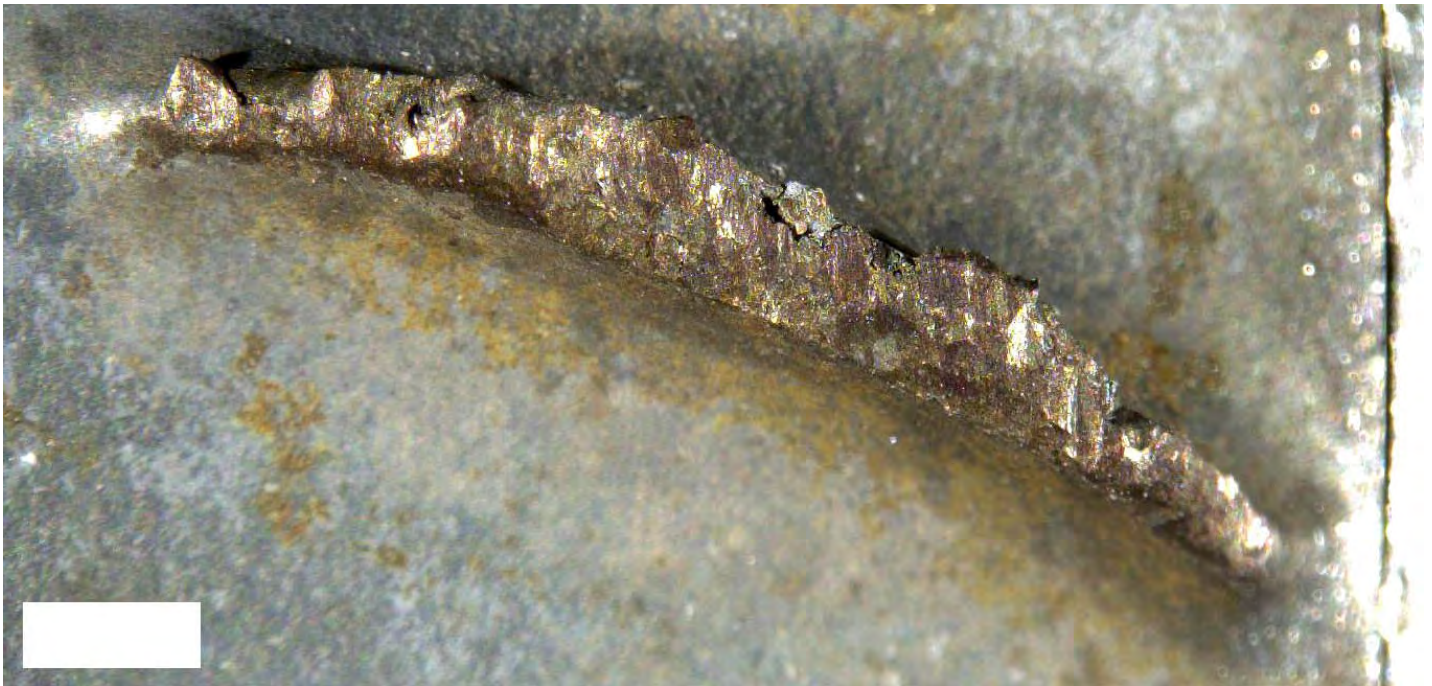
**Figure 35. Detailed views of two stage 4 blade fracture surfaces. No fatigue fracture features were present on either of the fracture surfaces.**

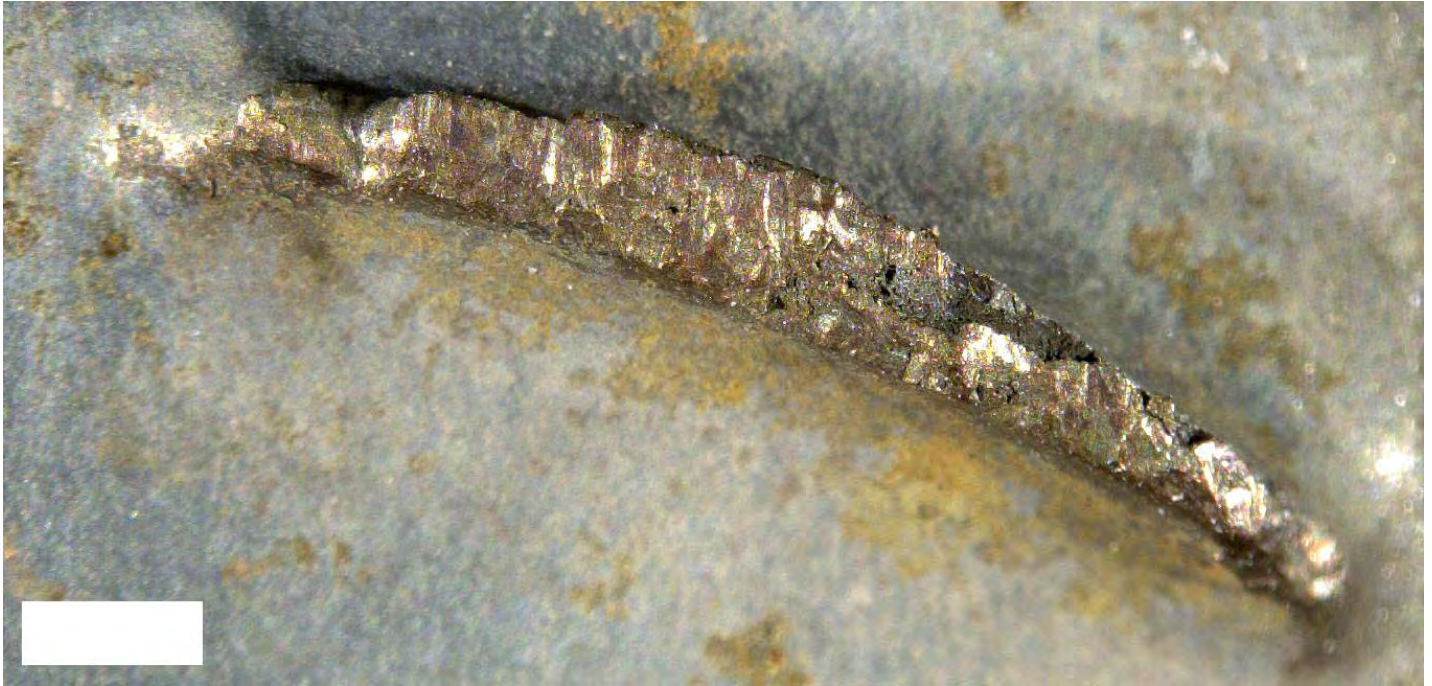
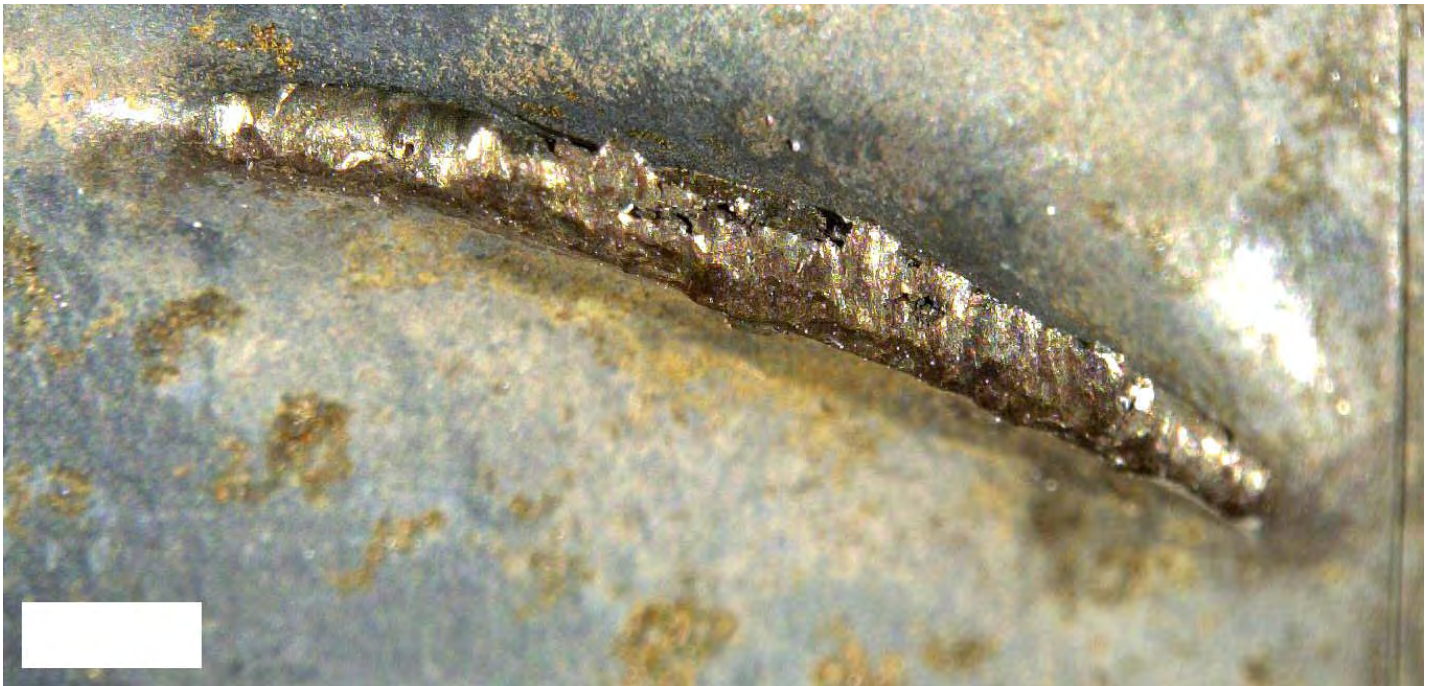
**Figure 36. Detailed views of two stage 4 blade fracture surfaces. No fatigue fracture features were present on either of the fracture surfaces.**

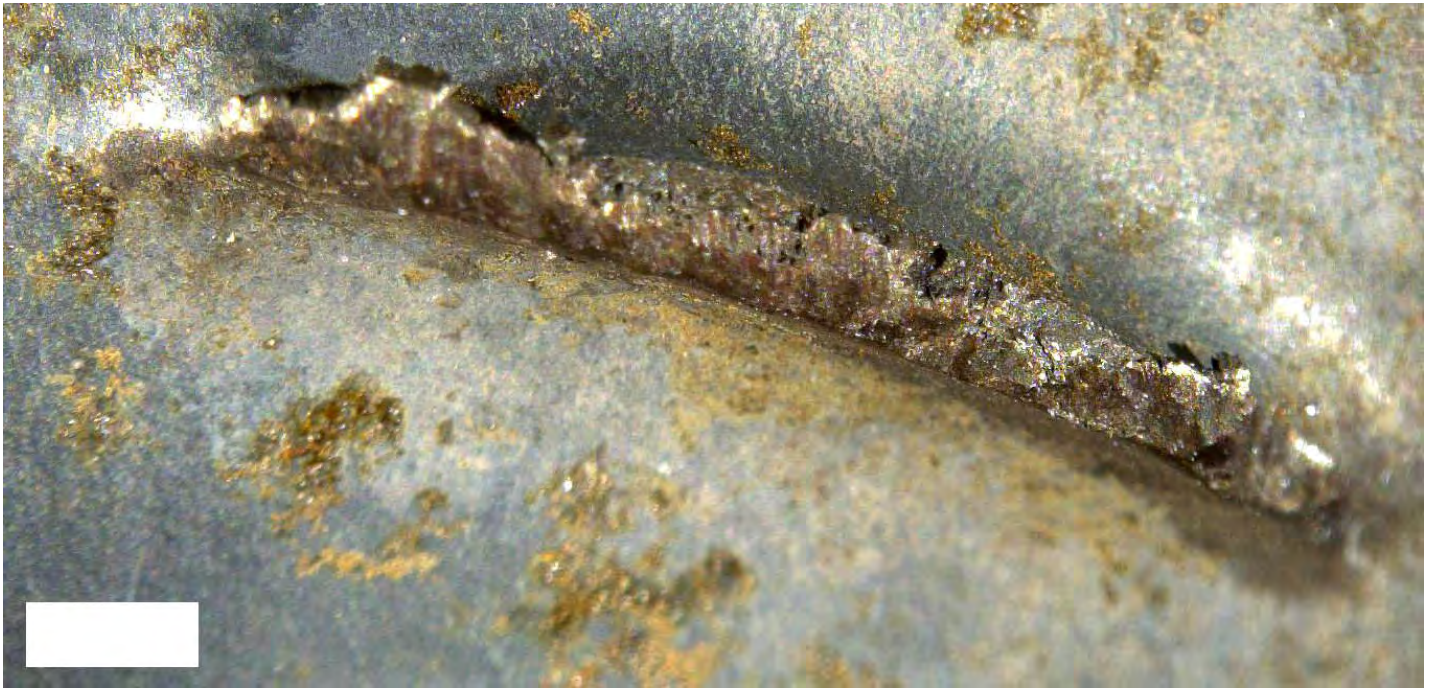
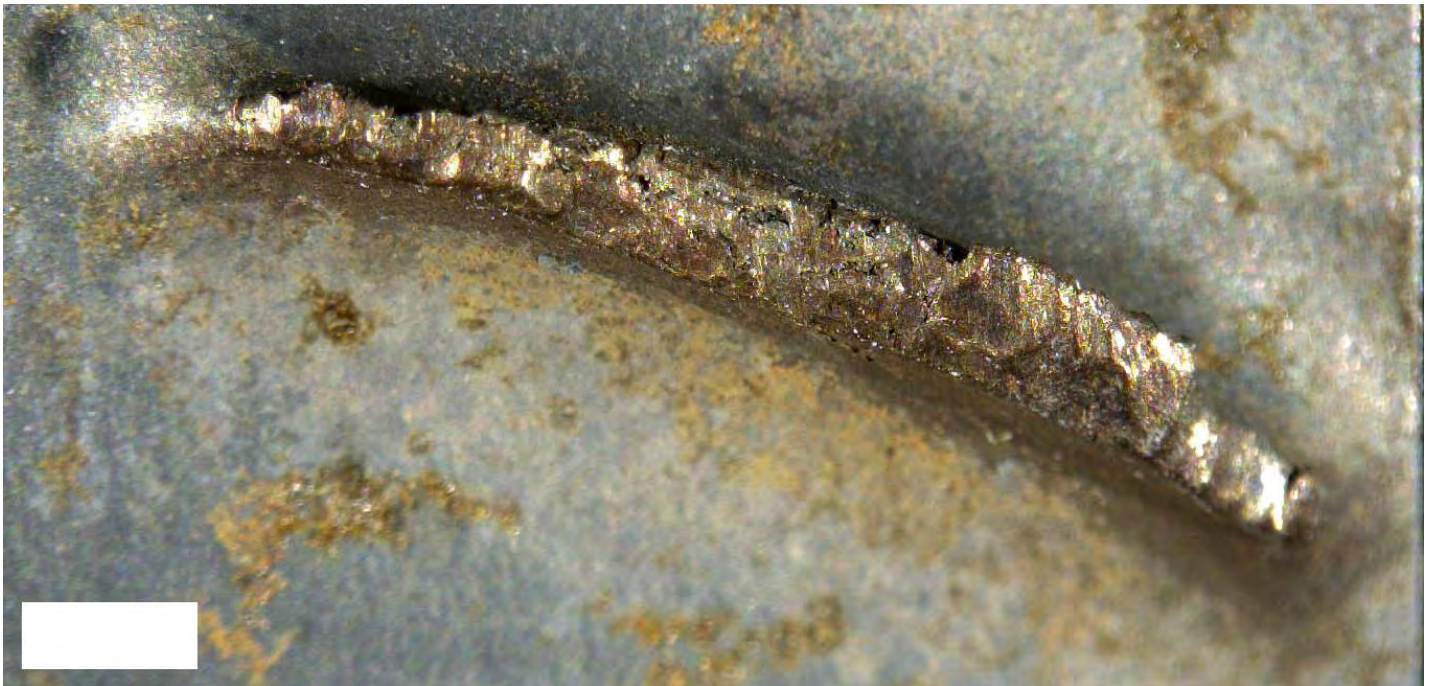
**Figure 37. Detailed views of two stage 4 blade fracture surfaces. No fatigue fracture features were present on either of the fracture surfaces.**

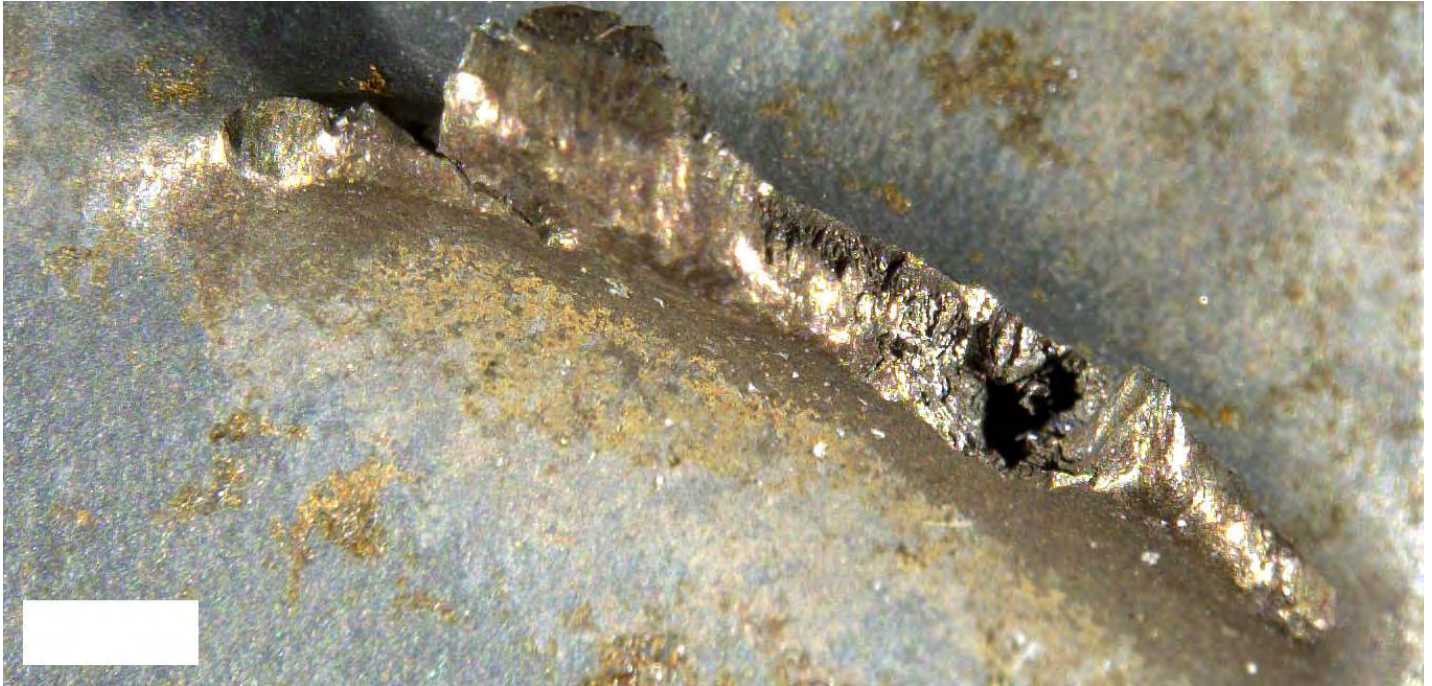
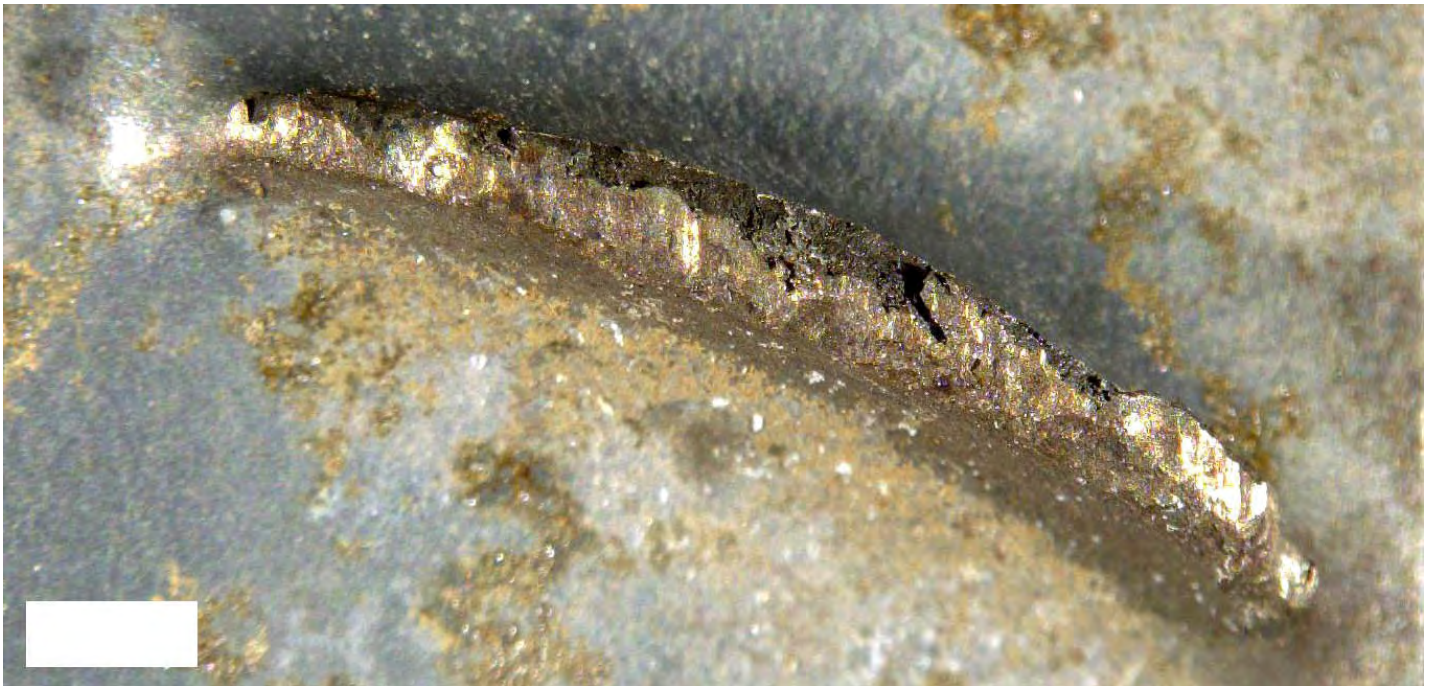
**Figure 38. Detailed views of two stage 4 blade fracture surfaces. No fatigue fracture features were present on either of the fracture surfaces.**
